I-15 Express Lanes Project Southern Extension

RAPID ASSESSMENT OF STREAM CROSSINGS

Riverside I-15, PM 20.3/PM 40.1

December 2021

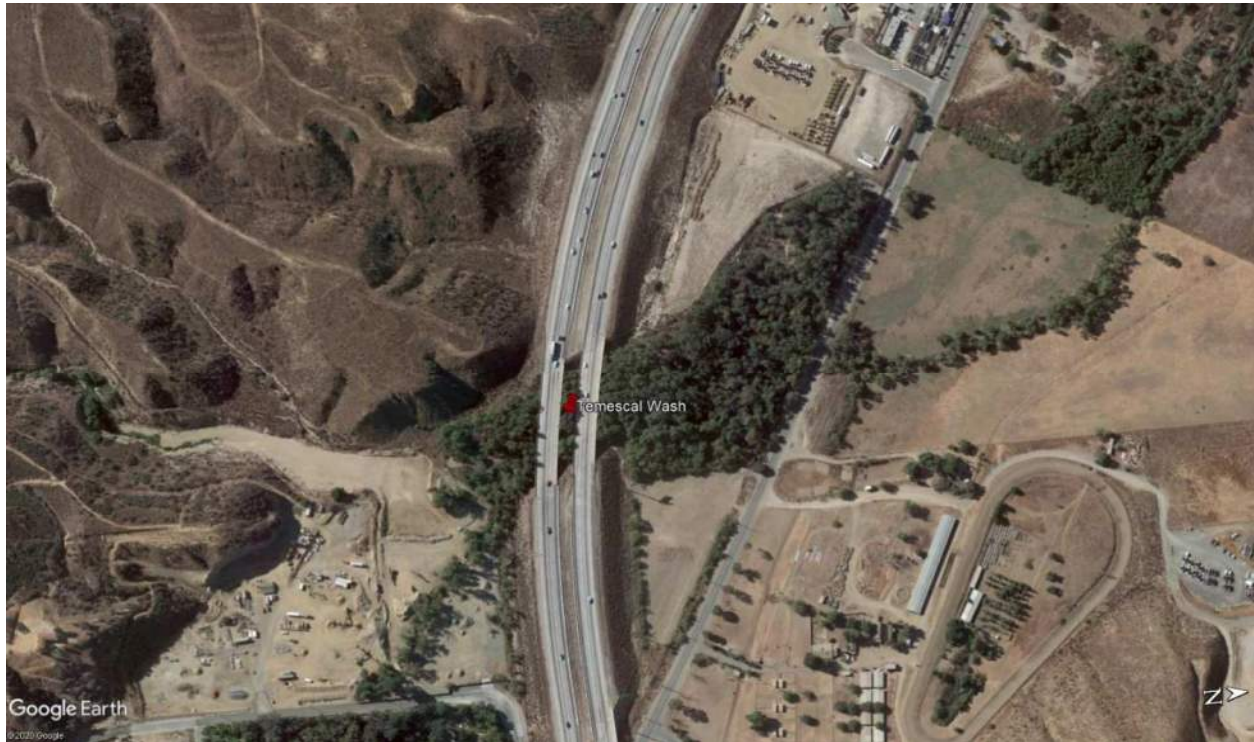
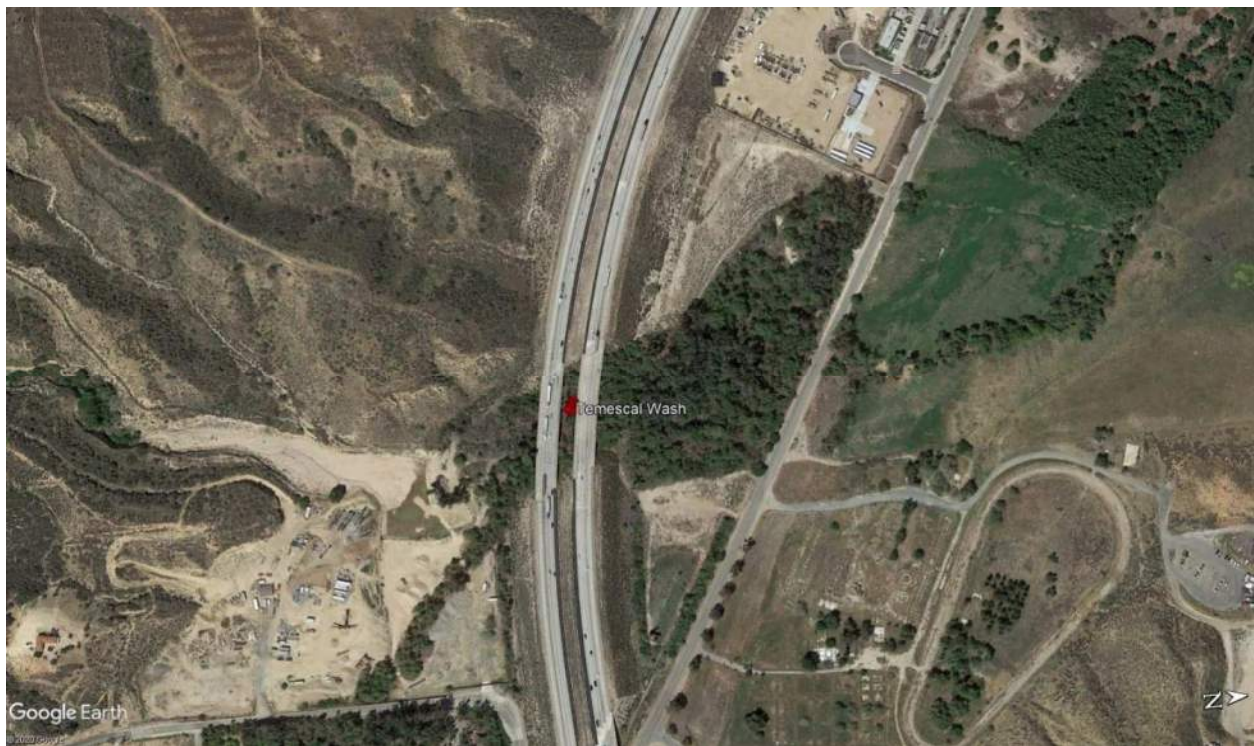
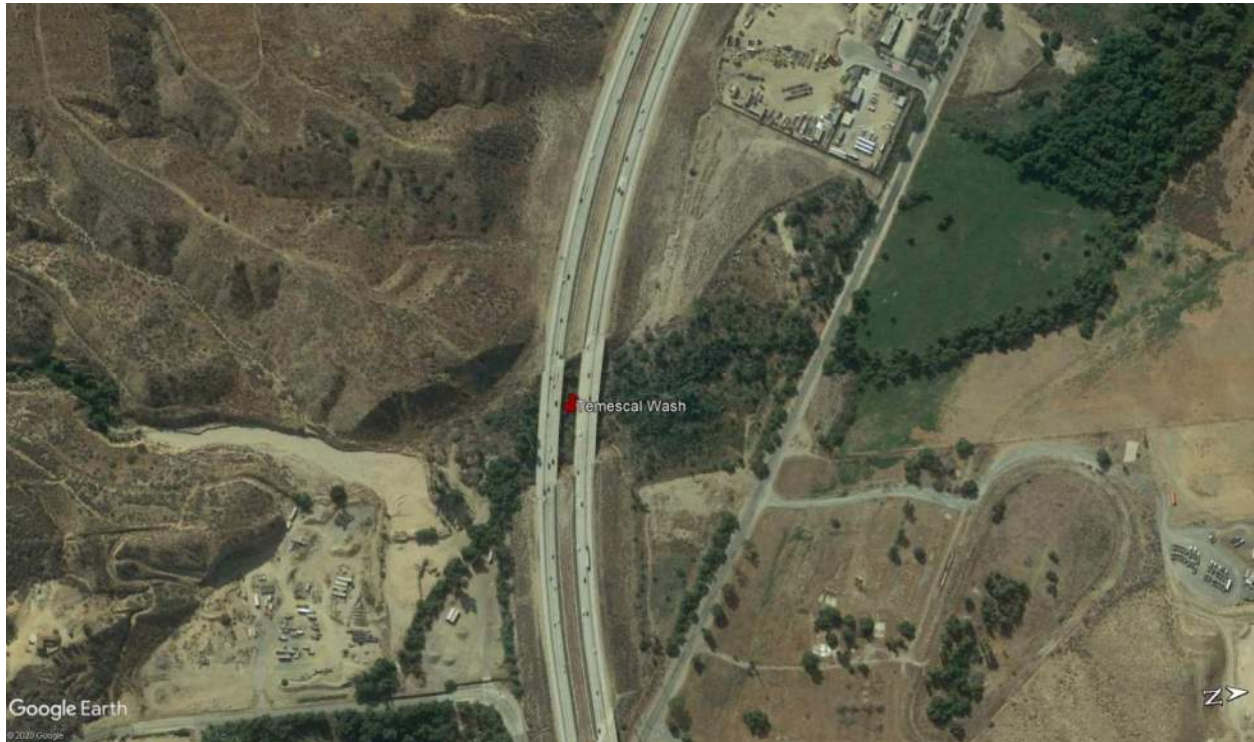
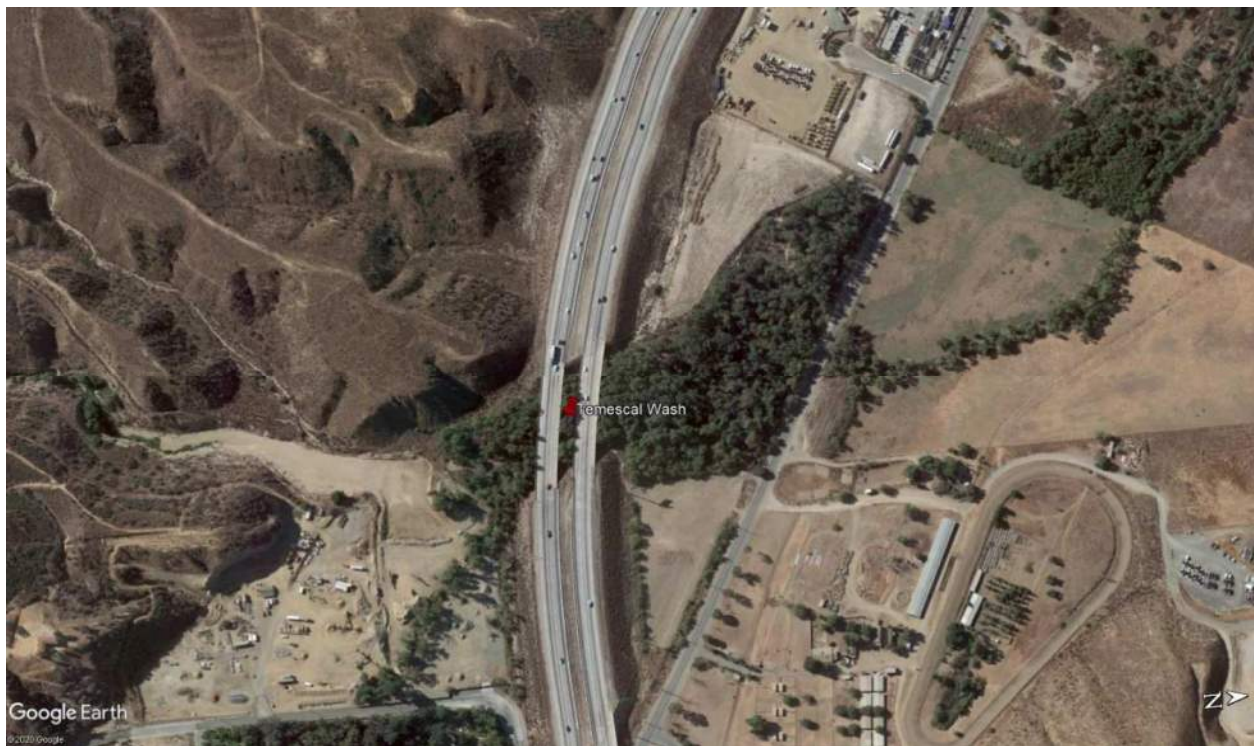
The bridge inspection report (BIR) for Temescal Wash Bridge, dated February 19, 2020, states that the channel has soft sandy bottoms with an abundant number of trees and vegetation. The channel does not contain side-slope protection. Abutment 1 near the north end has eroded up to 2 feet wide by 3 feet deep. No obvious scour or exposed foundation was observed during the inspection. Figures 3-1 to 3-4 show aerial images of Temescal Wash taken from Google Earth at various times of the year. As shown in the figures, there is little evidence of geomorphology or channel instability.

The upstream reach of Temescal Wash is a meandering stream that is trapezoidal in shape and crosses under two pedestrian bridges and one local road. The side slopes are flatter in this area and the incised channels have minimal channel confinement. Further down the upstream reach, the channel confinement increases and there is more evidence of mass wasting and bank erosion. The channel bottom is approximately 35 feet wide. On the downstream reach, the channel continues to be confined with exposed channel banks. The banks are densely vegetated and vary from flat to vertical slopes. Human-made debris and large woody debris is present in the channel causing flow and channel alignment to divert. As the reach approaches Temescal Canyon Road, the flow is directed into eight corrugated metal pipes. This downstream-most cross section is fairly confined and has dense vegetation in the channel bed. Channel bank distress can be observed from the presence of root exposure and mass wasting.

The following figures (3-1, 3-2, 3-3, 3-4) show the Temescal Wash area over more than a decade of time.

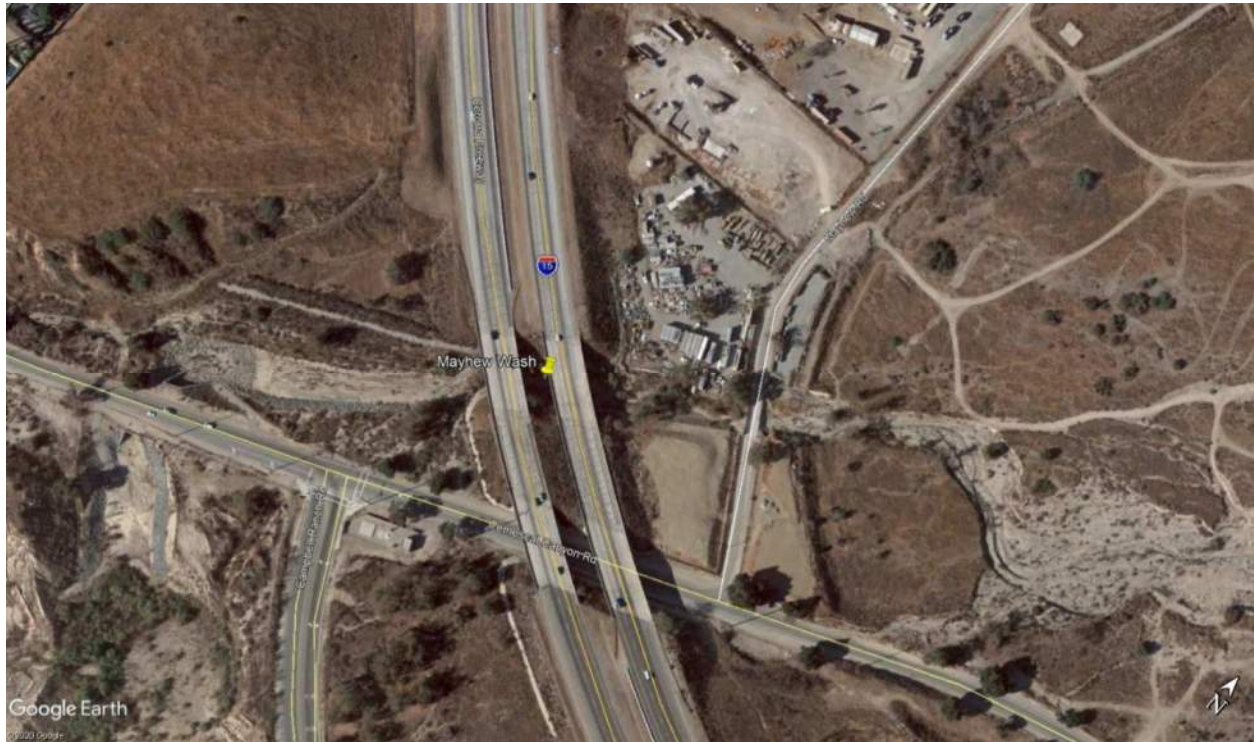
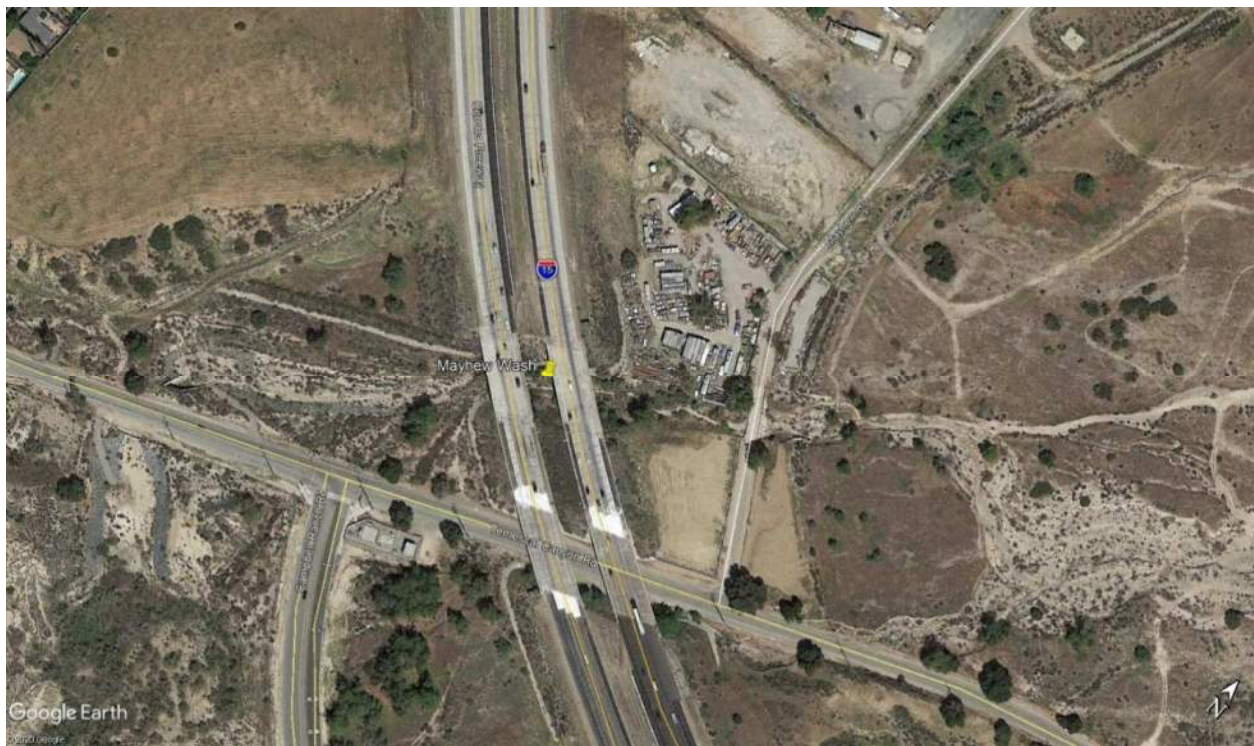
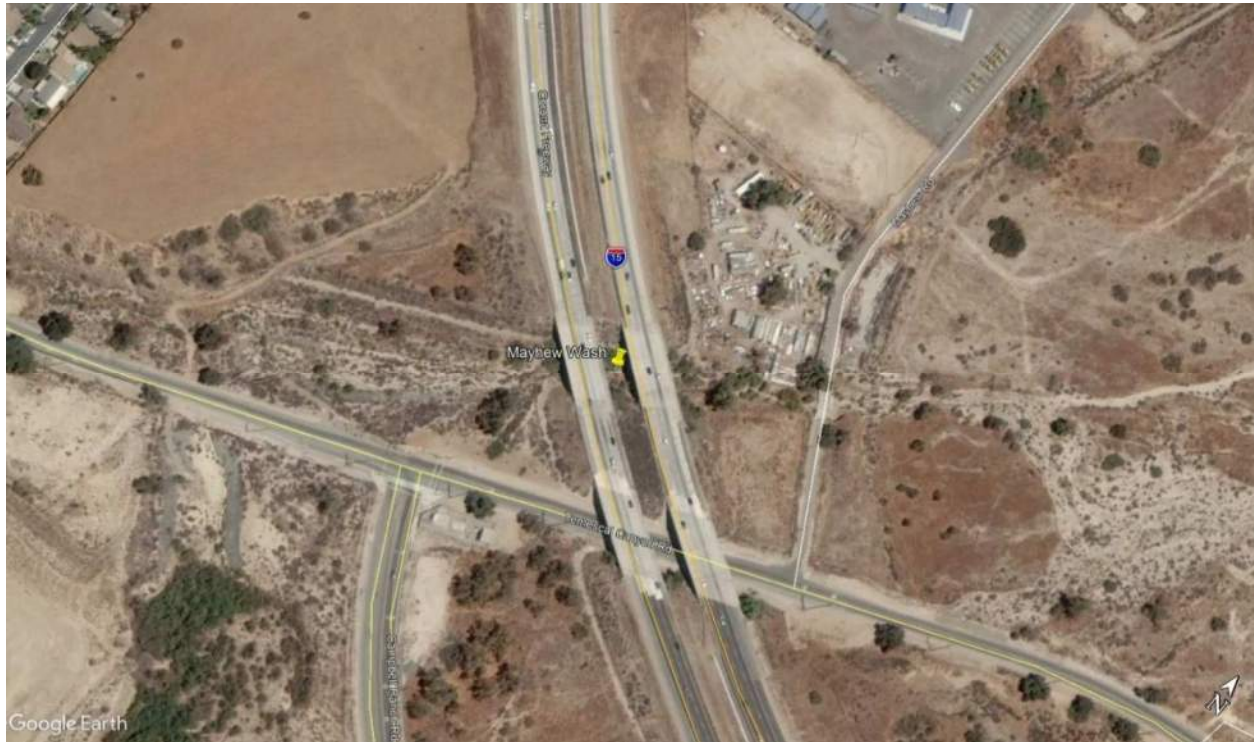
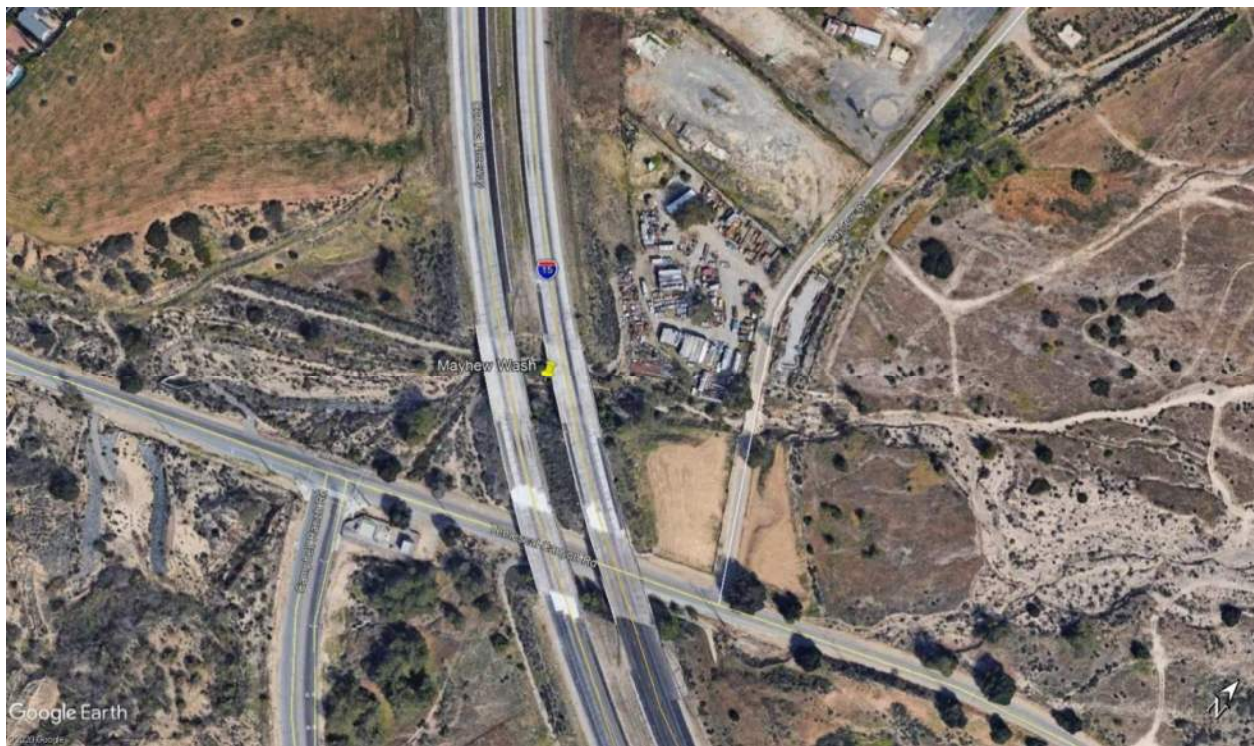
The bridge inspection report for Mayhew Wash Bridge dated February 24, 2018 states that the channel has minor vegetation and a soft sandy bottom. The south embankment has partial concrete lined side slope protection; it is roughly 6.5 feet high, while the north embankment has partial rock side slope protection roughly 6.5 feet high with concrete slurry. The channel consists of disturbed open area downstream and of open vegetated areas with pockets of non-vegetated areas upstream.

During the site visit, the observations made substantiated the BIR. Erosion was observed at an abutment on the north end of the bridge. The erosion exposed a minor portion of the concrete side-slope. The channel itself was dry during the site visit, suggesting it was experiencing an ephemeral flow condition. Layers of sand and gravel were present in the channel underneath the bridge.

The following figures (3-5, 3-6, 3-7 and 3-8) show the Mayhew Wash area over more than a decade of time.
