Interstate 15 Express Lanes Project Southern Extension (ELPSE)

RIVERSIDE COUNTY, CALIFORNIA
DISTRICT 8 – RIV-15 PM 20.3 TO PM 40.1
EA: RIV 08-0J0820 / ID: 08-18000063

Jurisdictional Delineation Report

September 2021

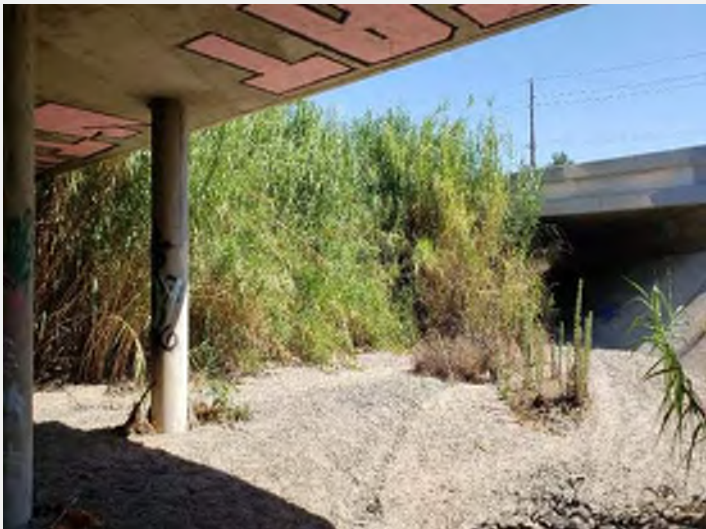
<p>Photograph #: 21.5-1_1</p> <p>Photo Date: 8/12/20</p> <p>Feature Number: 21.5-1 (Wasson Canyon Wash)</p> <p>Direction: Northeast</p> <p>Notes: View of Wasson Canyon Wash showing giant reed (<i>Arundo donax</i>) in opening between SB and NB I-15 Bridges.</p>

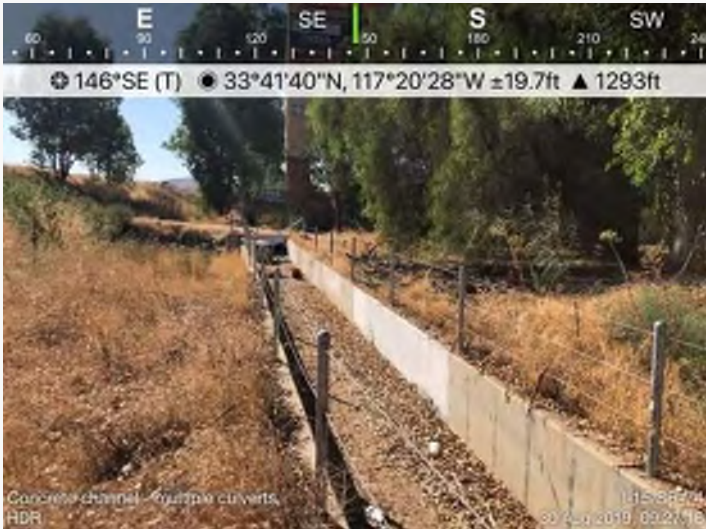
<p>Photograph #: 22.5-1_1</p> <p>Photo Date: 8/29/19</p> <p>Feature Number: 22.5-1 (Arroyo Del Toro Channel, Segment 1)</p> <p>Direction: Southeast</p> <p>Notes: View of Feature 22.5-1 towards upstream.</p>

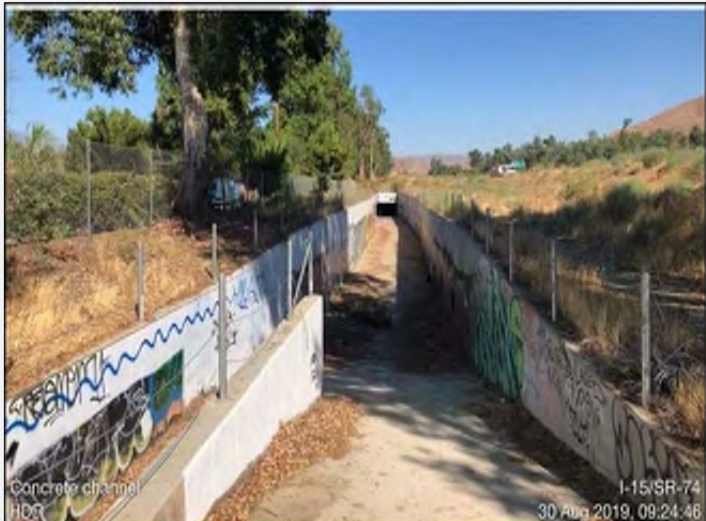
<p>Photograph #: 22.6-1</p> <p>Photo Date: 8/30/19</p> <p>Feature Number: 22.6-1</p> <p>Direction: Northwest</p> <p>Notes: (Arroyo Del Toro Channel, Segment 2)</p>

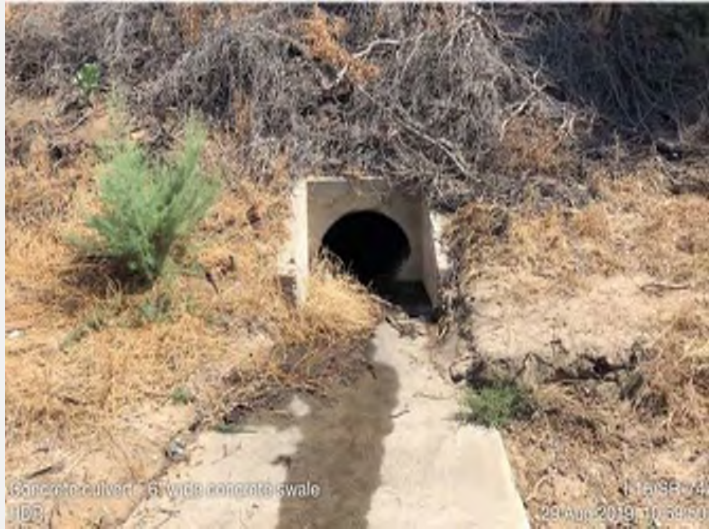
Photograph #: 23.1-1_1
Photo Date: 8/29/2019
Feature Number: 23.1-1
Direction: Northeast
Notes: Feature 23.1-1 located in the shoulder east of NB I-15, where culvert pictured outlets into the shoulder of NB I-15, toward east.

23.1-1	Concrete	Ephemeral		Jurisdictional	2	-	0.004	-	Jurisdictional	2	-	0.004	-	Jurisdictional	6	-	0.004	-	Ephemeral concrete channel.
23.2-1	Concrete	Ephemeral		Jurisdictional	3	-	0.003	-	Jurisdictional	3	-	0.003	-	Jurisdictional	4	-	0.004	-	Culvert from high school, no water stains visible on concrete. OHWM based on width of low-flow channel in concrete.

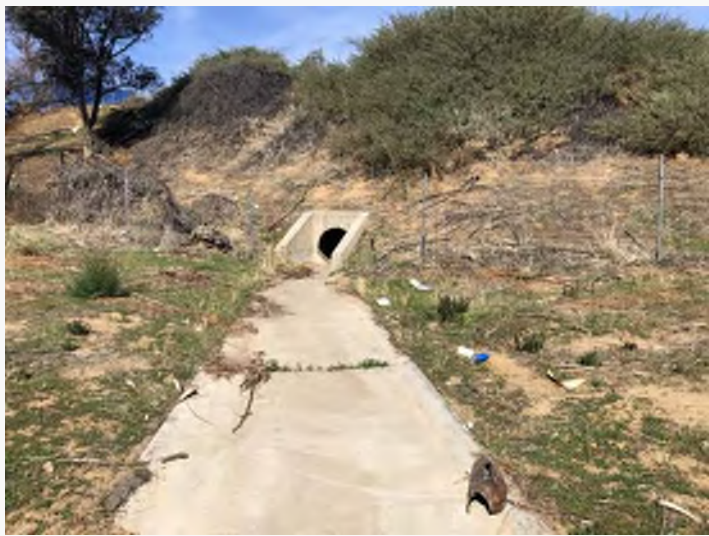
Photograph #: 23.2-1_1
Photo Date: 2/8/21
Feature Number: 23.2-1
Direction: North
Notes: View of concrete lined channel, Feature 23.2-1.

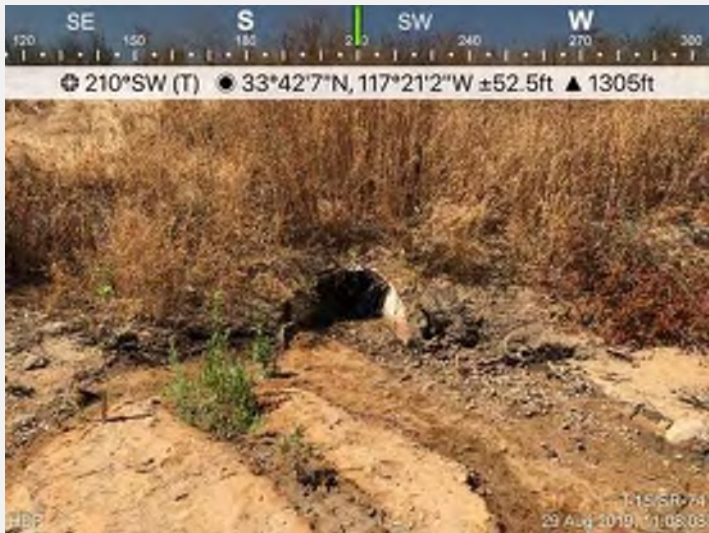
Photograph #: 23.3-1_1
Photo Date: 8/29/2019
Feature Number: 23.3-1
Direction: Southwest
Notes: View of culvert, wet soils, and riparian vegetation in Feature 23.3-1.

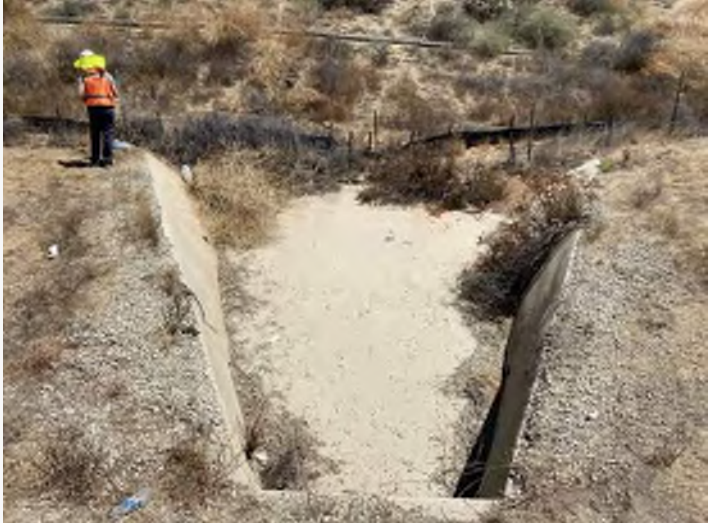
<p>Photograph #: 24.0-1_1</p> <p>Photo Date: 8/12/20</p> <p>Feature Number: 24.0-1</p> <p>Direction: Northeast</p> <p>Notes: View of concrete channel outlet for Feature 24.0-1.</p>

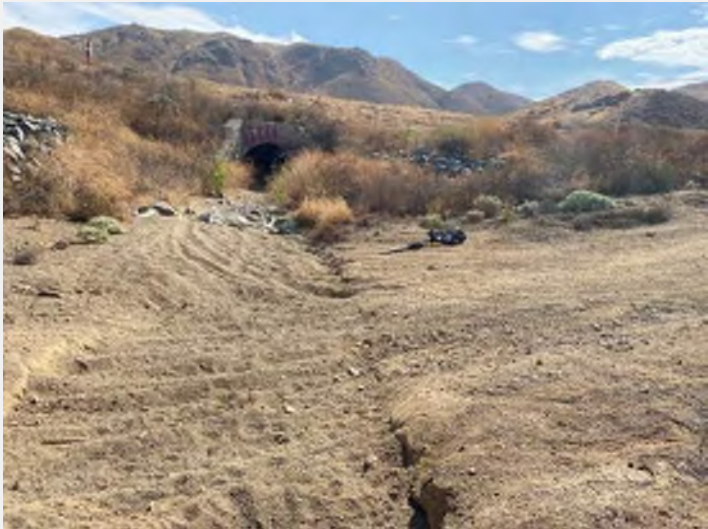
<p>Photograph #: 25.1-1_1</p> <p>Photo Date: 8/13/20</p> <p>Feature Number: 25.1-1</p> <p>Direction: Northeast</p> <p>Notes: View of earthen channel, concrete culvert and riparian vegetation for Feature 25.1-1.</p>

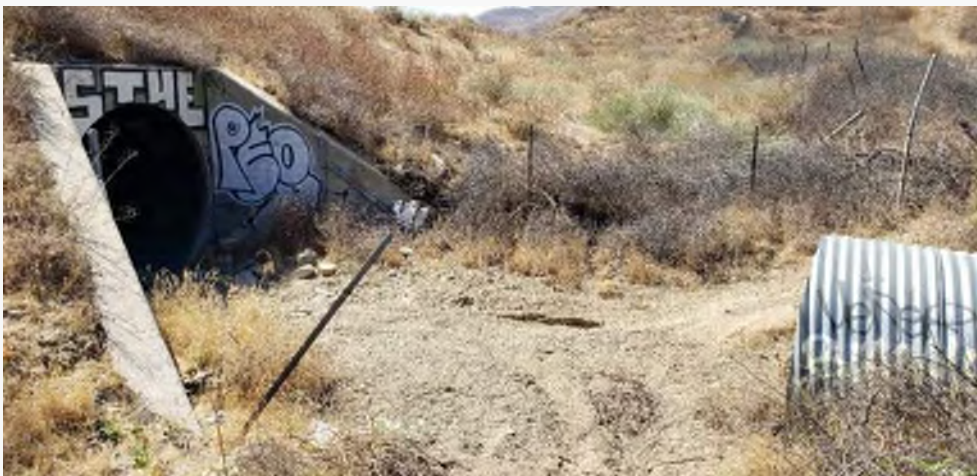
<p>Photograph #: 25.1-2_1</p> <p>Photo Date: 8/12/20</p> <p>Feature Number: 25.1-2</p> <p>Direction: Northwest</p> <p>Notes: View of concrete culvert, earthen channel, and corrugated pipe for Feature 25.1-2.</p>

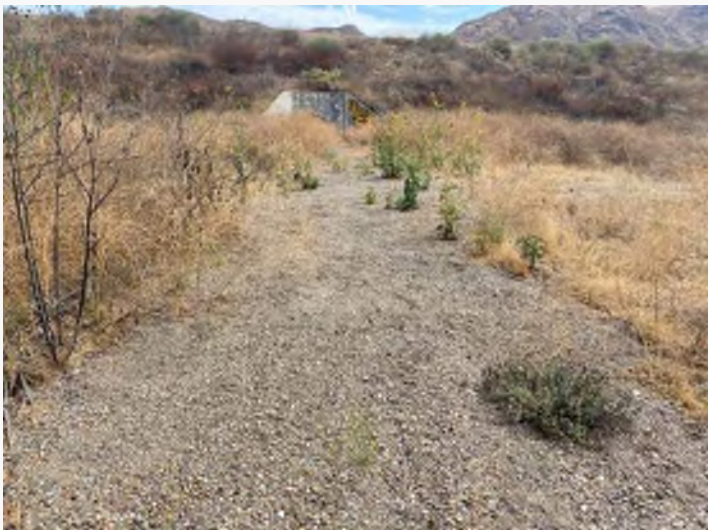
<p>Photograph #: 25.3-3_1</p> <p>Photo Date: 8/13/20</p> <p>Feature Number: 25.3-3</p> <p>Direction: Northeast</p> <p>Notes: View of gravel-bottomed channel, riparian vegetation, and concrete headwall for Feature 25.3-3.</p>

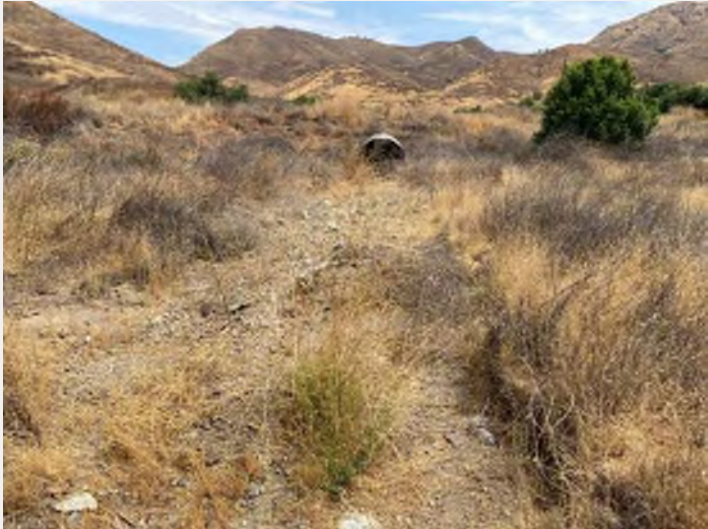
<p>Photograph #: 25.3-4_1</p> <p>Photo Date: 8/13/20</p> <p>Feature Number: 25.3-4</p> <p>Direction: Northeast</p> <p>Notes: View of the earthen-bottomed channel and culvert for Feature 25.3-4.</p>

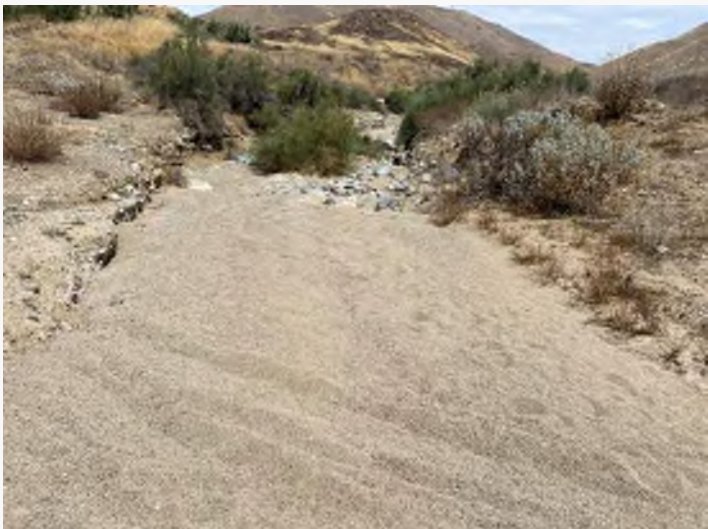
<p>Photograph #: 25.5-1_1</p> <p>Photo Date: 8/13/20</p> <p>Feature Number: 25.5-1</p> <p>Direction: Northeast</p> <p>Notes: View of sandy unvegetated channel and riparian vegetation for Feature 25.5-1.</p>

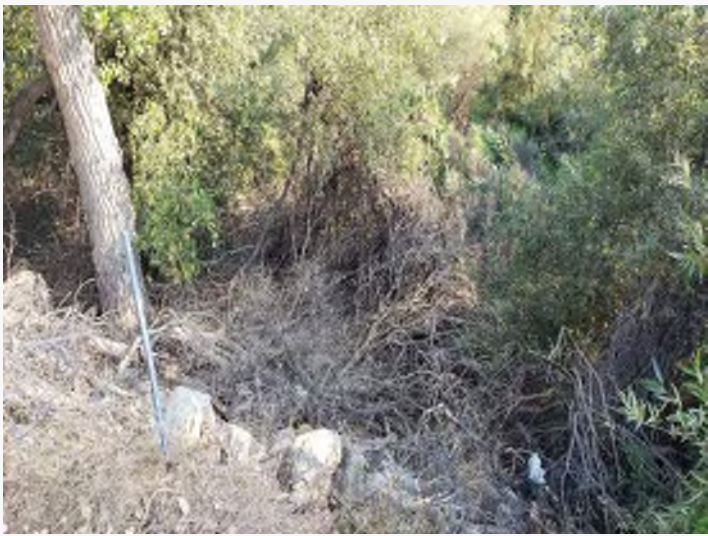
<p>Photograph #: 25.8-1_1</p> <p>Photo Date: 8/13/20</p> <p>Feature Number: 25.8-1</p> <p>Direction: Southwest</p> <p>Notes: View of riparian vegetation for Feature 25.8-1.</p>

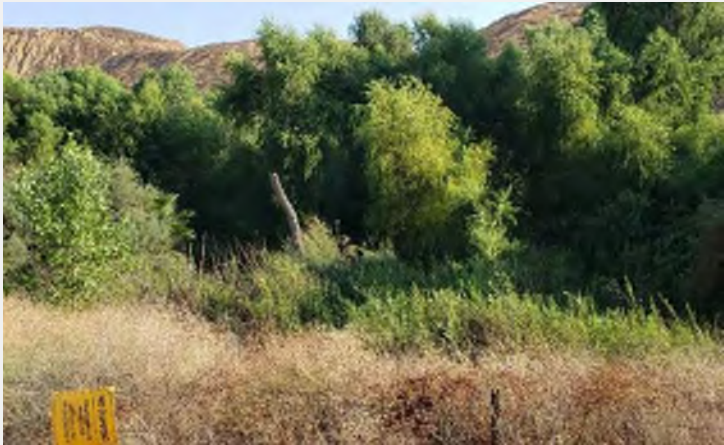
<p>Photograph #: 25.8-1_2</p> <p>Photo Date: 8/13/20</p> <p>Feature Number: 25.8-1</p> <p>Direction: Southwest</p> <p>Notes: View of riparian vegetation for Feature 25.8-1.</p>

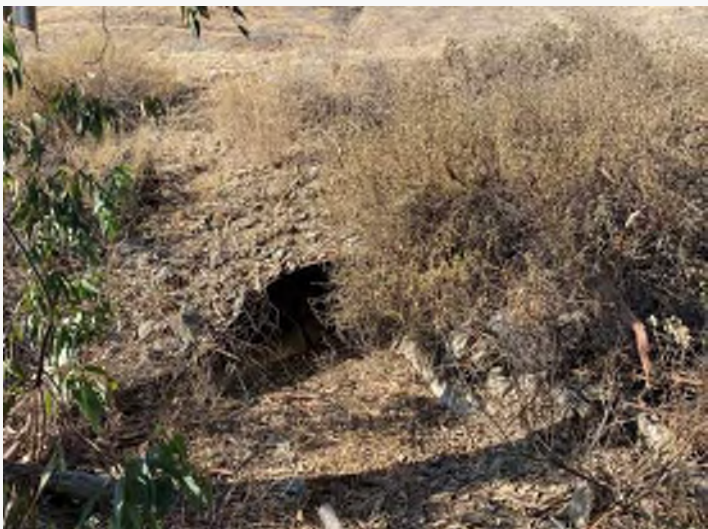
<p>Photograph #: 26.2-1_1</p> <p>Photo Date: 8/26/20</p> <p>Feature Number: 26.2-1</p> <p>Direction: Northeast</p> <p>Notes: View of culvert and riparian vegetation for Feature 26.2-1.</p>

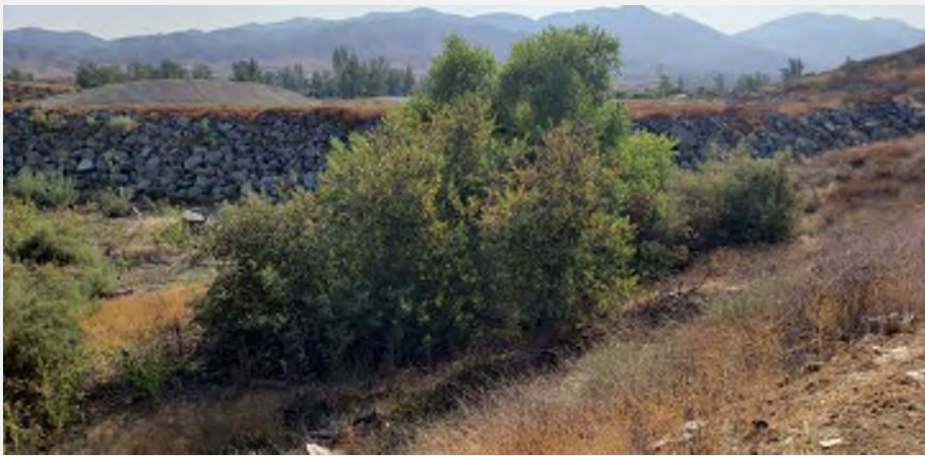
<p>Photograph #: 26.2-1_2</p> <p>Photo Date: 8/26/20</p> <p>Feature Number: 26.2-1</p> <p>Direction: Southwest</p> <p>Notes: View of riparian vegetation and basin for Feature 26.2-1.</p>

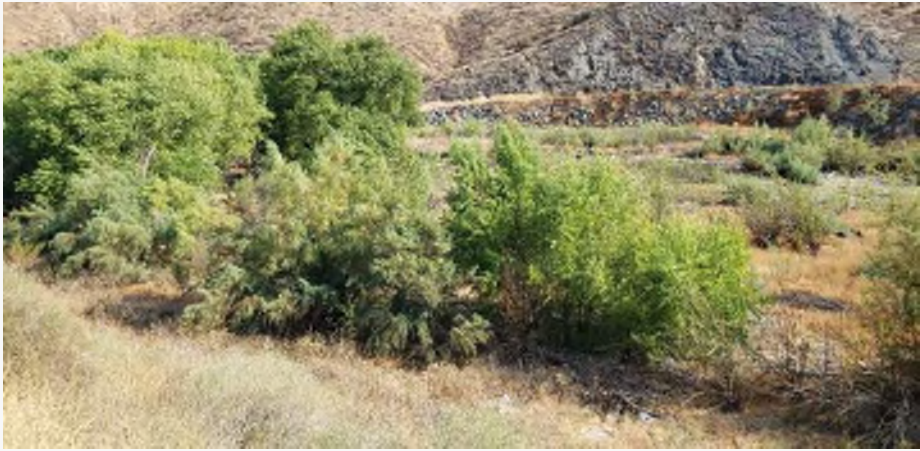
<p>Photograph #: 26.2-1_3</p> <p>Photo Date: 8/26/20</p> <p>Feature Number: 26.2-1</p> <p>Direction: Southeast</p> <p>Notes: View of riparian vegetation and basin for Feature 26.2-1.</p>

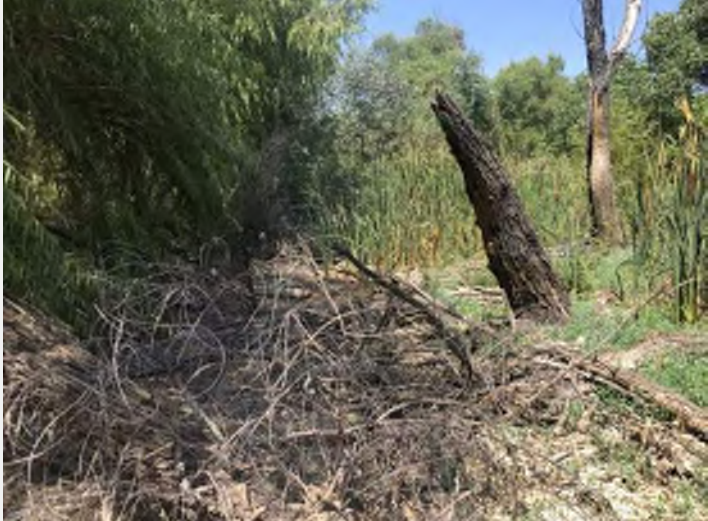
<p>Photograph #: 26.4-1_1</p> <p>Photo Date: 8/27/20</p> <p>Feature Number: 26.4-1</p> <p>Direction: Northwest</p> <p>Notes: View of riparian vegetation for Feature 26.4-1.</p>

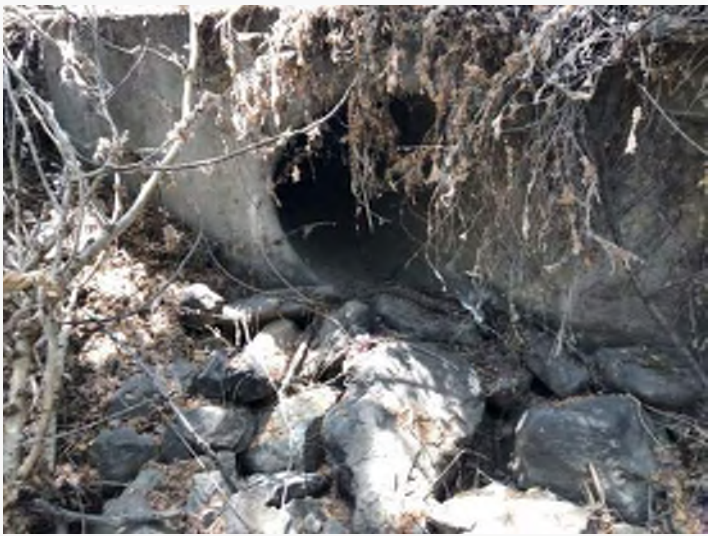
<p>Photograph #: 26.4-1_2</p> <p>Photo Date: 8/27/20</p> <p>Feature Number: 26.4-1</p> <p>Direction: Southeast</p> <p>Notes: View of concrete culvert for Feature 26.4-1.</p>

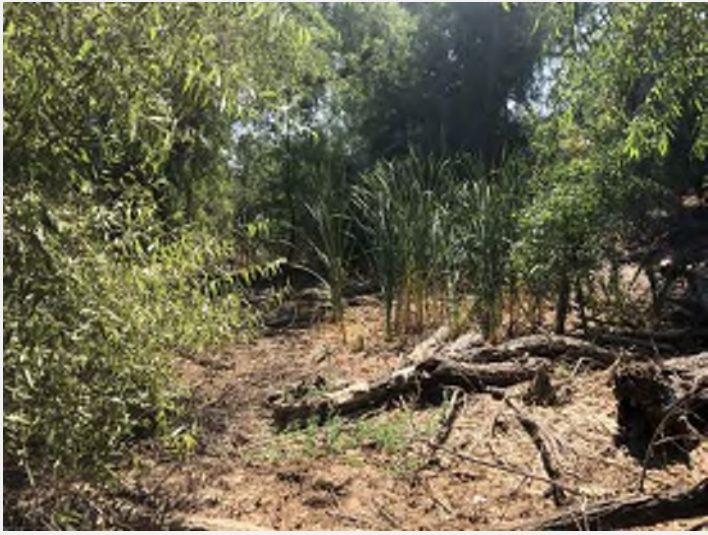
<p>Photograph #: 26.4-1_3</p> <p>Photo Date: 8/27/20</p> <p>Feature Number: 26.4-1</p> <p>Direction: Northwest</p> <p>Notes: View of riparian vegetation for Feature 26.4-1.</p>

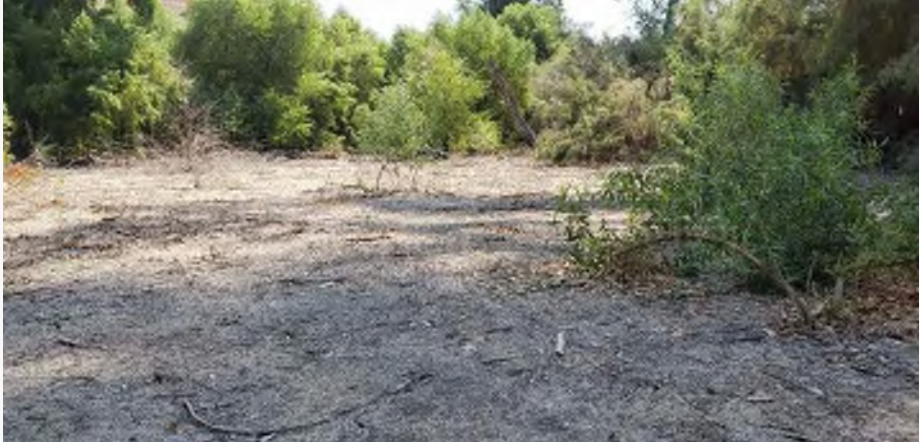
<p>Photograph #: 26.4-1_4</p> <p>Photo Date: 8/27/20</p> <p>Feature Number: 26.4-1</p> <p>Direction: South</p> <p>Notes: View of riparian vegetation and bare ground for Feature 26.4-1.</p>

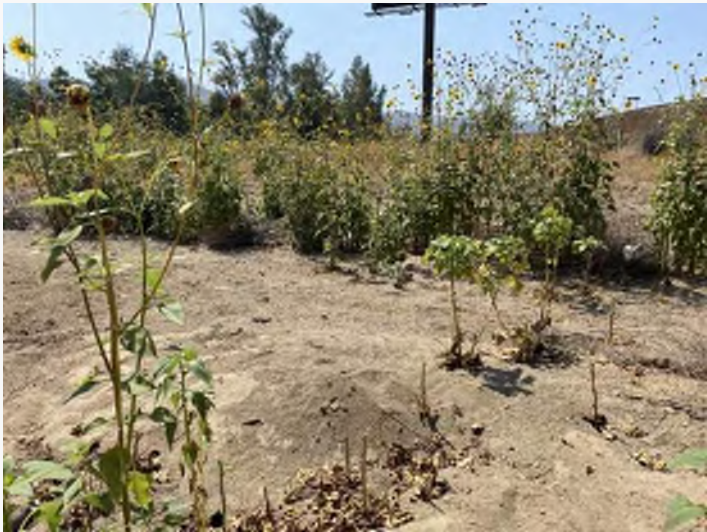
Photograph #: 26.7-2_2

Notes: View of riparian vegetation and bare ground for Feature 26.7-2.

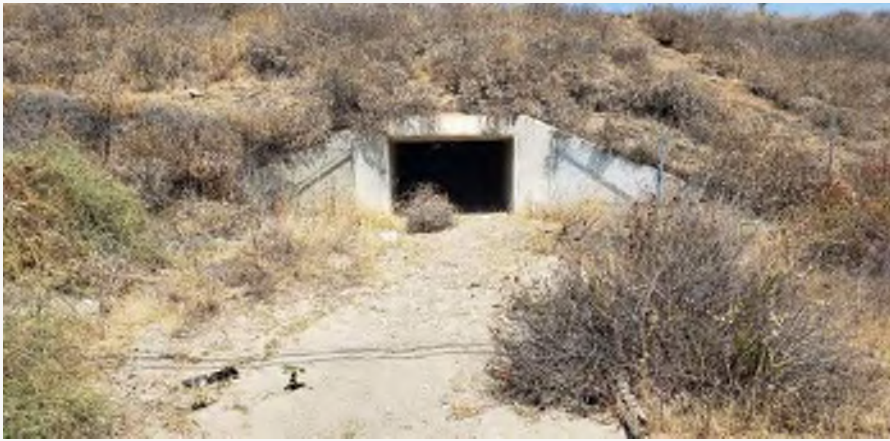
Photograph #: 27.1-1_1

Notes: View of concrete headwall and earthen channel for Feature 27.1-1.

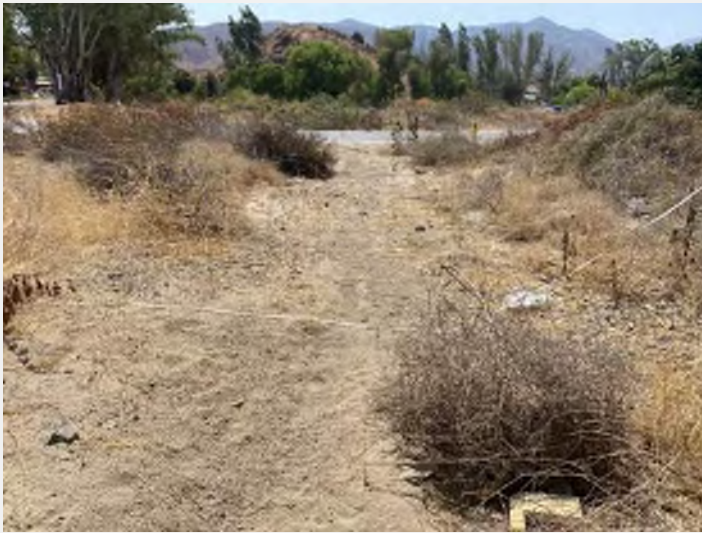
Photograph #: 27.1-1_2

Notes: View of earthen bottomed channel for Feature 27.1-1.

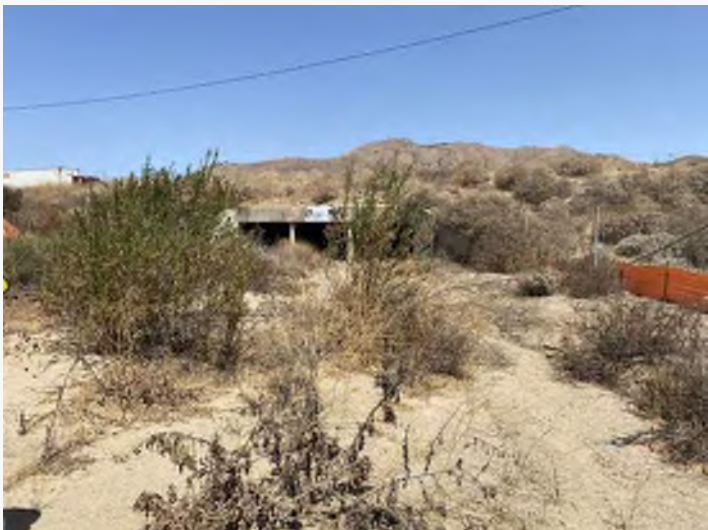
<p>Photograph #: 27.4-1_1</p> <p>Photo Date: 8/26/20</p> <p>Feature Number: 27.4-1</p> <p>Direction: Northwest</p> <p>Notes: View of earthen channel, riparian vegetation, and four concrete channel headwalls for Feature 27.4-1.</p>

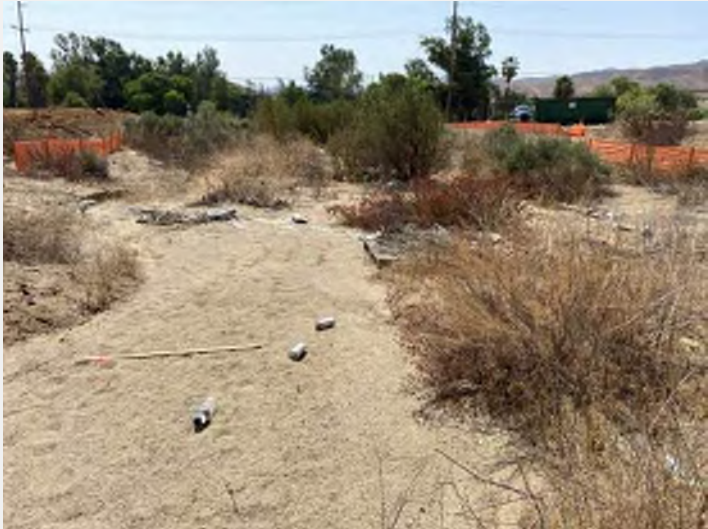
<p>Photograph #: 27.4-1_2</p> <p>Photo Date: 8/26/20</p> <p>Feature Number: 27.4-1</p> <p>Direction: Southeast</p> <p>Notes: View of earthen channel and riparian vegetation for Feature 27.4-1.</p>

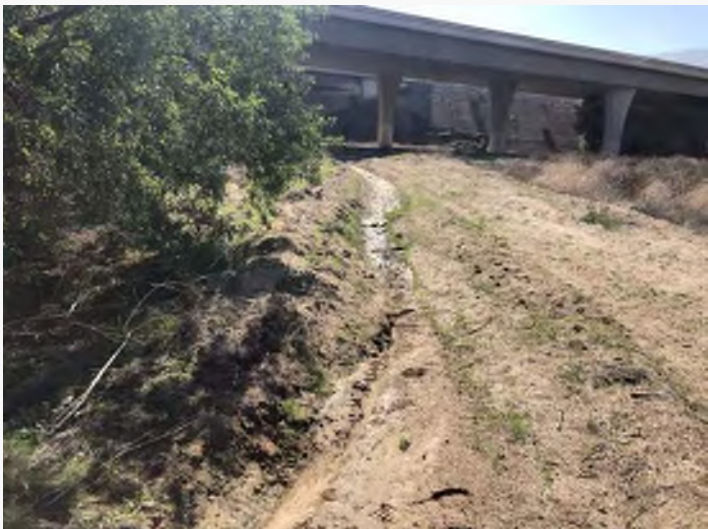
<p>Photograph #: 27.8-1_1</p> <p>Photo Date: 2/8/21</p> <p>Feature Number: 27.8-1</p> <p>Direction: Southeast</p> <p>Notes: View of earthen swale for Feature 27.8-1.</p>

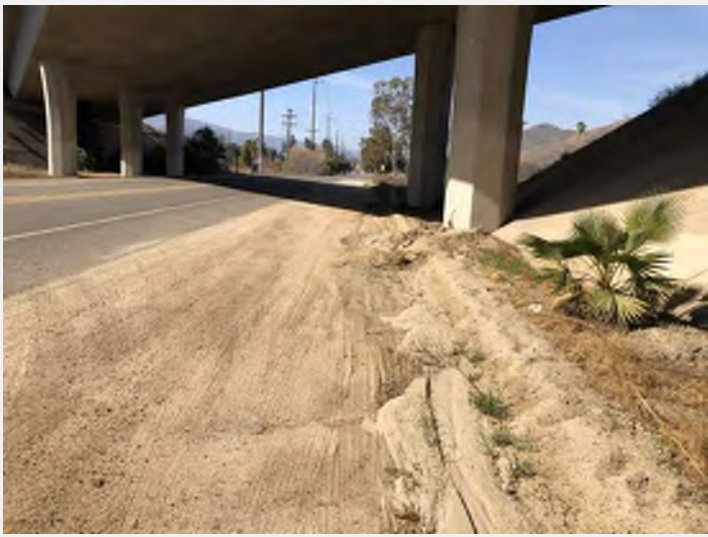
<p>Photograph #: 27.8-1_2</p> <p>Photo Date: 2/8/21</p> <p>Feature Number: 27.8-1</p> <p>Direction: Northwest</p> <p>Notes: View of roadside swale for Feature 27.8-1.</p>

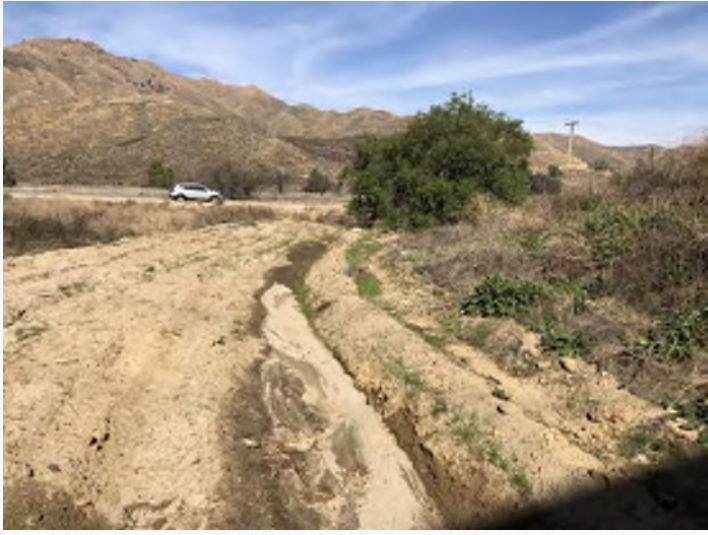
<p>Photograph #: 27.8-1_3</p> <p>Photo Date: 2/8/21</p> <p>Feature Number: 27.8-1</p> <p>Direction: Northeast</p> <p>Notes: View of earthen swale for Feature 27.8-1.</p>

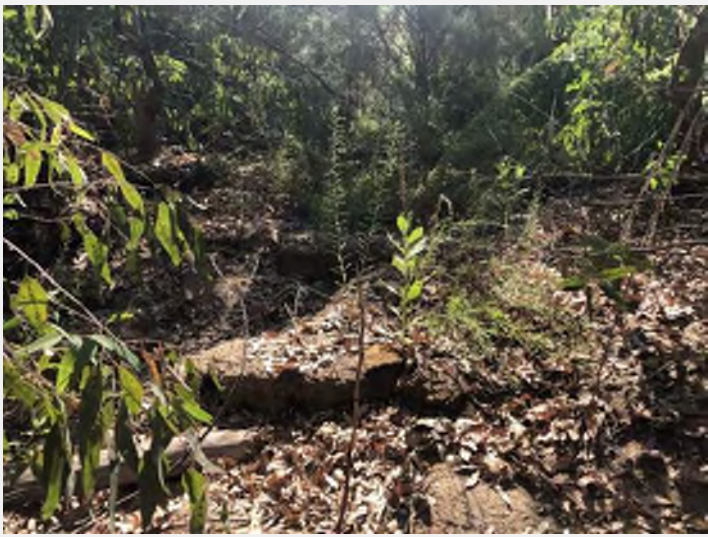
<p>Photograph #: 28.1-1_2</p> <p>Photo Date: 8/11/20</p> <p>Feature Number: 28.1-1</p> <p>Direction: North</p> <p>Notes: View of incised banks and riparian vegetation for Feature 28.1-1.</p>

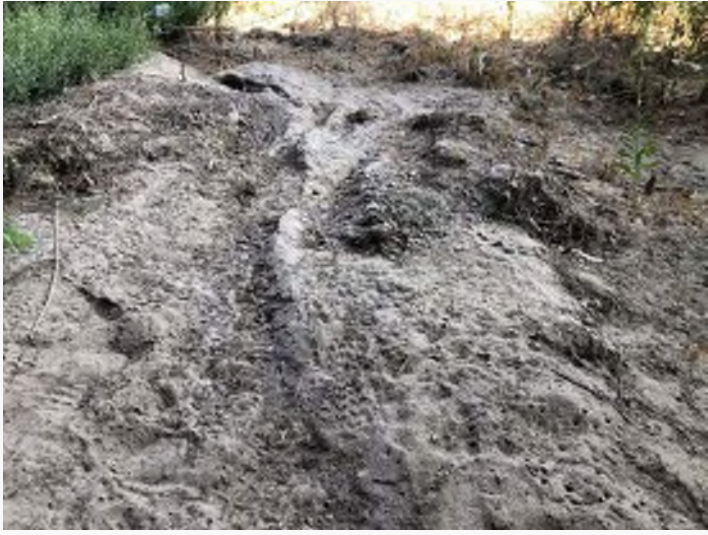
<p>Photograph #: 28.1-1_3</p> <p>Photo Date: 8/11/20</p> <p>Feature Number: 28.1-1</p> <p>Direction: Northeast</p> <p>Notes: View of wrack and unvegetated channel for Feature 28.1-1.</p>

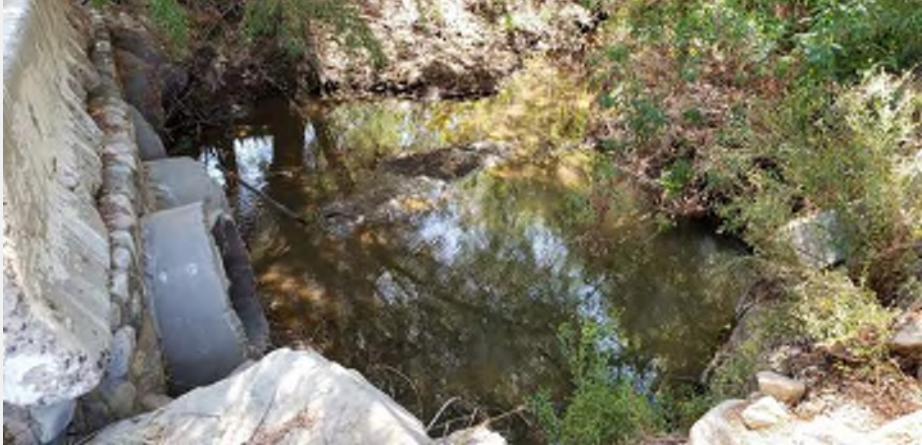
A photograph showing a concrete culvert structure on the left side, with water flowing through it. The surrounding area is filled with dense, green riparian vegetation, including trees and shrubs, situated on a rocky bank.	<p>Photograph #: 28.1-1_8</p> <p>Photo Date: 8/11/20</p> <p>Feature Number: 28.1-1</p> <p>Direction: Northwest</p> <p>Notes: View of concrete culvert, flowing water and riparian vegetation for Feature 28.1-1.</p>

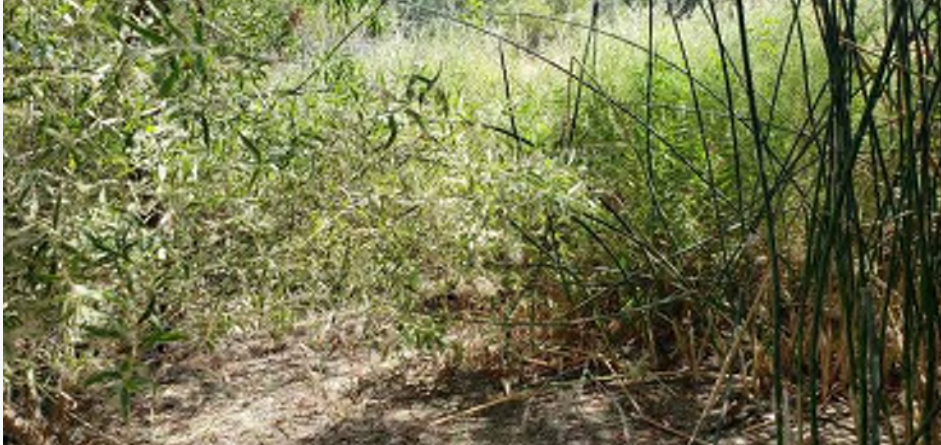
A photograph showing a dense thicket of riparian vegetation. The foreground is dominated by tall, thin, green reeds or grasses, with various other green plants and shrubs visible in the background.	<p>Photograph #: 28.1-1_9</p> <p>Photo Date: 8/11/20</p> <p>Feature Number: 28.1-1</p> <p>Direction: South</p> <p>Notes: View of riparian vegetation for Feature 28.1-1.</p>

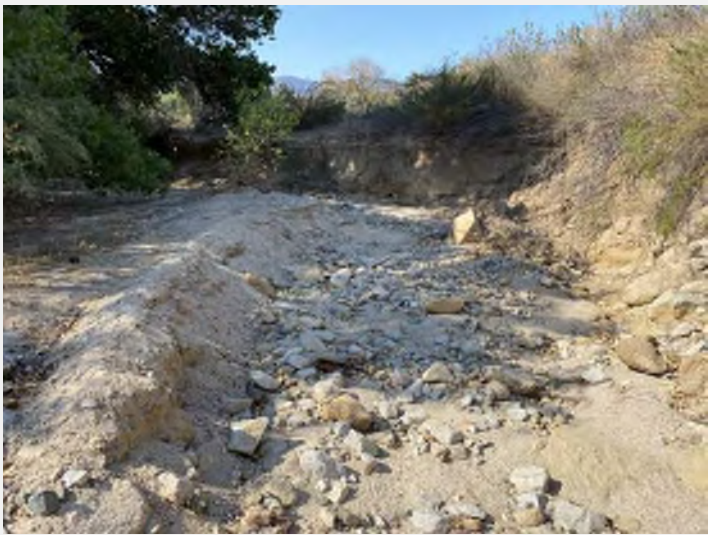
A photograph showing a wide, shallow, earthen channel filled with light-colored sand and small rocks. The channel is bordered by dense green trees and shrubs on the left and a rocky, sloping bank on the right. The sky is clear and blue.	<p>Photograph #: 28.4-1_2</p> <p>Photo Date: 8/26/20</p> <p>Feature Number: 28.4-1</p> <p>Direction: Southwest</p> <p>Notes: View of earthen, incised channel, and riparian vegetation for Feature 28.4-1.</p>

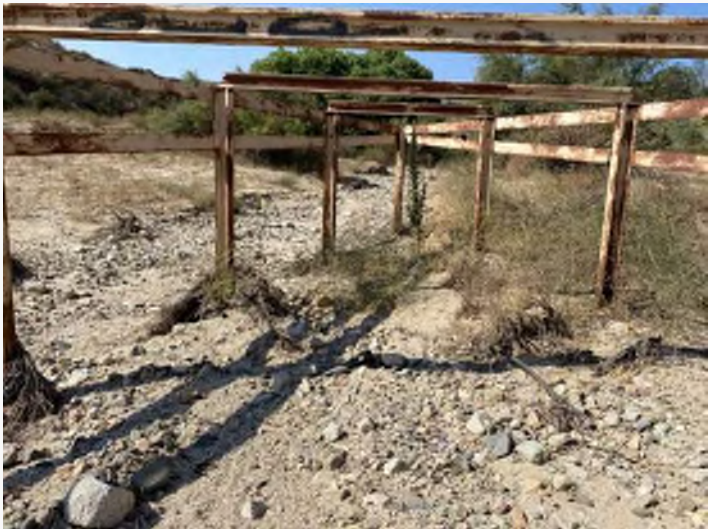
A photograph of an earthen channel with a wooden structure made of vertical posts and horizontal rails. The channel is filled with sand and rocks. The background shows a dry, hilly landscape under a clear sky.	<p>Photograph #: 28.4-1_3</p> <p>Photo Date: 8/26/20</p> <p>Feature Number: 28.4-1</p> <p>Direction: Southwest</p> <p>Notes: View of earthen channel for Feature 28.4-1.</p>

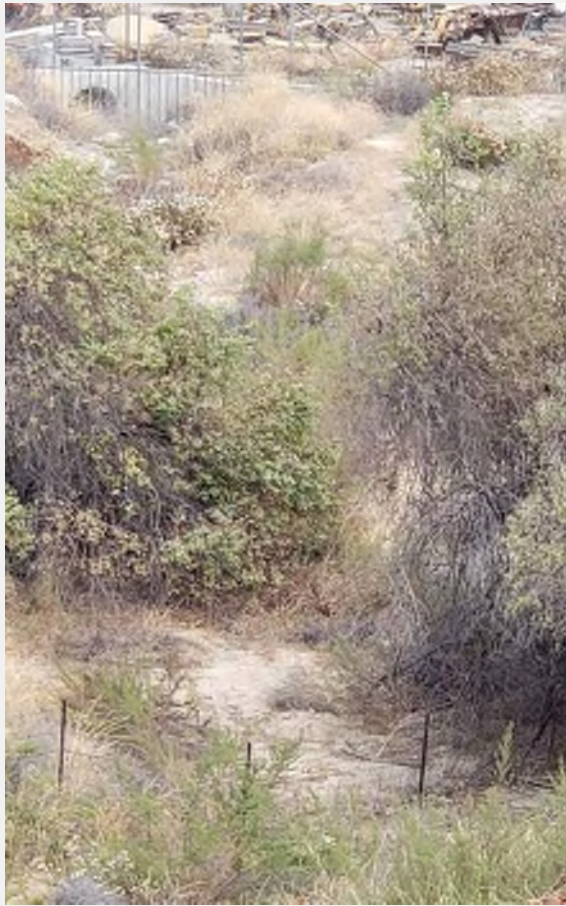
Photograph #: 28.6-2_1

Notes: View of earthen channel and concrete culvert for Feature 28.6-2.

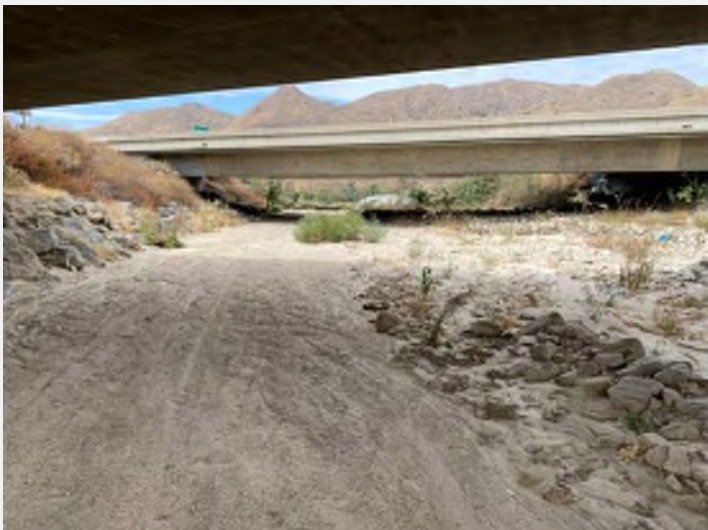
<p>Photograph #: 29.1-1_1</p> <p>Photo Date: 8/13/20</p> <p>Feature Number: 29.1-1</p> <p>Direction: North</p> <p>Notes: View of earthen channel for Feature 29.1-1.</p>

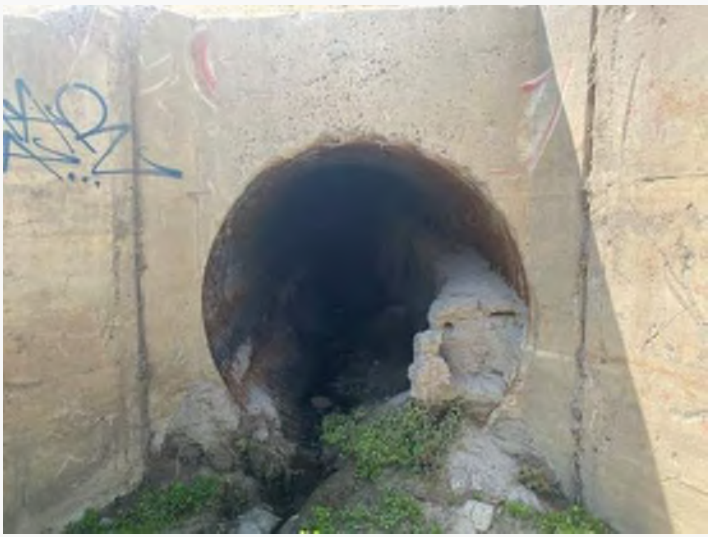
<p>Photograph #: 29.6-1_1</p> <p>Photo Date: 8/25/20</p> <p>Feature Number: 29.6-1</p> <p>Direction: Southwest</p> <p>Notes: View of concrete headwall and culvert for Feature 29.6-1.</p>

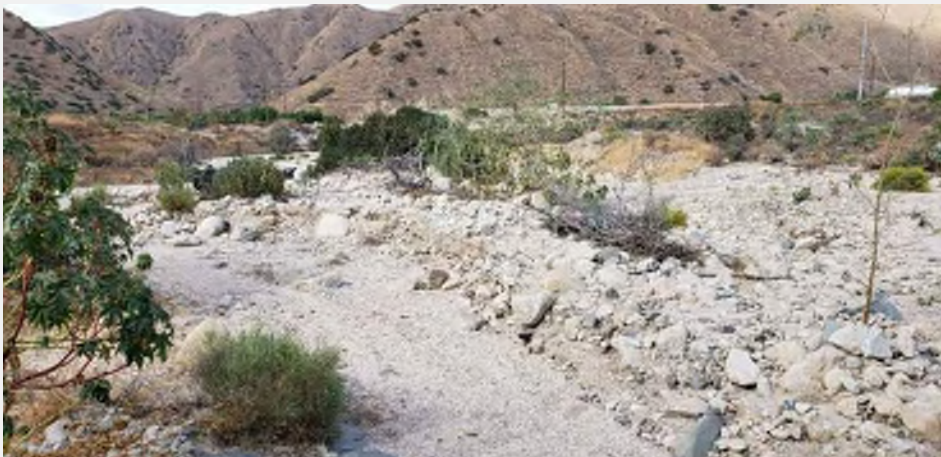
<p>Photograph #: 30.0-1_3</p> <p>Photo Date: 8/13/20</p> <p>Feature Number: 30.0-1</p> <p>Direction: Northeast</p> <p>Notes: View of earthen channel and basin for Feature 30.0-1.</p>

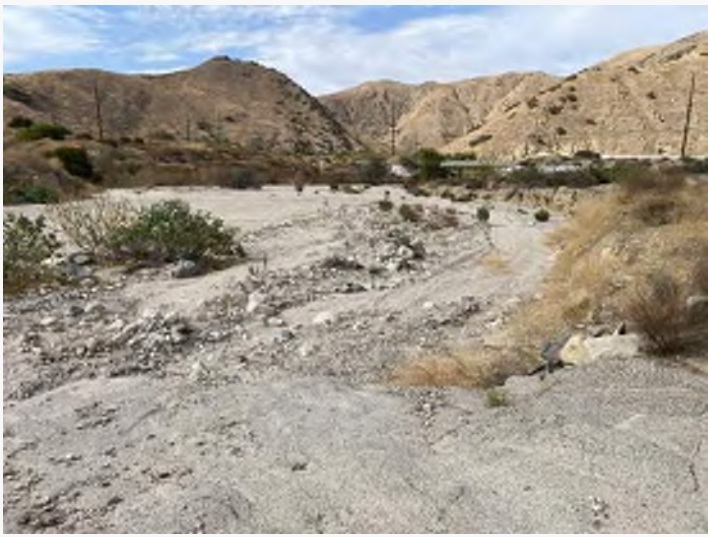
A wide-angle photograph showing a dry, earthen channel and basin in a desert environment. The ground is light-colored and rocky, with sparse, dry vegetation. In the background, there are brown, hilly mountains under a blue sky with some clouds.	<p>Photograph #: 30.0-1_4</p> <p>Photo Date: 8/13/20</p> <p>Feature Number: 30.0-1</p> <p>Direction: Northeast</p> <p>Notes: View of earthen channel and basin for Feature 30.0-1.</p>

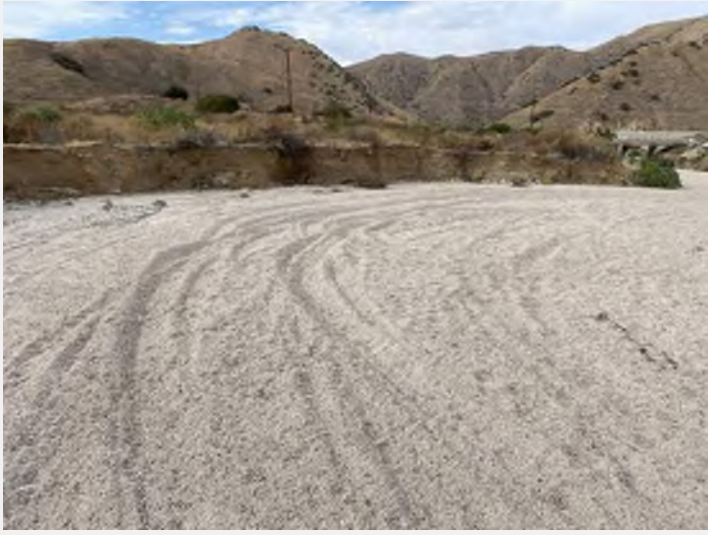
A photograph of an earthen channel and basin, similar to the first image. The foreground shows distinct tire tracks in the light-colored soil. The background features the same desert landscape with brown hills and a blue sky.	<p>Photograph #: 30.0-1_5</p> <p>Photo Date: 8/13/20</p> <p>Feature Number: 30.0-1</p> <p>Direction: North</p> <p>Notes: View of earthen channel and basin for Feature 30.0-1.</p>

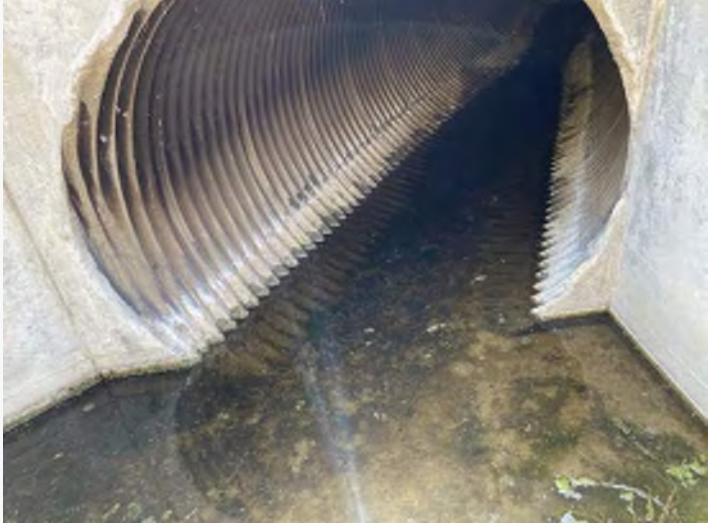
A close-up photograph of a concrete culvert. The culvert is made of corrugated metal and is partially filled with dark, standing water. The concrete walls of the culvert are visible on either side.	<p>Photograph #: 30.2-1_1</p> <p>Photo Date: 8/13/20</p> <p>Feature Number: 30.2-1</p> <p>Direction: Southwest</p> <p>Notes: View of concrete culvert and standing water for Feature 30.2-1.</p>

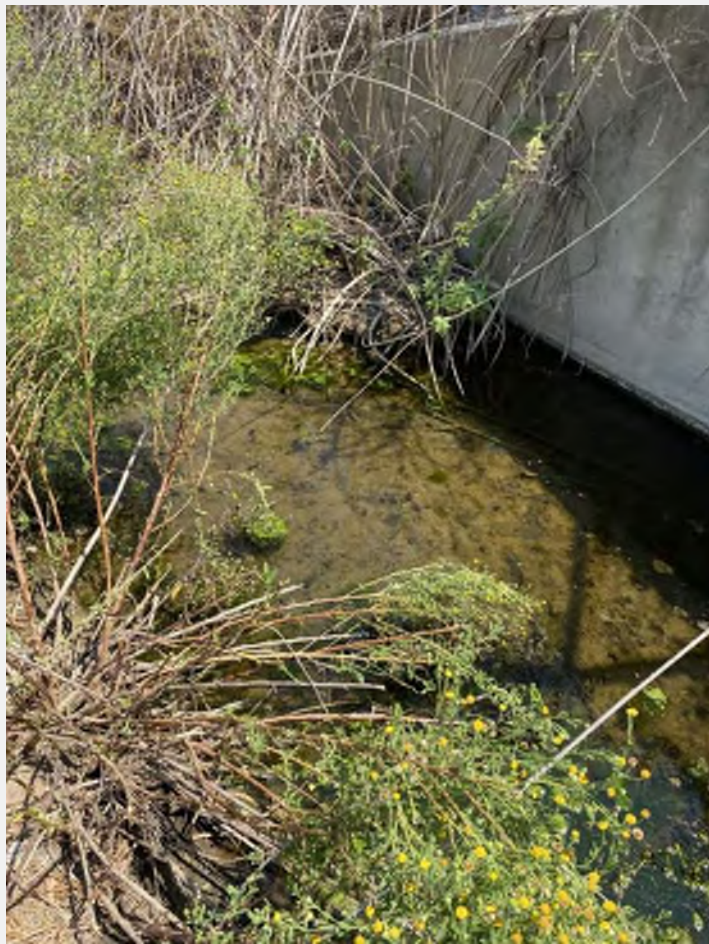
Photograph #: 30.2-1_2

Notes: View of riparian vegetation and standing water for Feature 30.2-1.

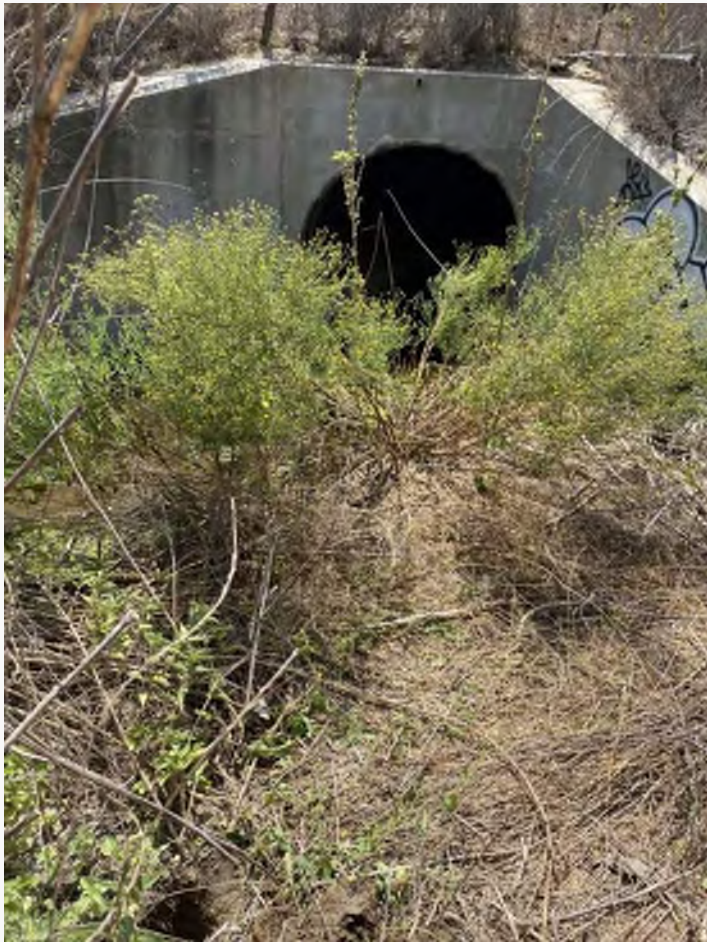
Photograph #: 30.2-1_3

Notes: View of riparian vegetation and concrete culvert for Feature 30.2-1.

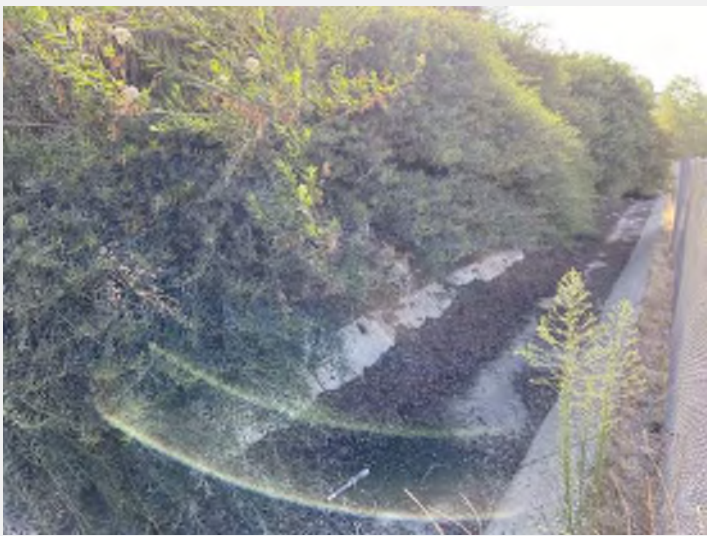
Photograph #: 30.2-2_2

Notes: View of concrete brow ditch for Feature 30.2-2.

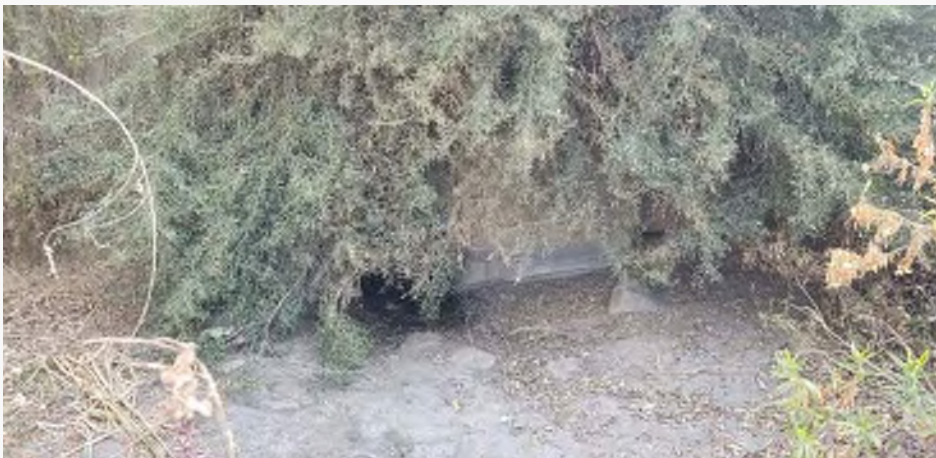
Photograph #: 30.2-2_3

Notes: View of culvert for Feature 30.2-2.

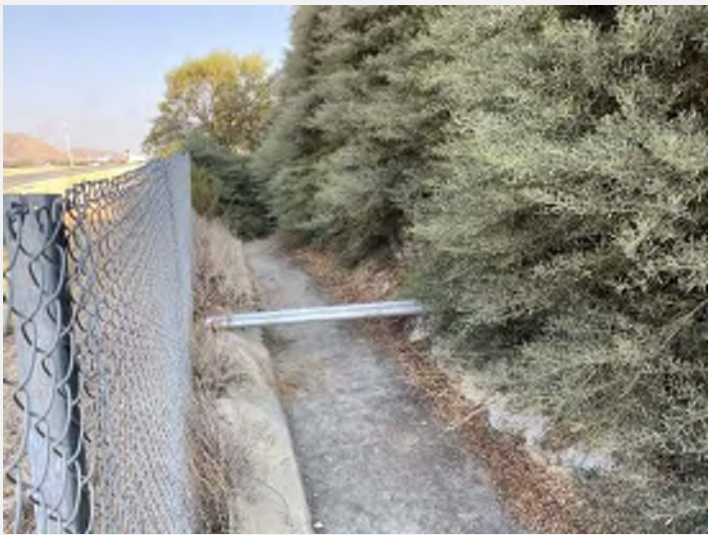
<p>Photograph #: 30.2-2_4</p> <p>Photo Date: 8/25/20</p> <p>Feature Number: 30.2-2</p> <p>Direction: Northwest</p> <p>Notes: View of concrete brow ditch for Feature 30.2-2.</p>

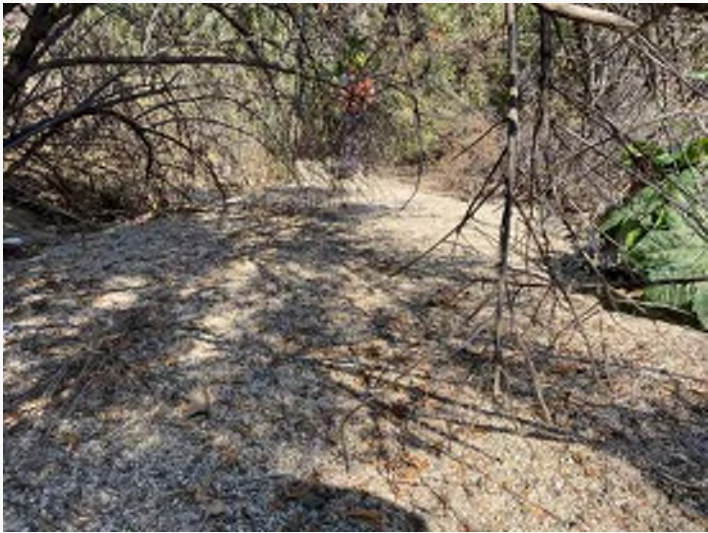
<p>Photograph #: 30.3-1_1</p> <p>Photo Date: 8/25/20</p> <p>Feature Number: 30.3-1</p> <p>Direction: East</p> <p>Notes: View of earthen channel for Feature 30.3-1.</p>

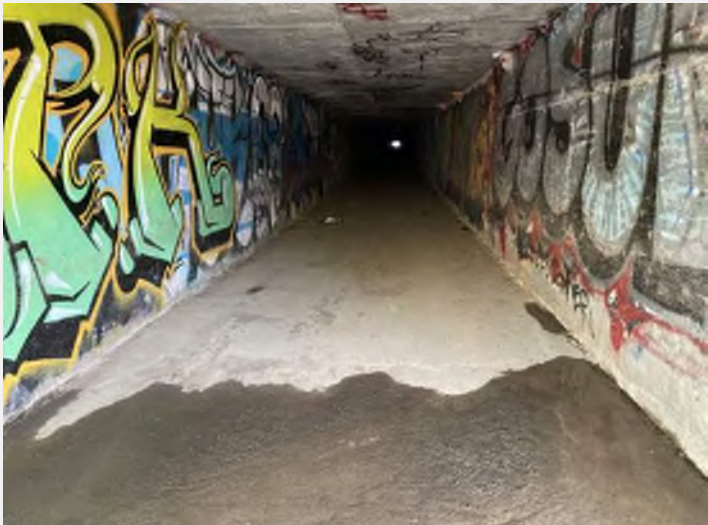
<p>Photograph #: 30.3-1_2</p> <p>Photo Date: 8/25/20</p> <p>Feature Number: 30.3-1</p> <p>Direction: West</p> <p>Notes: View of concrete channel with staining for Feature 30.3-1.</p>

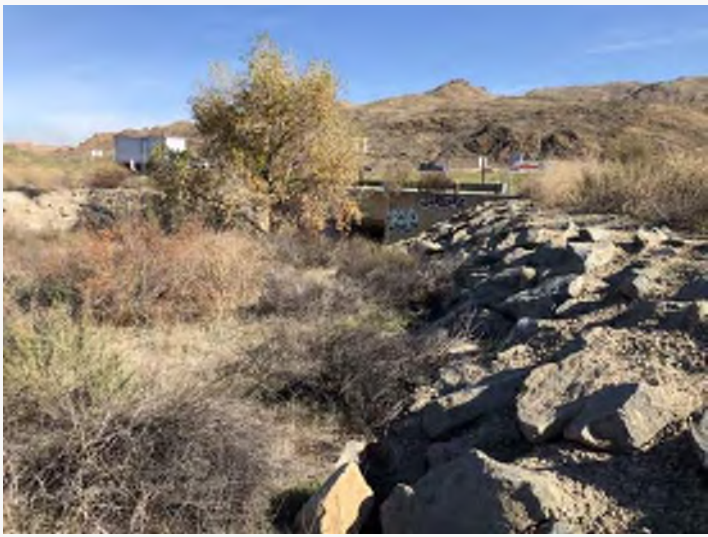
<p>Photograph #:30.4-1_4</p> <p>Photo Date :2/8/21</p> <p>Feature Number: 30.4-1</p> <p>Direction: Northeast</p> <p>Notes: View of earthen channel, riparian vegetation, and rip-rap bank for Feature 30.4-1.</p>
