Interstate 15 Express Lanes Project Southern Extension (ELPSE)

RIVERSIDE COUNTY, CALIFORNIA
DISTRICT 8 – RIV-15 PM 20.3 TO PM 40.1
EA: RIV 08-0J0820 / ID: 08-18000063

Jurisdictional Delineation Report

September 2021

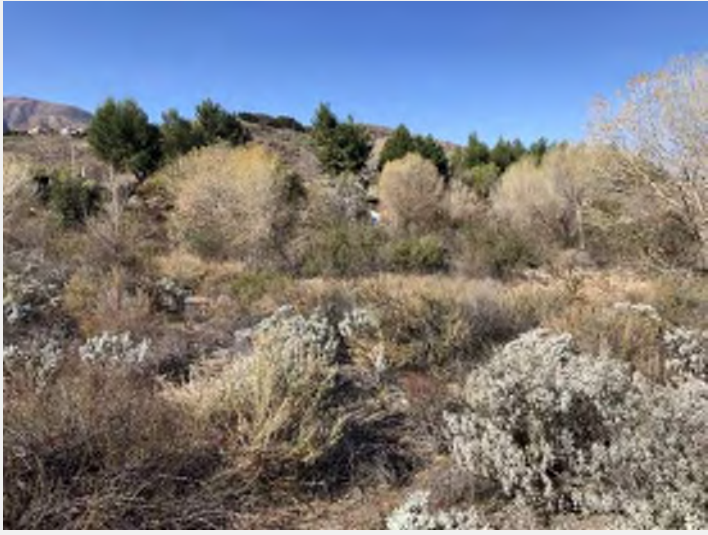
<p>Photograph #: 30.4-1_5</p> <p>Photo Date :2/8/21</p> <p>Feature Number: 30.4-1</p> <p>Direction: West</p> <p>Notes: View of riparian vegetation for Feature 30.4-1</p>

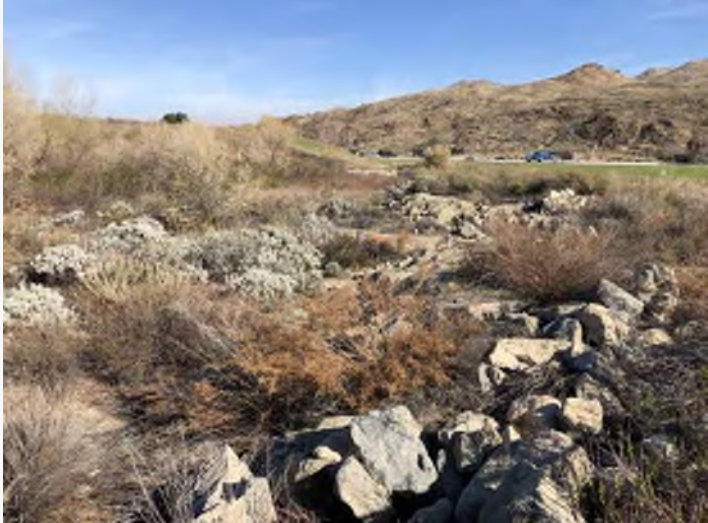
<p>Photograph #: 30.4-1_6</p> <p>Photo Date :2/8/21</p> <p>Feature Number: 30.4-1</p> <p>Direction: Northeast</p> <p>Notes: View of earthen channel, riparian vegetation, and rip-rap bank for Feature 30.4-1.</p>

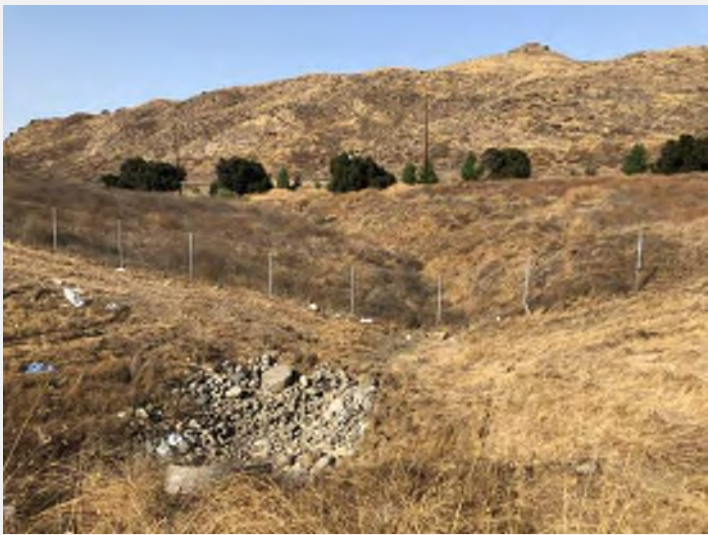
<p>Photograph #: 30.5-1_1</p> <p>Photo Date: 8/26/20</p> <p>Feature Number: 30.5-1</p> <p>Direction: Northeast</p> <p>Notes: View of earthen swale with rip-rap pad and concrete culvert for Feature 30.5-1.</p>

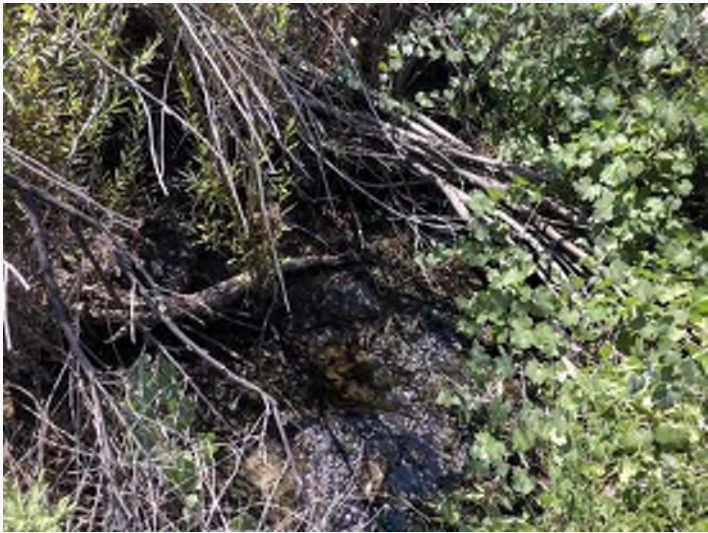
<p>Photograph #: 30.8-1_1</p> <p>Photo Date: 8/26/20</p> <p>Feature Number: 30.8-1</p> <p>Direction: Southwest</p> <p>Notes: View of flowing water and riparian vegetation for Feature 30.8-1.</p>

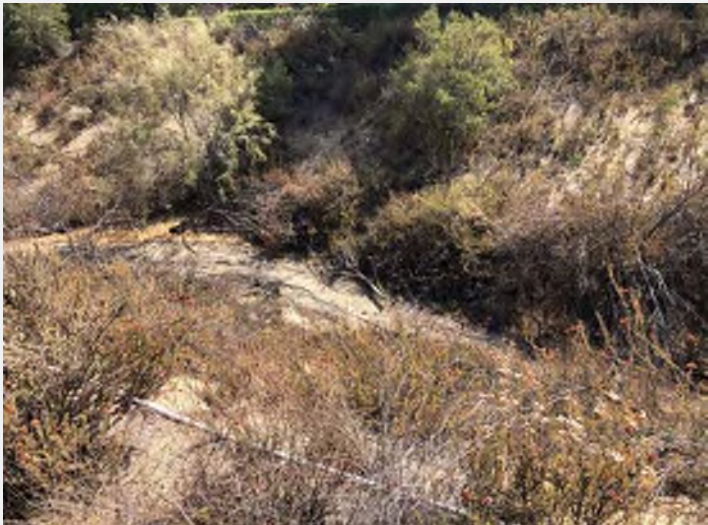
<p>Photograph #: 31.0-1_1</p> <p>Photo Date: 8/26/20</p> <p>Feature Number: 31.0-1</p> <p>Direction: Southeast</p> <p>Notes: View of riparian vegetation surrounding basin for Feature 31.0-1.</p>

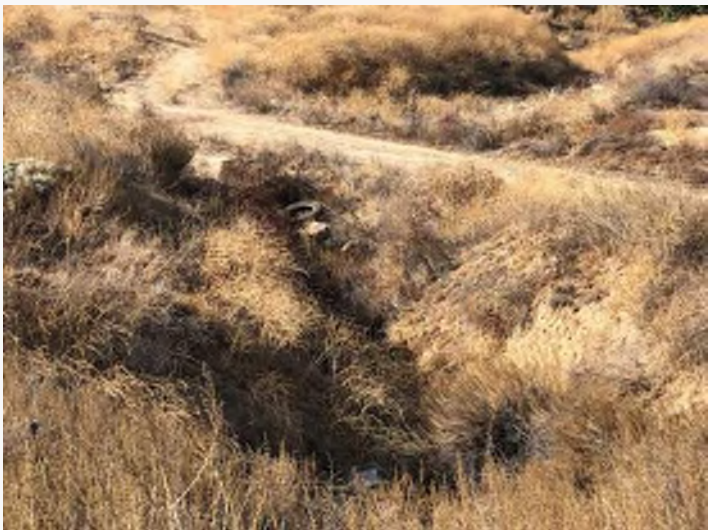
<p>Photograph #: 31.0-2_1</p> <p>Photo Date: 8/26/20</p> <p>Feature Number: 31.0-2</p> <p>Direction: North</p> <p>Notes: View of earthen swale for Feature 31.0-2.</p>

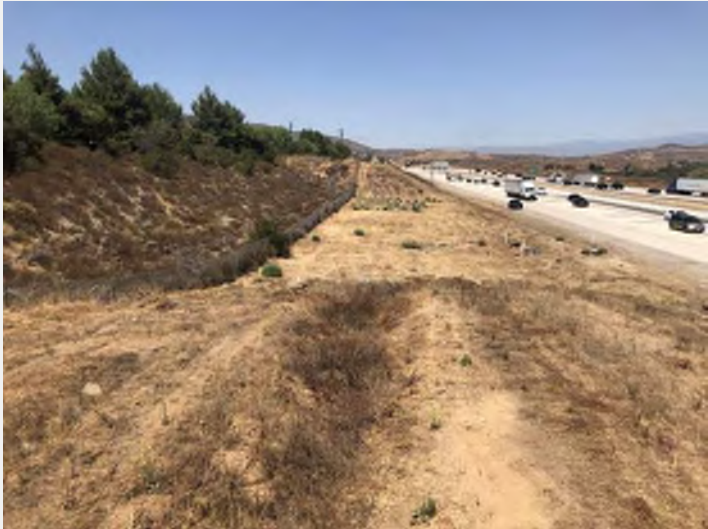
<p>Photograph #: 31.0-3_1</p> <p>Photo Date: 8/26/20</p> <p>Feature Number: 31.0-3</p> <p>Direction: Northwest</p> <p>Notes: View of earthen hillside ditch adjacent to I-15 freeway SB for Feature 31.0-3.</p>

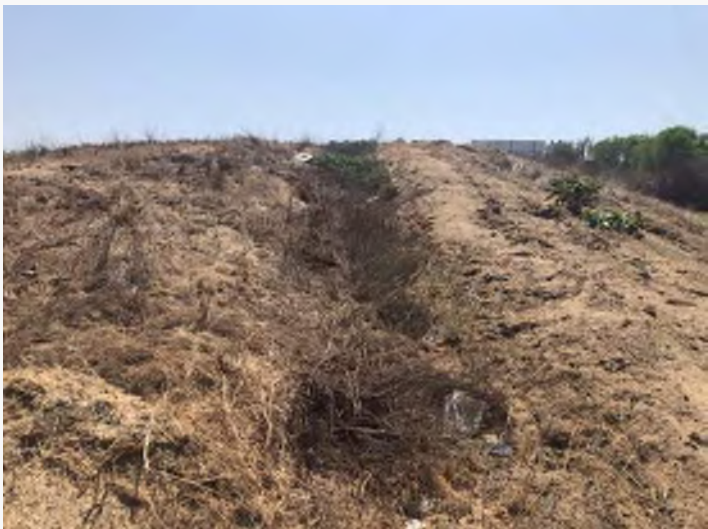
<p>Photograph #: 31.0-3_2</p> <p>Photo Date: 8/26/20</p> <p>Feature Number: 31.0-3</p> <p>Direction: Southeast</p> <p>Notes: View of earthen hillside ditch for Feature 31.0-3.</p>

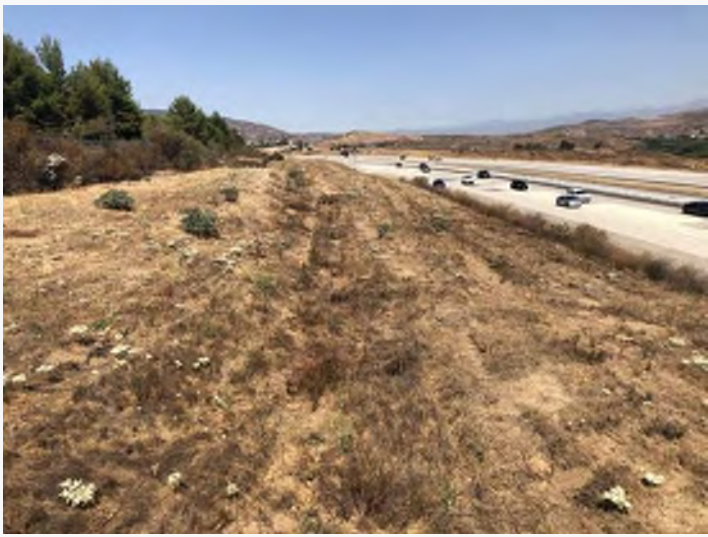
<p>Photograph #: 31.3-1_1</p> <p>Photo Date: 8/26/20</p> <p>Feature Number: 31.3-1</p> <p>Direction: Northwest</p> <p>Notes: View of hillside ditch adjacent to I-15 freeway SB for Feature 31.3-1.</p>

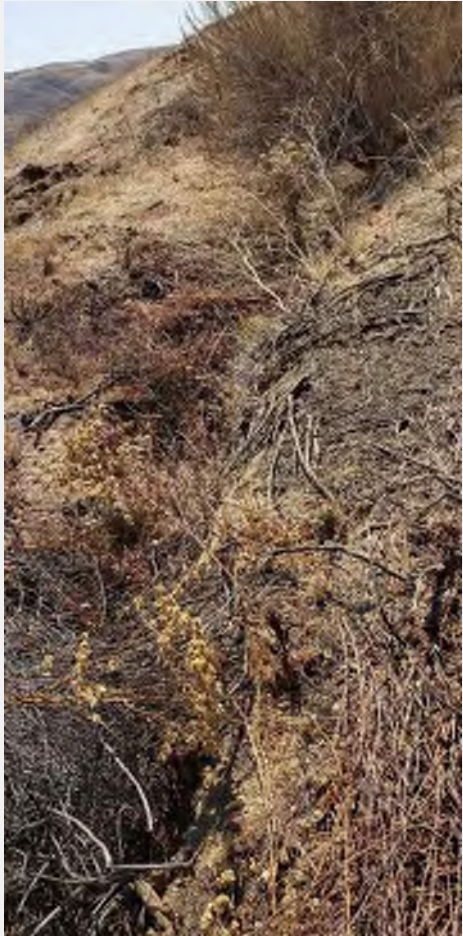
<p>Photograph #: 31.3-1_2</p> <p>Photo Date: 8/26/20</p> <p>Feature Number: 31.3-1</p> <p>Direction: Southeast</p> <p>Notes: View of hillside ditch for Feature 31.3-1.</p>

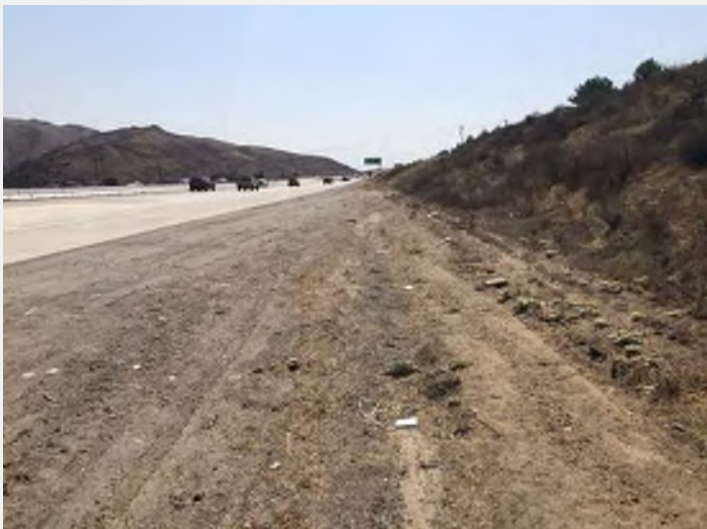
A wide-angle photograph showing a dirt and gravel roadside swale running parallel to a multi-lane highway. In the background, several vehicles are visible on the road, and a hillside with sparse vegetation rises on the right. The sky is clear and blue.	<p>Photograph #: 31.3-2_1</p> <p>Photo Date: 8/26/20</p> <p>Feature Number: 31.3-2</p> <p>Direction: Southeast</p> <p>Notes: View of roadside swale adjacent to I-15 freeway NB for Feature 31.3-2.</p>

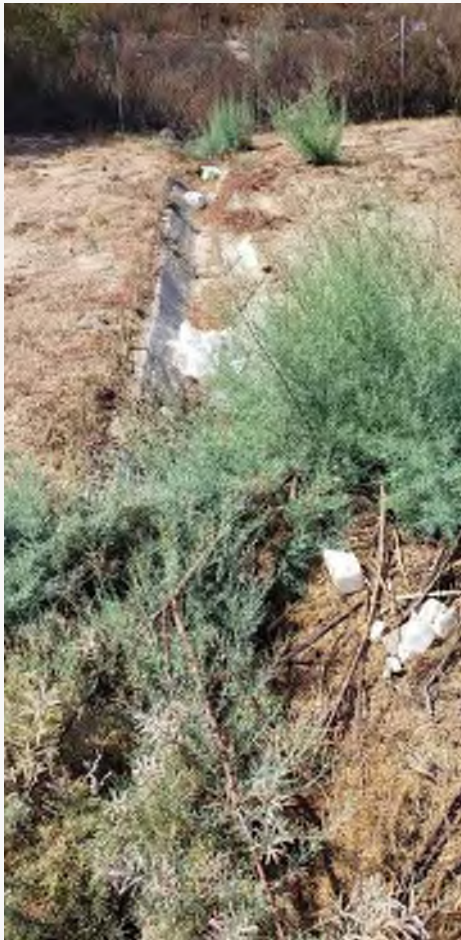
A close-up photograph of a concrete-lined ditch or brow ditch. The ditch is filled with water and surrounded by dense, green Tamarisk vegetation. The ground around the ditch is dry and brown, with some scattered white plastic bags or debris.	<p>Photograph #: 31.4-1_1</p> <p>Photo Date: 8/26/20</p> <p>Feature Number: 31.4-1</p> <p>Direction: Southwest</p> <p>Notes: View of concrete brow ditch and Tamarisk for Feature 31.4-1.</p>

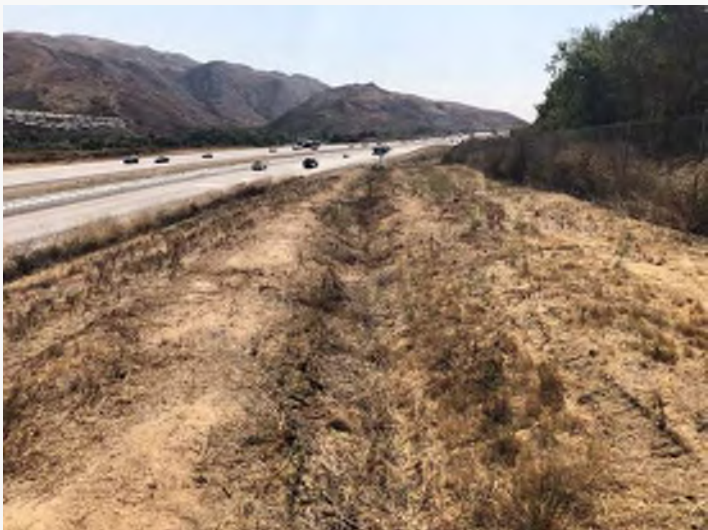
<p>Photograph #: 31.5-1_1</p> <p>Photo Date: 8/26/20</p> <p>Feature Number: 31.5-1</p> <p>Direction: Southeast</p> <p>Notes: View of hillside ditch adjacent to I-15 freeway NB for Feature 31.5-1.</p>

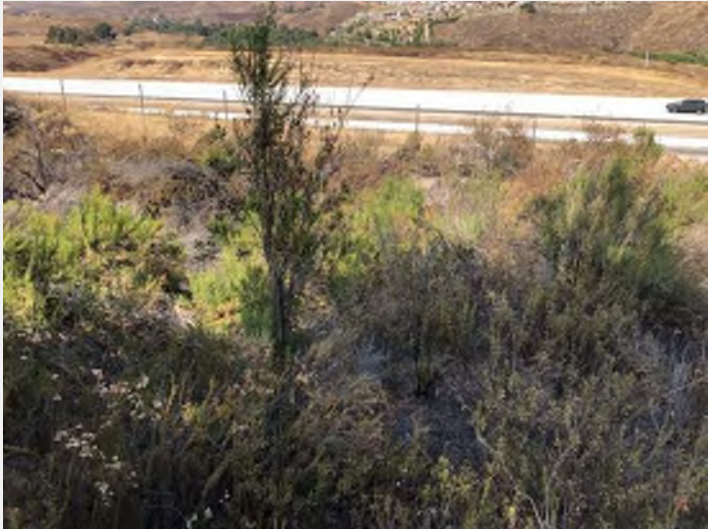
<p>Photograph #: 31.5-2_1</p> <p>Photo Date: 8/26/20</p> <p>Feature Number: 31.5-2</p> <p>Direction: Northwest</p> <p>Notes: View of riparian vegetation for Feature 31.5-2.</p>

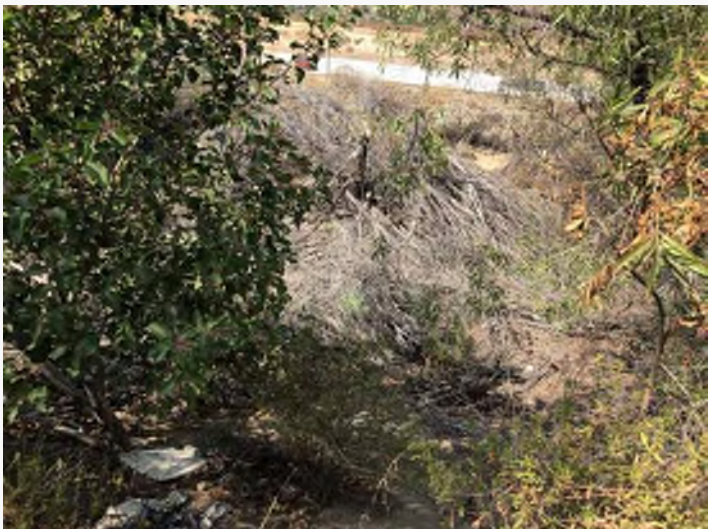
<p>Photograph #: 31.5-2_2</p> <p>Photo Date: 8/26/20</p> <p>Feature Number: 31.5-2</p> <p>Direction: Northwest</p> <p>Notes: View of riparian vegetation for Feature 31.5-2.</p>

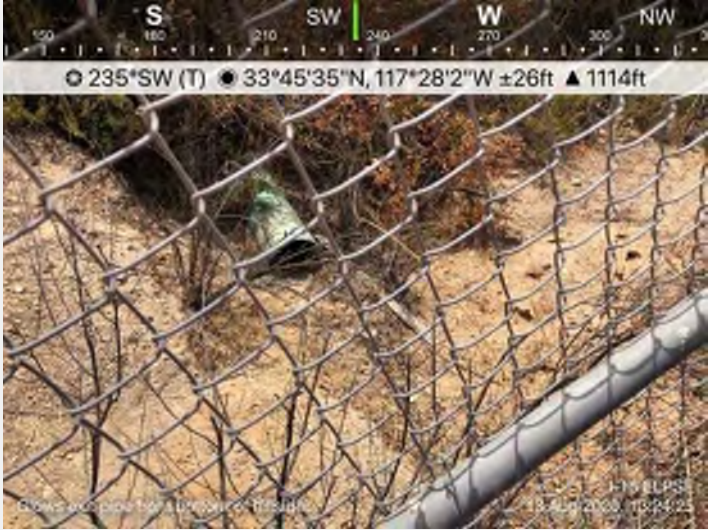
<p>A photograph showing a grey pipe running through a chain-link fence. The pipe is partially obscured by the fence's diamond pattern. The background shows dry, brownish vegetation and soil. At the top of the image, there is a compass overlay with directions S, SW, W, and NW, and a scale from 150 to 300. Below the scale, the text reads: "235°SW (T) 33°45'35"N, 117°28'2"W ±26ft ▲ 1114ft". In the bottom right corner, there is a timestamp: "1-15-13 13:24:23".</p>	<p>Photograph #: 31.5-3_1</p> <p>Photo Date: 8/13/20</p> <p>Feature Number: 31.5-3</p> <p>Direction: Southwest</p> <p>Notes: View of pipe conveying flows for Feature 31.5-3.</p>

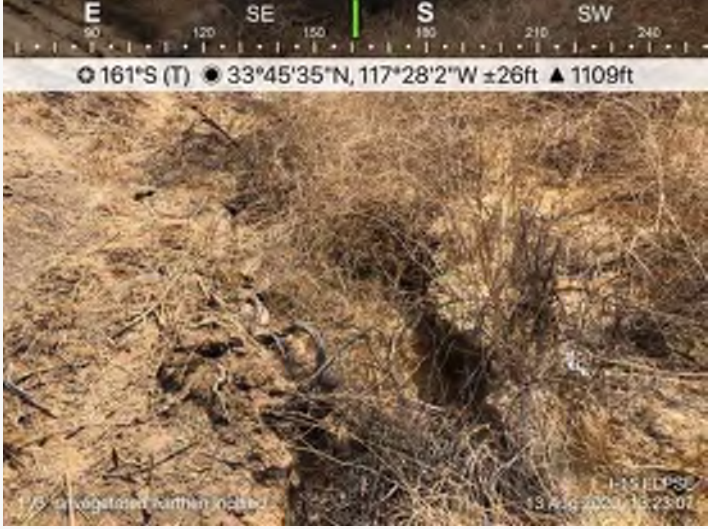
<p>A photograph of an earthen channel or gully. The channel is filled with dry, brownish vegetation and soil. The background shows a hillside with similar vegetation. At the top of the image, there is a compass overlay with directions E, SE, S, and SW, and a scale from 90 to 240. Below the scale, the text reads: "161°S (T) 33°45'35"N, 117°28'2"W ±26ft ▲ 1109ft". In the bottom right corner, there is a timestamp: "1-15-13 13:23:07".</p>	<p>Photograph #: 31.5-3_2</p> <p>Photo Date: 8/13/20</p> <p>Feature Number: 31.5-3</p> <p>Direction: Southeast</p> <p>Notes: View of earthen channel for Feature 31.5-3.</p>

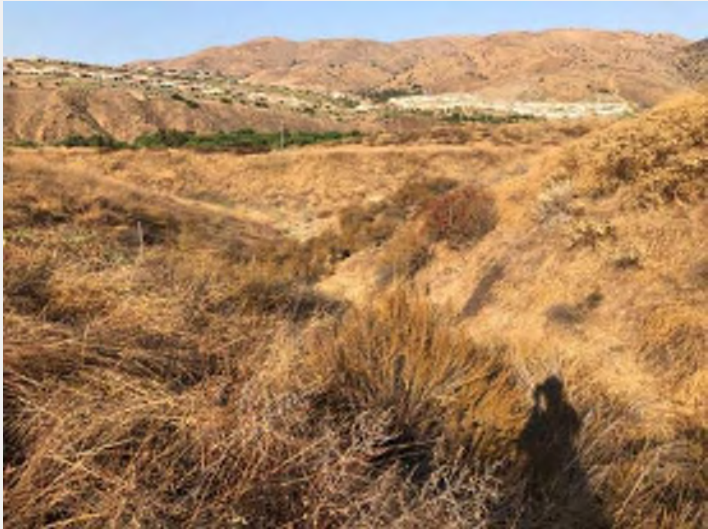
<p>A wide-angle photograph of an earthen swale in a dry, hilly landscape. The foreground is dominated by dry, brownish vegetation. In the background, there are rolling hills under a clear blue sky. The swale is a shallow, earthen channel that runs through the landscape. The overall scene is arid and dry.</p>	<p>Photograph #: 31.5-4_1</p> <p>Photo Date: 8/26/20</p> <p>Feature Number: 31.5-4</p> <p>Direction: Northeast</p> <p>Notes: View of earthen swale for Feature 31.5-4.</p>

31.5-4	Earthen	Ephemeral		Jurisdictional	1	-	0.003	-	Jurisdictional	1	-	0.003	-	Jurisdictional	3	-	0.010	-	Earthen, incised channel with non-native grasses and buckwheat scrub vegetation. No culvert found at top. Flows into concrete culvert outside of JSA and is eventually tributary to Temescal Wash. Portions mapped using aerial and topographic lines due to lack of access.

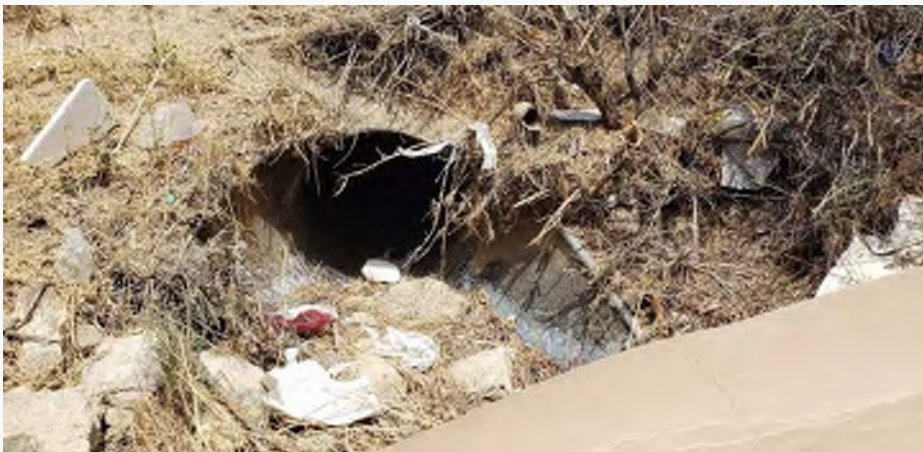
<p>Photograph #: 31.6-1_1</p> <p>Photo Date: 8/13/20</p> <p>Feature Number: 31.6-1</p> <p>Direction: Northeast</p> <p>Notes: View of culvert for Feature 31.6-1.</p>

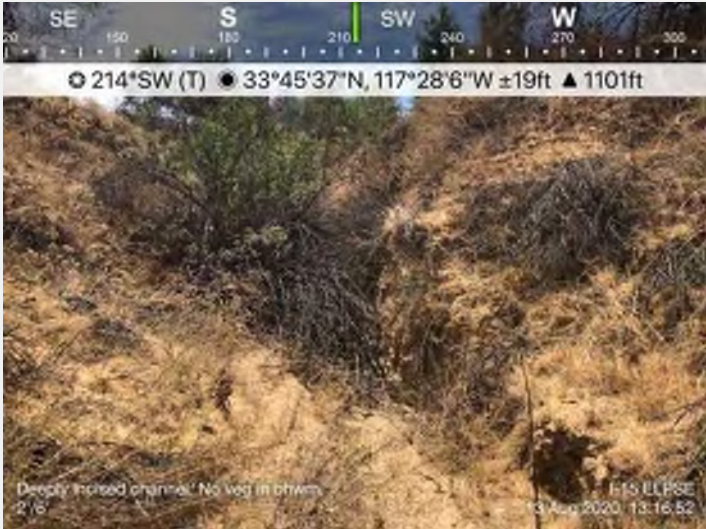
<p>Photograph #: 31.6-1_2</p> <p>Photo Date: 8/13/20</p> <p>Feature Number: 31.6-1</p> <p>Direction: Southwest</p> <p>Notes: View of earthen channel and riparian vegetation for Feature 31.6-1.</p>

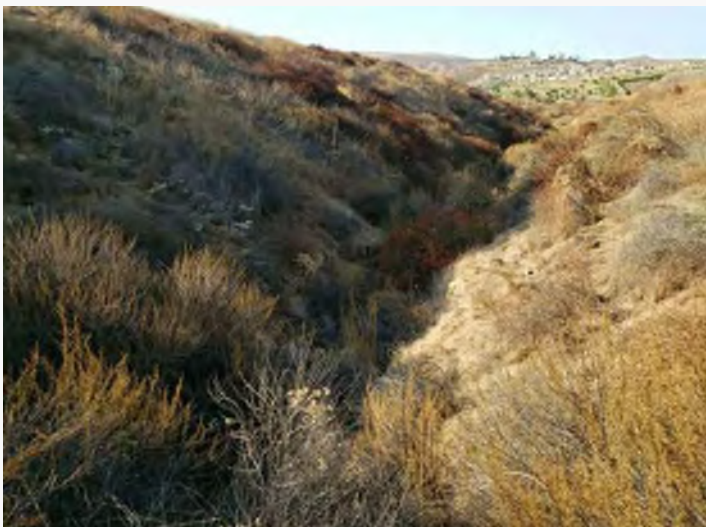
<p>Photograph #: 31.6-2_1</p> <p>Photo Date: 8/26/20</p> <p>Feature Number: 31.6-2</p> <p>Direction: Northeast</p> <p>Notes: View of earthen swale for Feature 31.6-2.</p>

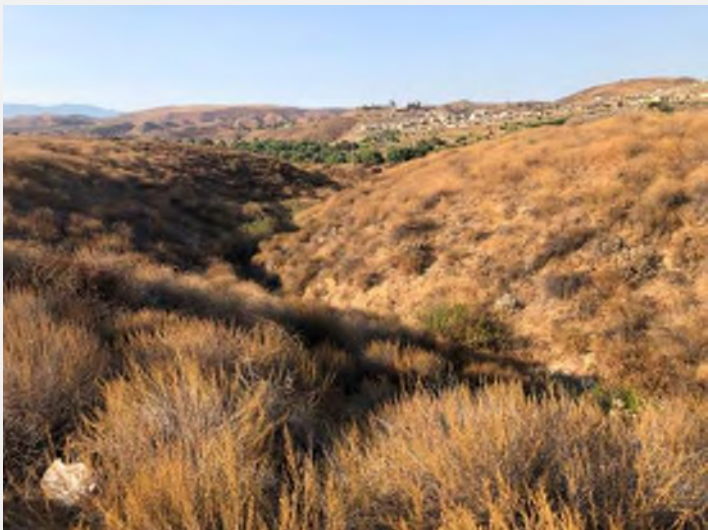
<p>Photograph #: 31.6-3_1</p> <p>Photo Date: 8/26/20</p> <p>Feature Number: 31.6-3</p> <p>Direction: Northeast</p> <p>Notes: View of earthen swale for Feature 31.6-3.</p>
 	<p>Photograph #: 31.7-1_1</p> <p>Photo Date: 8/13/20</p> <p>Feature Number: 31.7-1</p> <p>Direction: Southeast</p> <p>Notes: View of concrete v-ditch adjacent to I-15 freeway NB for Feature 31.7-1.</p>
 	<p>Photograph #: 31.7-2_1</p> <p>Photo Date: 8/26/20</p> <p>Feature Number: 31.7-2</p> <p>Direction: South</p> <p>Notes: View of riparian vegetation for Feature 31.7-2.</p>

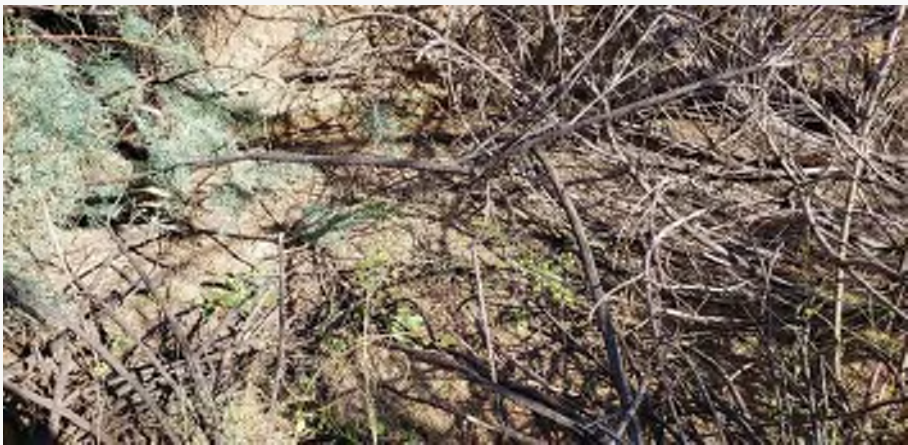
<p>Photograph #: 31.7-2_2</p> <p>Photo Date: 8/13/20</p> <p>Feature Number: 31.7-2</p> <p>Direction: Southwest</p> <p>Notes: View of riparian vegetation for Feature 31.7-2.</p>

31.7-2	Earthen	Ephemeral		Jurisdictional	4	-	0.007	-	Jurisdictional	4	-	0.007	-	Jurisdictional	19	-	0.087	-	Originates in south as incised channel with dry soils, no vegetation in channel. Tamarisk and willow at fence. Tamarisk only downstream of point. OHWM by water staining, shelving, wrack. Connects to concrete v-ditch collecting hillside runoff originating at top of this hill and conveying into culvert at bottom. 31.6-1 flows into channel near culvert

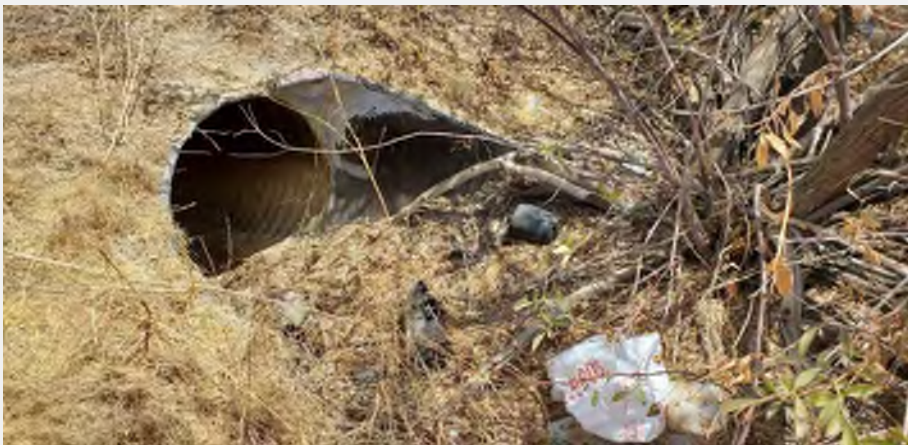
<p>Photograph #: 31.7-3_1</p> <p>Photo Date: 8/13/20</p> <p>Feature Number: 31.7-3</p> <p>Direction: Northwest</p> <p>Notes: View of culvert for Feature 31.7-3.</p>

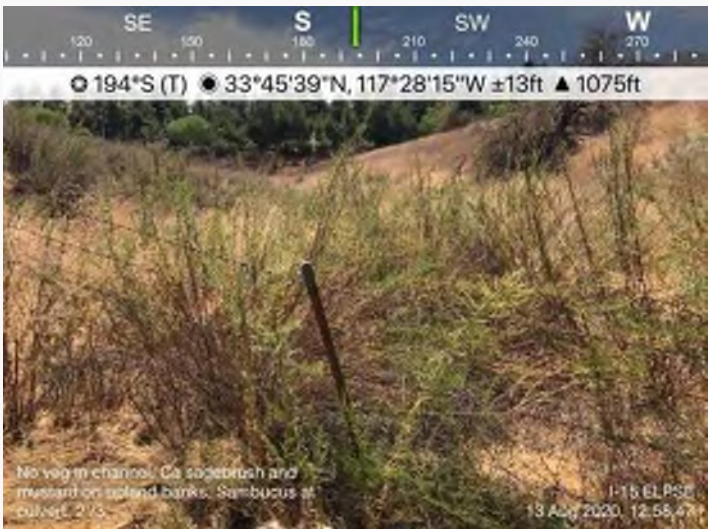
<p>Photograph #: 31.7-3_2</p> <p>Photo Date: 8/13/20</p> <p>Feature Number: 31.7-3</p> <p>Direction: South</p> <p>Notes: View of earthen channel for Feature 31.7-3.</p>

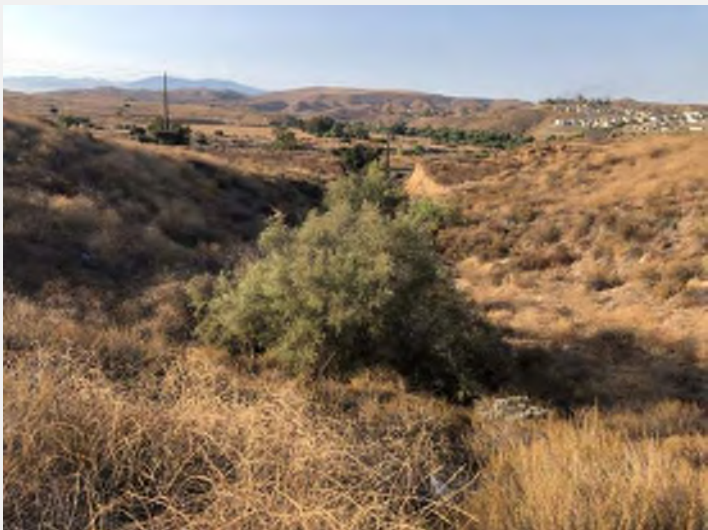
<p>Photograph #: 31.7-4_1</p> <p>Photo Date: 8/26/20</p> <p>Feature Number: 31.7-4</p> <p>Direction: Northeast</p> <p>Notes: View of riparian vegetation for Feature 31.7-4.</p>

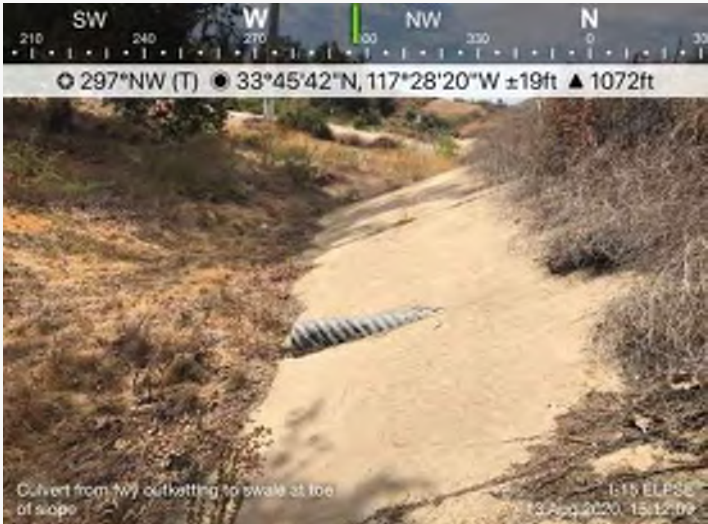
<p>Culvert from NW outkutting to swale at toe of slope</p> <p>1-15 ELPSE Aug 2020, 15:12:09</p>	<p>Photograph #: 31.8-1_1</p> <p>Photo Date: 8/13/20</p> <p>Feature Number: 31.8-1</p> <p>Direction: Northwest</p> <p>Notes: View of metal culvert and swale at toe of slope adjacent to I-15 freeway SB for Feature 31.8-1.</p>

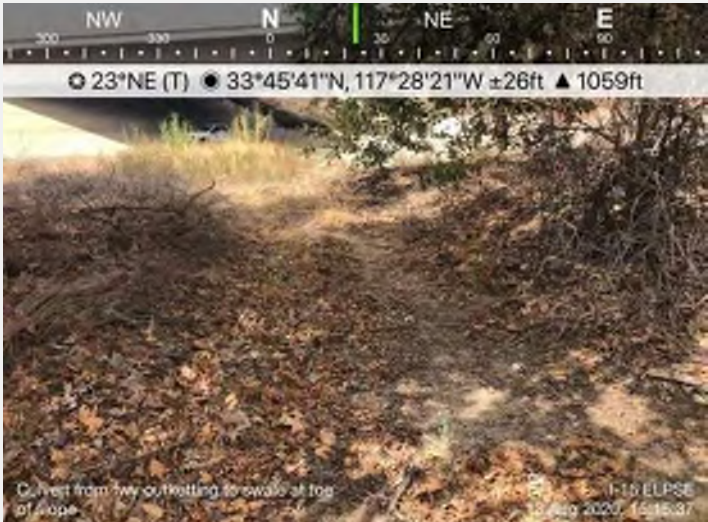
<p>Culvert from NW outkutting to swale at toe of slope</p> <p>1-15 ELPSE Aug 2020, 15:15:37</p>	<p>Photograph #: 31.8-1_2</p> <p>Photo Date: 8/13/20</p> <p>Feature Number: 31.8-1</p> <p>Direction: Northeast</p> <p>Notes: View of swale for Feature 31.8-1.</p>

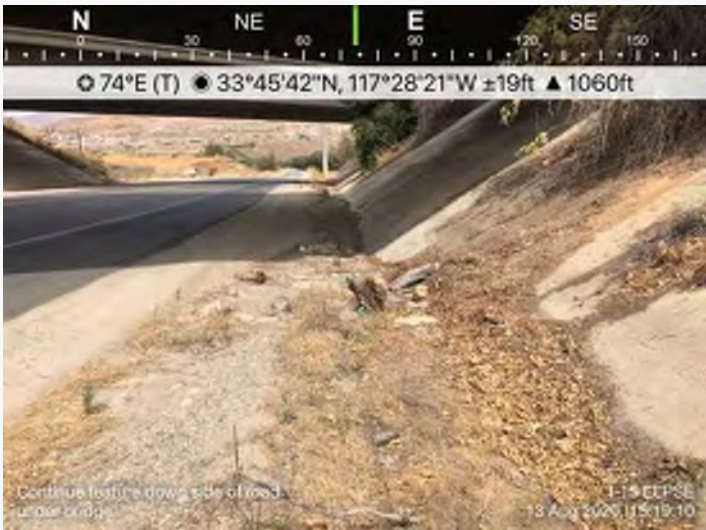
<p>Continue feature down side of road under bridge</p> <p>1-15 GPS SE 18 Aug 2020 11:51:10</p>	<p>Photograph #: 31.8-1_3</p> <p>Photo Date: 8/13/20</p> <p>Feature Number: 31.8-1</p> <p>Direction: Northeast</p> <p>Notes: View of roadside swale for Feature 31.8-1.</p>

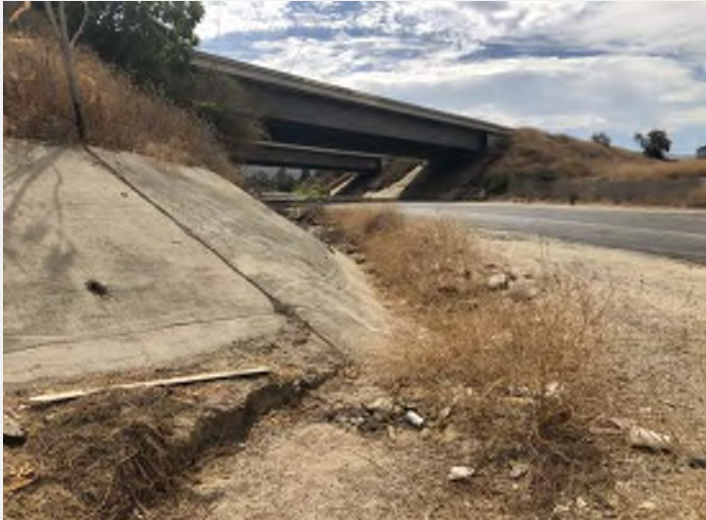
<p>Photograph #: 31.8-1_4</p> <p>Photo Date: 8/13/20</p> <p>Feature Number: 31.8-1</p> <p>Direction: Northwest</p> <p>Notes: View of roadside swale for Feature 31.8-1.</p>

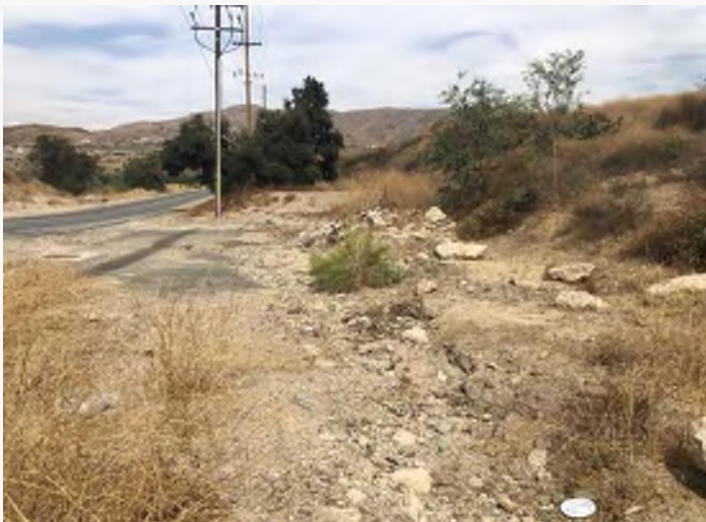
<p>Photograph #: 31.8-1_5</p> <p>Photo Date: 8/13/20</p> <p>Feature Number: 31.8-1</p> <p>Direction: Northeast</p> <p>Notes: View of earthen roadside channel for feature 31.8-1.</p>

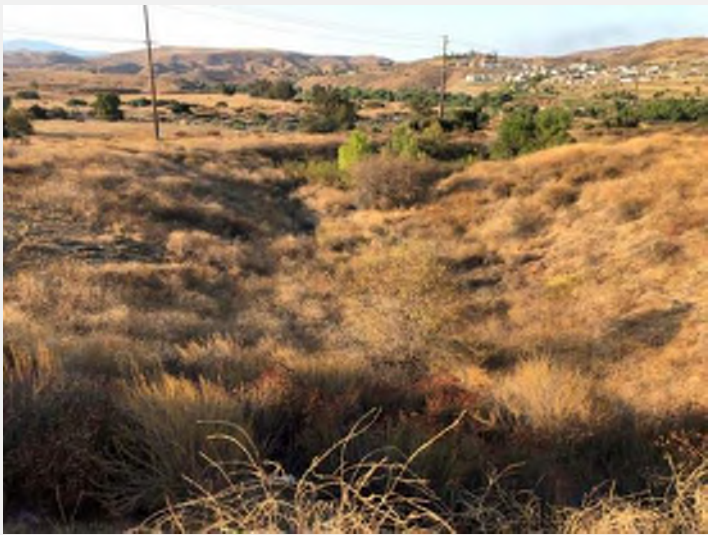
<p>Photograph #: 31.8-2_1</p> <p>Photo Date: 8/26/20</p> <p>Feature Number: 31.8-2</p> <p>Direction: Northeast</p> <p>Notes: View of Feature 31.8-2.</p>

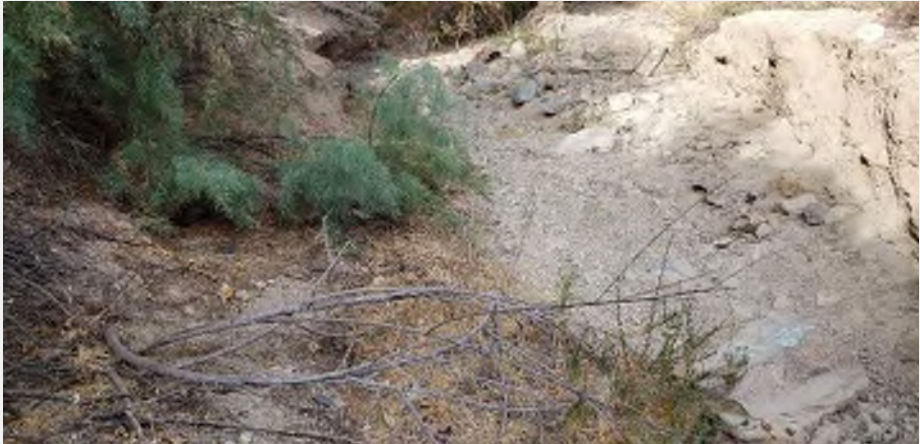
<p>Photograph #: 31.9-2_3</p> <p>Photo Date: 8/13/20</p> <p>Feature Number: 31.9-2 (Mayhew Wash)</p> <p>Direction: Northeast</p> <p>Notes: View of unvegetated braid with coarse sandy soils with adjacent upland-vegetated terrace for Feature 31.9-2.</p>
 	<p>Photograph #: 31.9-2_4</p> <p>Photo Date: 8/13/20</p> <p>Feature Number: 31.9-2 (Mayhew Wash)</p> <p>Direction: Northeast</p> <p>Notes: View of unvegetated braid with coarse sandy soils with adjacent vegetated terrace for Feature 31.9-2.</p>

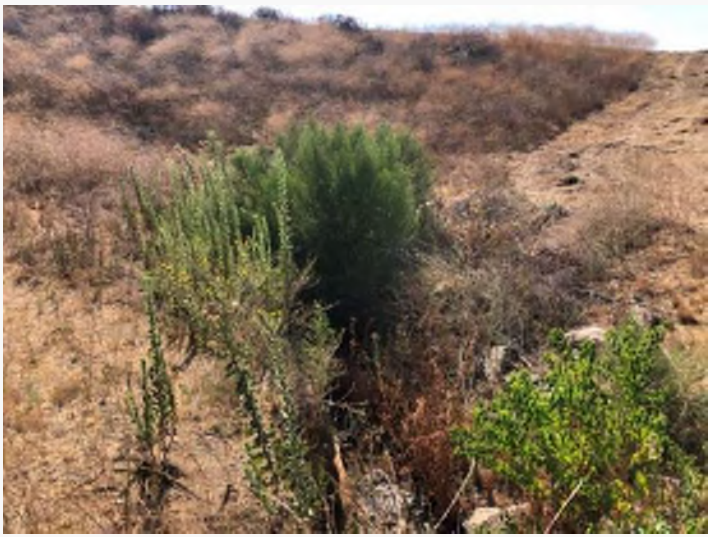
A photograph showing a hillside with sparse, dry vegetation. In the foreground, there is a cluster of green, leafy bushes and a tall, thin cactus-like plant. The background shows a dry, brownish hillside under a clear sky.	<p>Photograph #: 32.3-2_1</p> <p>Photo Date: 8/27/20</p> <p>Feature Number: 32.3-2</p> <p>Direction: Northeast</p> <p>Notes: View of riparian vegetation for Feature 32.3-2.</p>

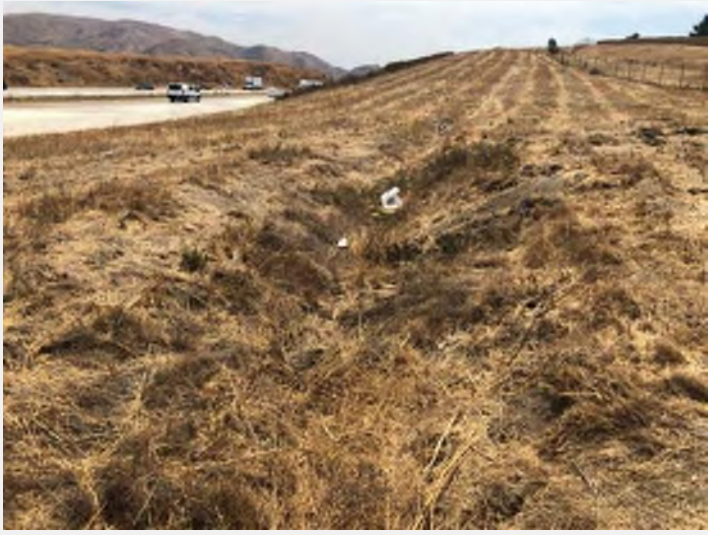
A photograph of a long, straight swale or drainage ditch. The swale is filled with dry, brown grass and brush. In the background, a multi-lane freeway (I-15) is visible, with several vehicles on the road. The sky is overcast.	<p>Photograph #: 32.5-1_1</p> <p>Photo Date: 8/13/20</p> <p>Feature Number: 32.5-1</p> <p>Direction: Southeast</p> <p>Notes: View of swale adjacent to I-15 freeway NB for Feature 32.5-1.</p>

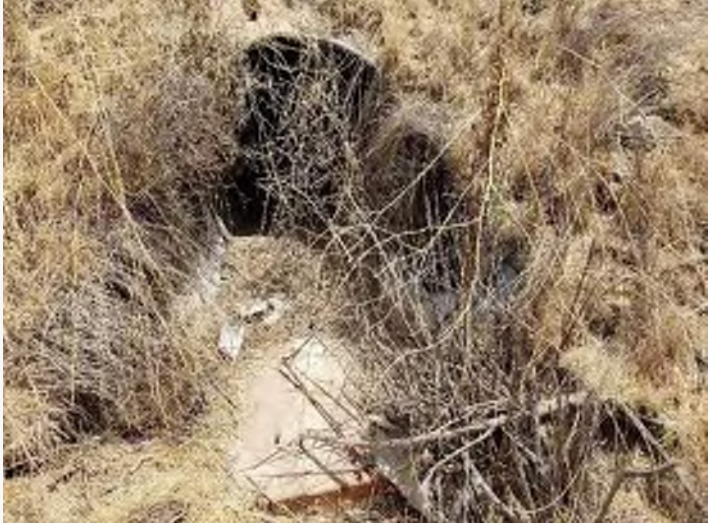
A photograph showing the entrance to a culvert. The entrance is a dark, rectangular opening, partially obscured by a dense thicket of dry, tangled brush and branches. The surrounding area is covered in dry grass and brush.	<p>Photograph #: 32.5-1_2</p> <p>Photo Date: 8/13/20</p> <p>Feature Number: 32.5-1</p> <p>Direction: Northeast</p> <p>Notes: View of culvert for Feature 32.5-1.</p>

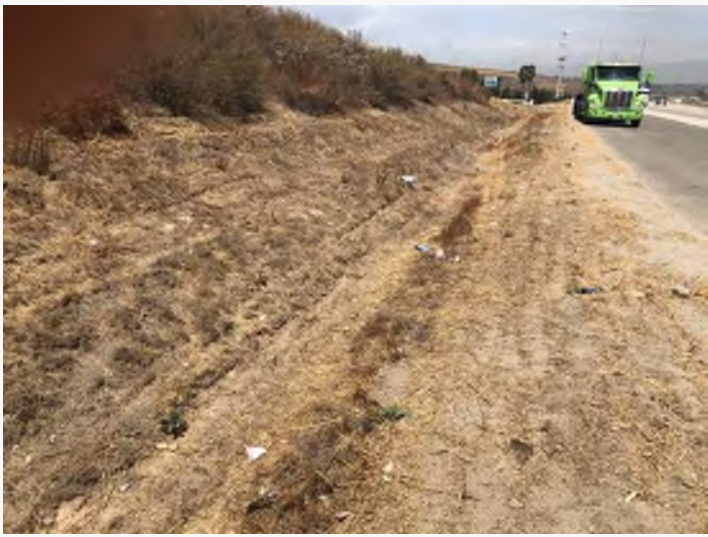
<p>Photograph #: 32.8-1_1</p> <p>Photo Date: 8/13/20</p> <p>Feature Number: 32.8-1</p> <p>Direction: Northwest</p> <p>Notes: View of roadside swale adjacent to I-15 freeway SB for Feature 32.8-1.</p>

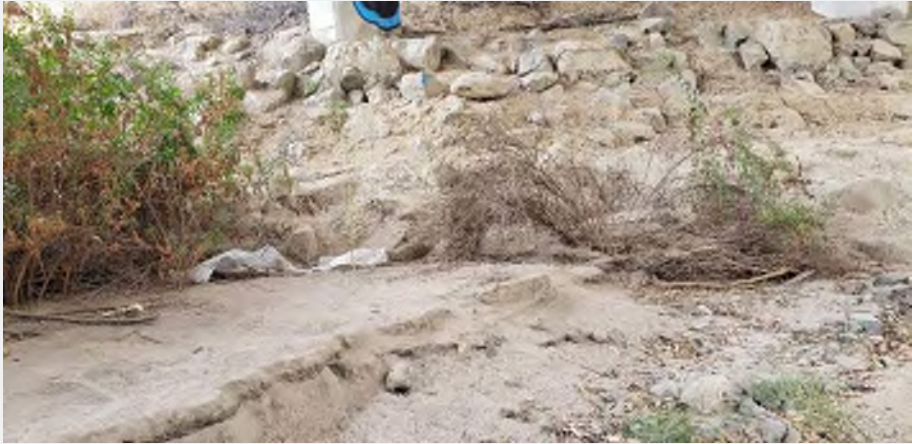
<p>Photograph #: 32.9-1_1</p> <p>Photo Date: 8/13/20</p> <p>Feature Number: 32.9-1 (Coldwater Wash)</p> <p>Direction: Northwest</p> <p>Notes: View of riparian vegetation, earthen channel and incised banks for Feature 32.9-1.</p>

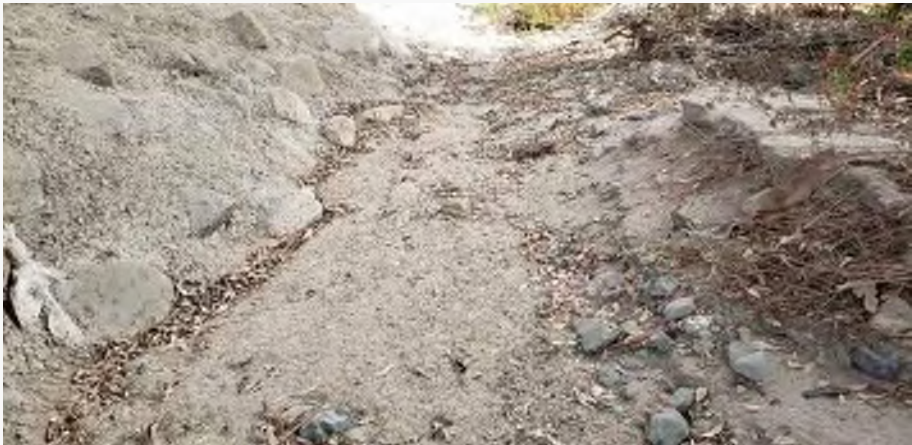
<p>Photograph #:32.9-1_2</p> <p>Photo Date: 8/13/20</p> <p>Feature Number: 32.9-1 (Coldwater Wash)</p> <p>Direction: Northeast</p> <p>Notes: View of riparian vegetation, earthen channel and incised banks for Feature 32.9-1.</p>

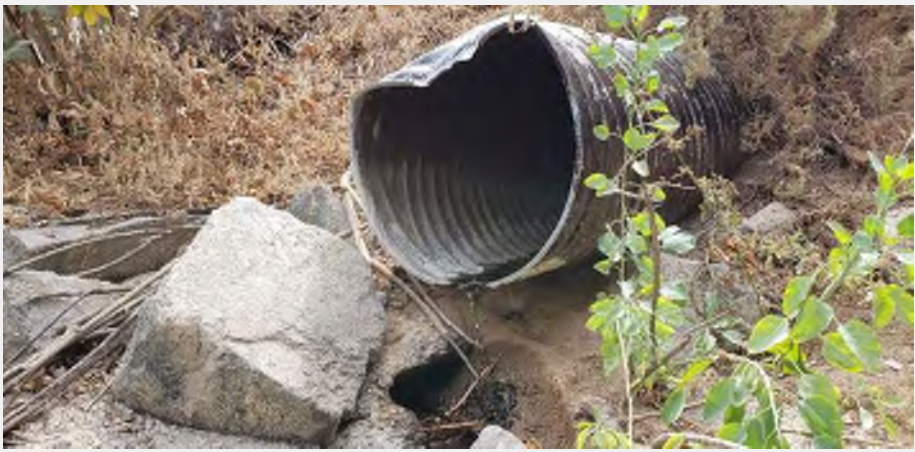
<p>Photograph #: 32.9-1_3</p> <p>Photo Date: 8/13/20</p> <p>Feature Number: 32.9-1 (Coldwater Wash)</p> <p>Direction: Southeast</p> <p>Notes: View of metal culvert, riparian vegetation, and seep for Feature 32.9-1.</p>

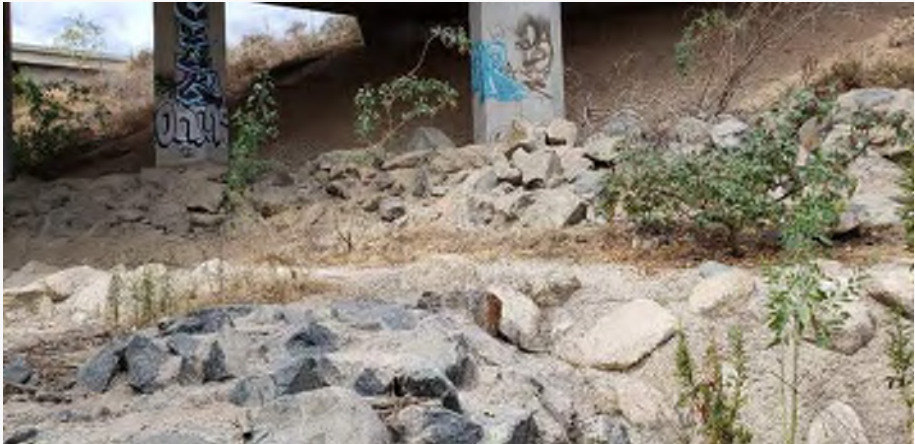
<p>Photograph #: 32.9-1_4</p> <p>Photo Date: 8/13/20</p> <p>Feature Number: 32.9-1 (Coldwater Wash)</p> <p>Direction: Southeast</p> <p>Notes: View of riparian vegetation and rip-rap for Feature 32.9-1.</p>

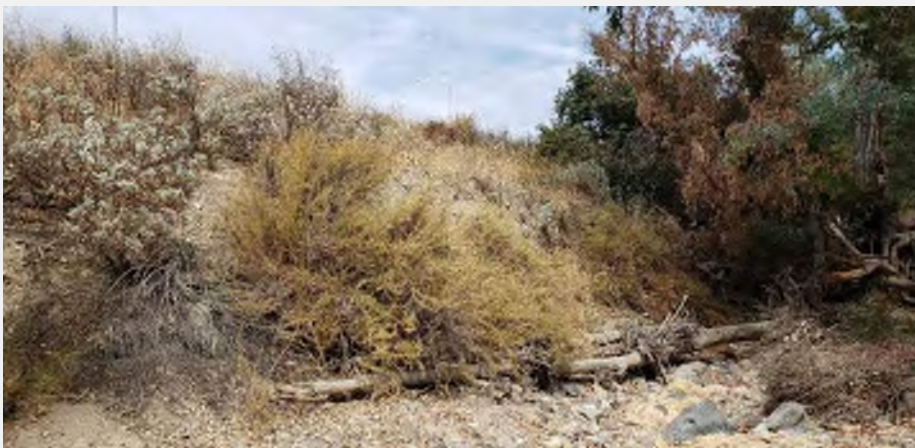
<p>Photograph #: 32.9-1_5</p> <p>Photo Date: 8/13/20</p> <p>Feature Number: 32.9-1 (Coldwater Wash)</p> <p>Direction: Northwest</p> <p>Notes: View of riparian vegetation for Feature 32.9-1.</p>

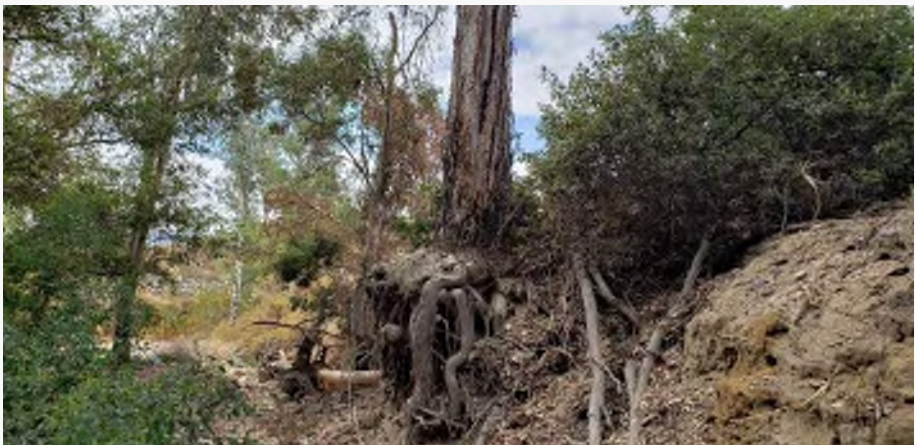
<p>Photograph #: 32.9-1_6</p> <p>Photo Date: 8/13/20</p> <p>Feature Number: 32.9-1 (Coldwater Wash)</p> <p>Direction: Southwest</p> <p>Notes: View of riparian vegetation for Feature 32.9-1.</p>

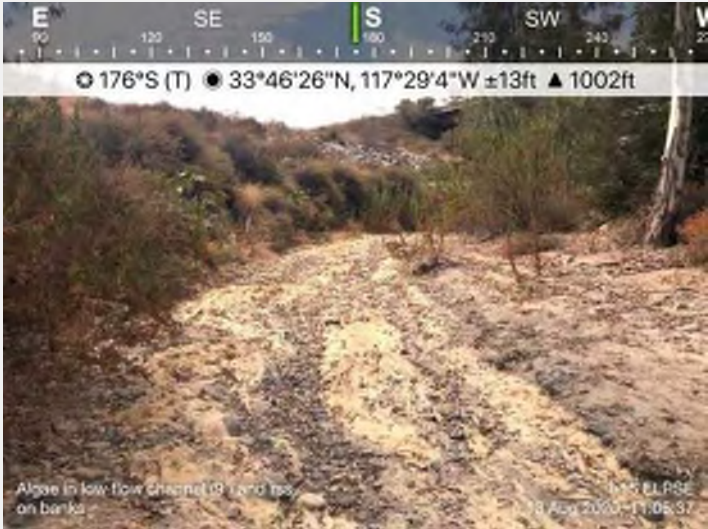
<p>Photograph #: 32.9-1_7</p> <p>Photo Date: 8/13/20</p> <p>Feature Number: 32.9-1 (Coldwater Wash)</p> <p>Direction: South</p> <p>Notes: View of earthen channel and riparian vegetation for Feature 32.9-1.</p>

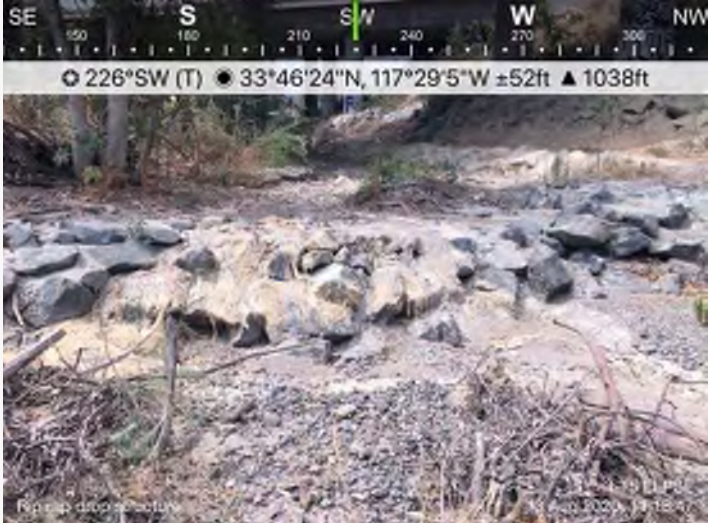
<p>Photograph #: 32.9-1_8</p> <p>Photo Date: 8/13/20</p> <p>Feature Number: 32.9-1 (Coldwater Wash)</p> <p>Direction: Southwest</p> <p>Notes: View of earthen channel, rip-rap and algae for Feature 32.9-1.</p>

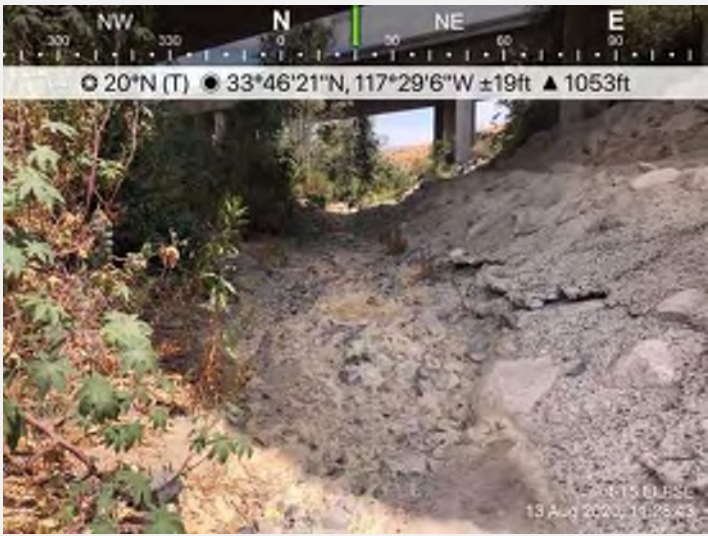
<p>Photograph #: 32.9-1_9</p> <p>Photo Date: 8/13/20</p> <p>Feature Number: 32.9-1 (Coldwater Wash)</p> <p>Direction: Northeast</p> <p>Notes: View of riparian vegetation and earthen channel for Feature 32.9-1.</p>

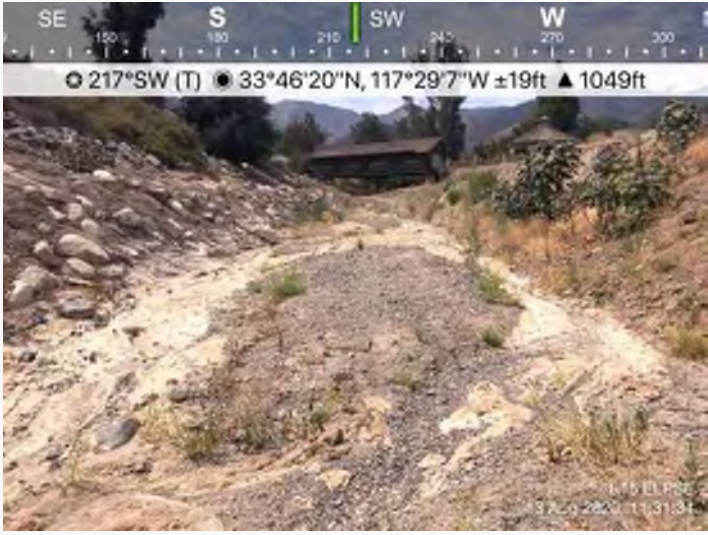
<p>Photograph #: 32.9-1_10</p> <p>Photo Date: 8/13/20</p> <p>Feature Number: 32.9-1 (Coldwater Wash)</p> <p>Direction: Southwest</p> <p>Notes: View of riparian vegetation and earthen channel for Feature 32.9-1.</p>

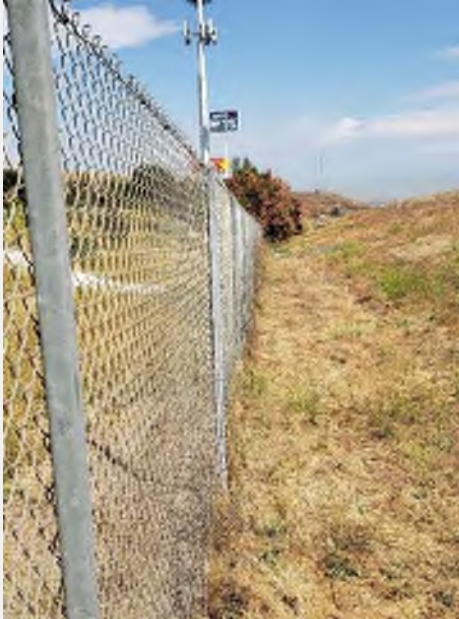
<p>Photograph #: 33.0-1_1</p> <p>Photo Date: 8/13/20</p> <p>Feature Number: 33.0-1</p> <p>Direction: Northwest</p> <p>Notes: View of swale for Feature 33.0-1.</p>

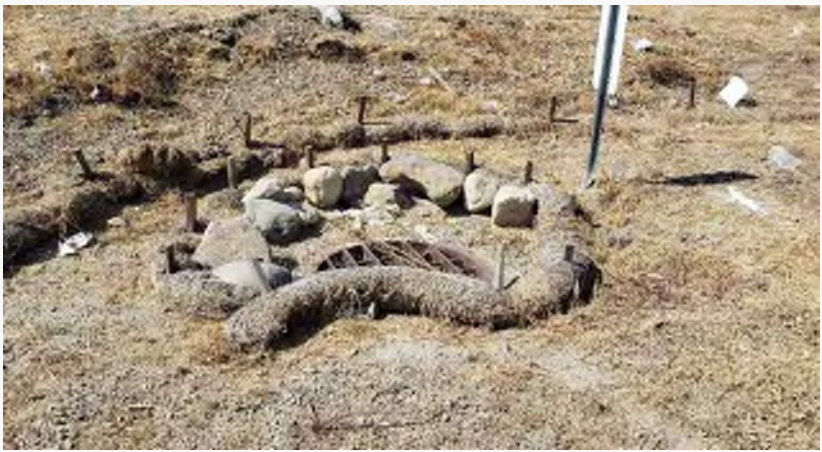
A circular structure made of stones and straw wattle, likely a drain or well, in a dry, open field. A metal pole is visible in the background.	<p>Photograph #: 33.1-1_1</p> <p>Photo Date: 8/27/20</p> <p>Feature Number: 33.1-1</p> <p>Direction: Northwest</p> <p>Notes: View of drain and straw wattles for Feature 33.1-1.</p>
