Interstate 15 Express Lanes Project Southern Extension (ELPSE)

RIVERSIDE COUNTY, CALIFORNIA
DISTRICT 8 – RIV-15 PM 20.3 TO PM 40.1
EA: RIV 08-0J0820 / ID: 08-18000063

Jurisdictional Delineation Report

September 2021

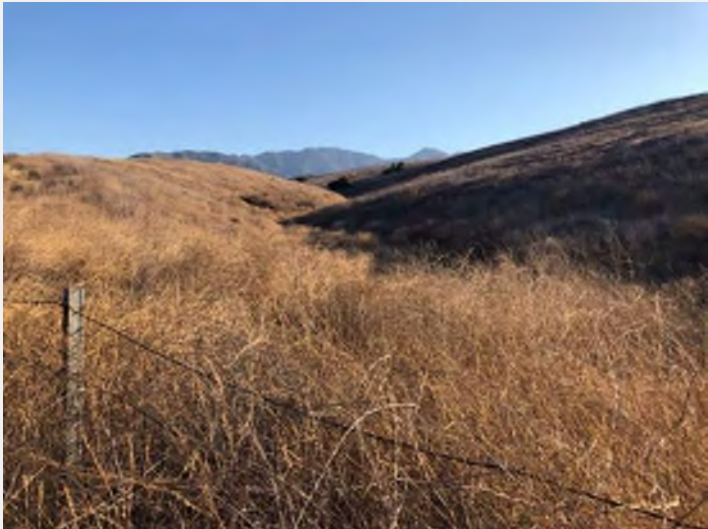
A view of a dry, hilly landscape with a fence in the foreground. The hills are covered in dry, brown vegetation under a clear blue sky.	<p>Photograph #: 33.5-1_1</p> <p>Photo Date: 8/12/20</p> <p>Feature Number: 33.5-1</p> <p>Direction: Southwest</p> <p>Notes: View of swale for Feature 33.5-1.</p>

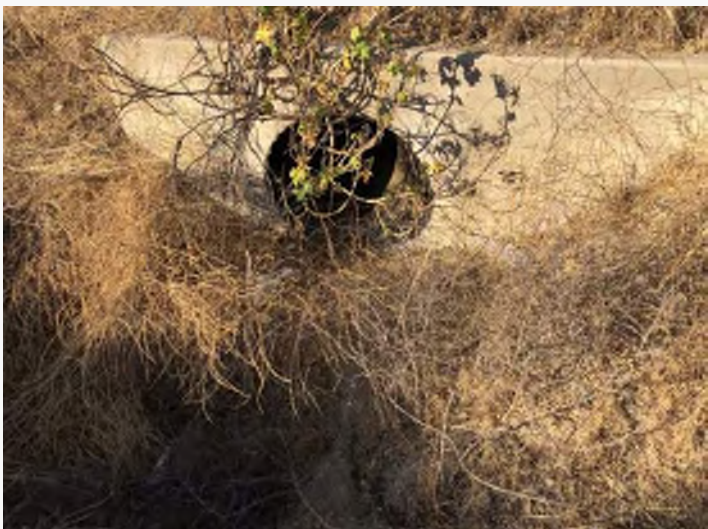
A concrete culvert partially obscured by dry brush and a small tree with yellow flowers. The culvert is set into a dirt embankment.	<p>Photograph #: 33.5-1_2</p> <p>Photo Date: 8/12/20</p> <p>Feature Number: 33.5-1</p> <p>Direction: Northeast</p> <p>Notes: View of concrete culvert for Feature 33.5-1.</p>

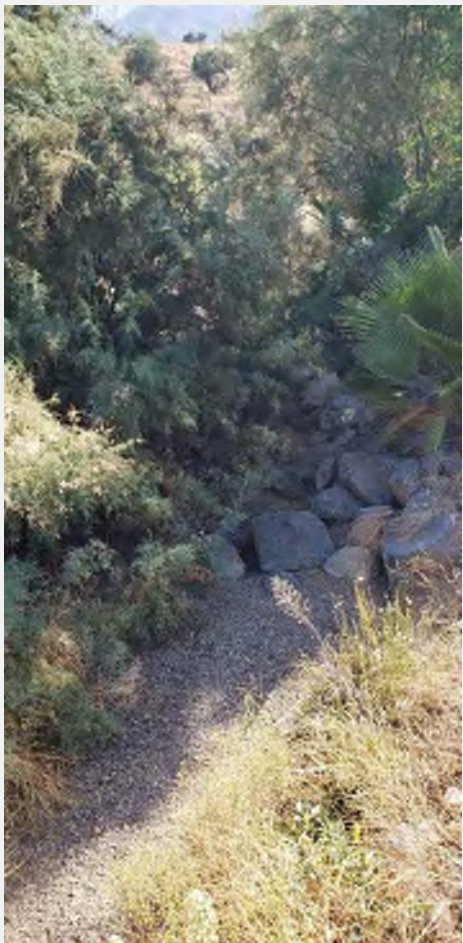
A photograph showing a steep hillside covered in dense, green riparian vegetation. The foreground is dominated by tall, yellowish-brown grasses and a gravelly path. The vegetation extends up the slope, with various shrubs and trees visible against a clear sky.	<p>Photograph #: 33.8-2_2</p> <p>Photo Date: 8/27/20</p> <p>Feature Number: 33.8-2</p> <p>Direction: Southeast</p> <p>Notes: View of riparian vegetation for Feature 33.8-2.</p>

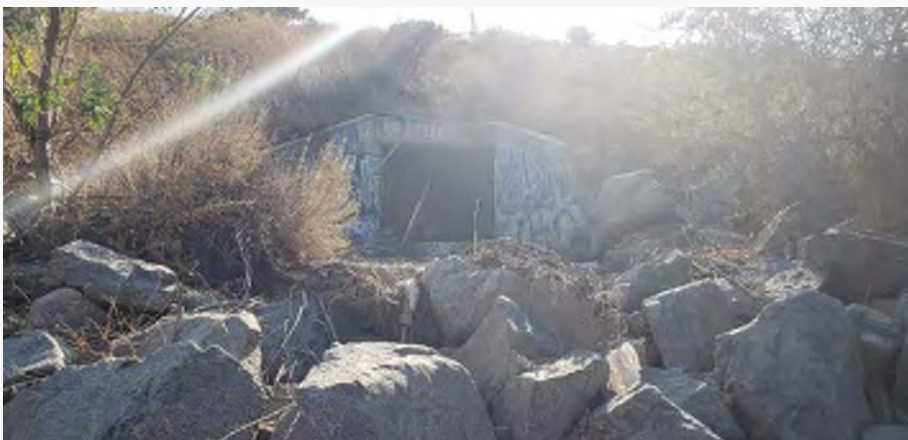
A photograph showing a concrete channel filled with large, grey rocks. In the background, there is a structure covered with a blue tarp, partially obscured by trees and bushes. The scene is brightly lit, with a lens flare visible in the upper left corner.	<p>Photograph #: 33.8-2_3</p> <p>Photo Date: 8/27/20</p> <p>Feature Number: 33.8-2</p> <p>Direction: Southwest</p> <p>Notes: View of concrete channel for Feature 33.8-2.</p>

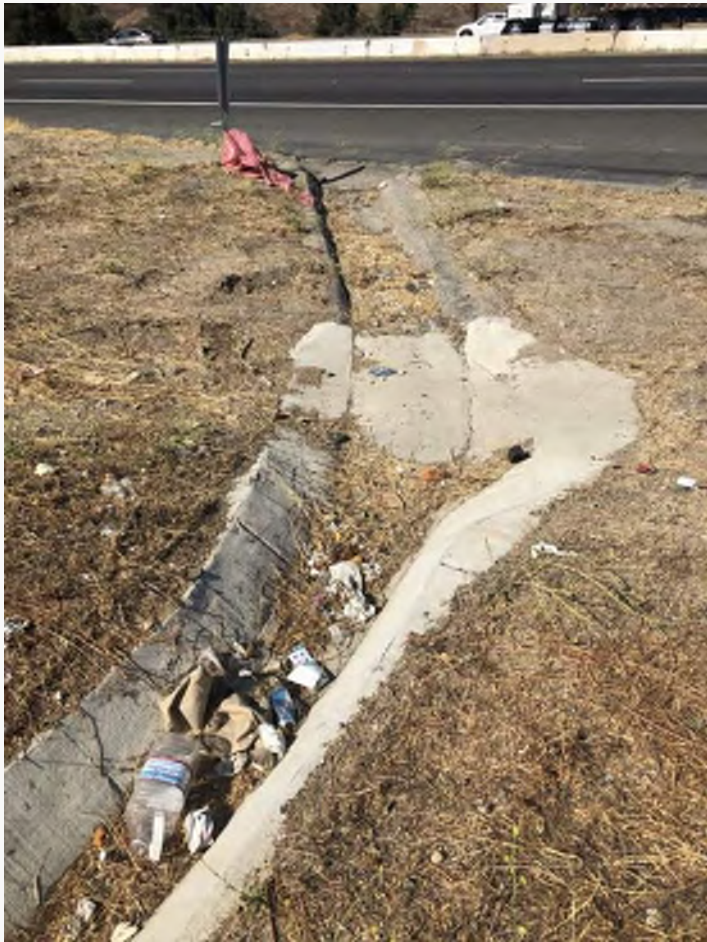
Photograph #: 33.8-3_3

Notes: View of concrete ditch conveying roadside flows for Feature 33.8-3.

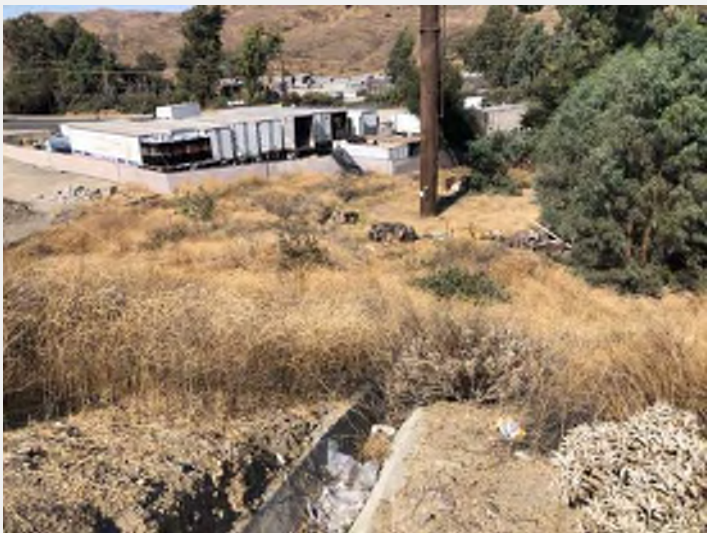
Photograph #: 33.9-1_1

Notes: View of concrete ditch and riparian vegetation for Feature 33.9-1.

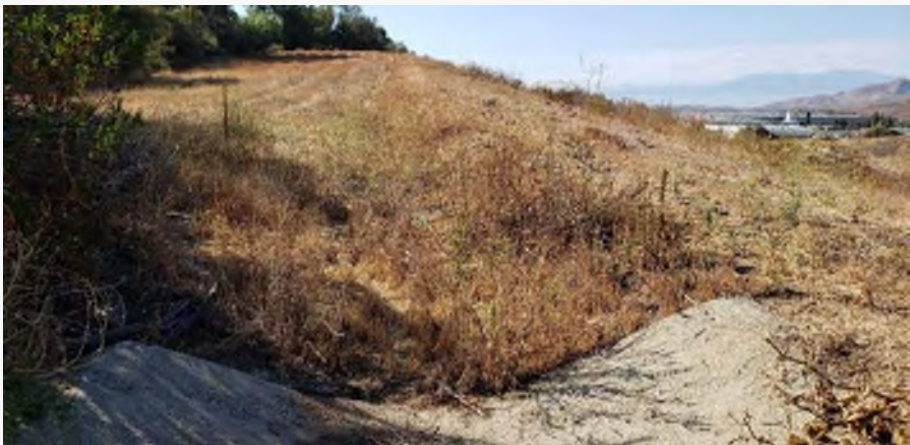
A photograph showing a concrete pad and a swale in a dry, brushy landscape. The pad is a flat, light-colored concrete surface, and the swale is a shallow, narrow channel. The surrounding vegetation is sparse and dry, with some green shrubs in the background. In the distance, a town and mountains are visible under a clear sky.	<p>Photograph #: 34.0-1_1</p> <p>Photo Date: 8/12/20</p> <p>Feature Number: 34.0-1</p> <p>Direction: Northwest</p> <p>Notes: View of concrete pad and swale for Feature 34.0-1.</p>

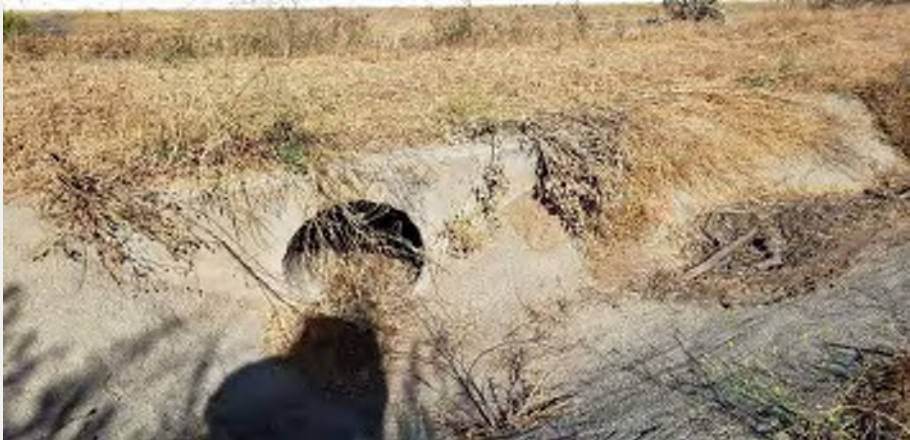
A photograph showing a concrete culvert in a dry, brushy landscape. The culvert is a circular opening in a concrete structure, surrounded by dry grass and brush. The surrounding vegetation is sparse and dry, with some green shrubs in the background. In the distance, a town and mountains are visible under a clear sky.	<p>Photograph #: 34.0-1_2</p> <p>Photo Date: 8/12/20</p> <p>Feature Number: 34.0-1</p> <p>Direction: Northwest</p> <p>Notes: View of concrete culvert for Feature 34.0-1.</p>

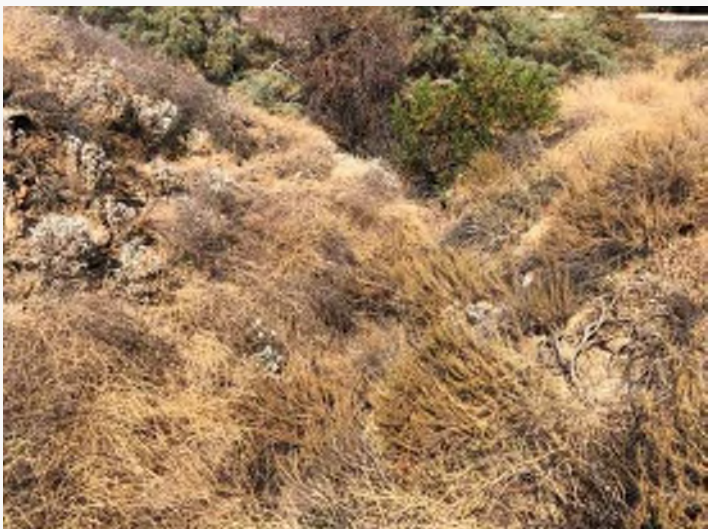
A photograph showing riparian vegetation in a dry, brushy landscape. The vegetation is dense and green, with some yellowish-brown grasses in the foreground. The surrounding vegetation is sparse and dry, with some green shrubs in the background. In the distance, a town and mountains are visible under a clear sky.	<p>Photograph #: 34.0-2_1</p> <p>Photo Date: 8/27/20</p> <p>Feature Number: 34.0-2</p> <p>Direction: Northeast</p> <p>Notes: View of riparian vegetation for Feature 34.0-2.</p>

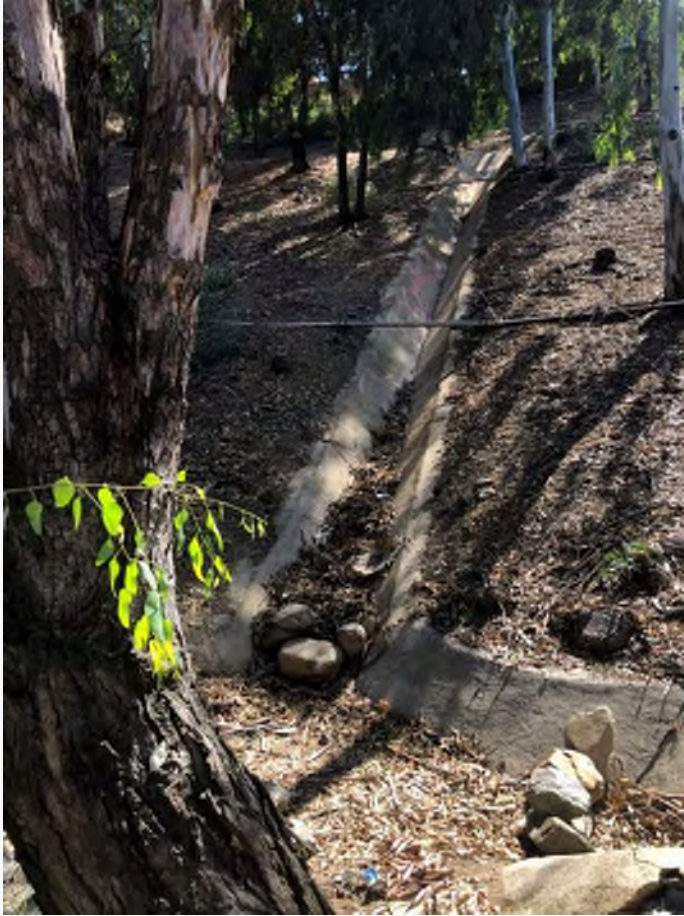
Photograph #: 34.2-1_1

Notes: View of concrete v-ditch and riparian vegetation for Feature 34.1-1.

34.2-1	Concrete	Ephemeral	X	Non-jurisdictional	3	0.016	-	-	Non-jurisdictional	3	0.016	-	-	Non-jurisdictional	12	0.065	-	-	Concrete v-ditch collecting road runoff and freeway irrigation only. OHWM on SB side determined based on concrete staining. No OHWM visible on NB side.

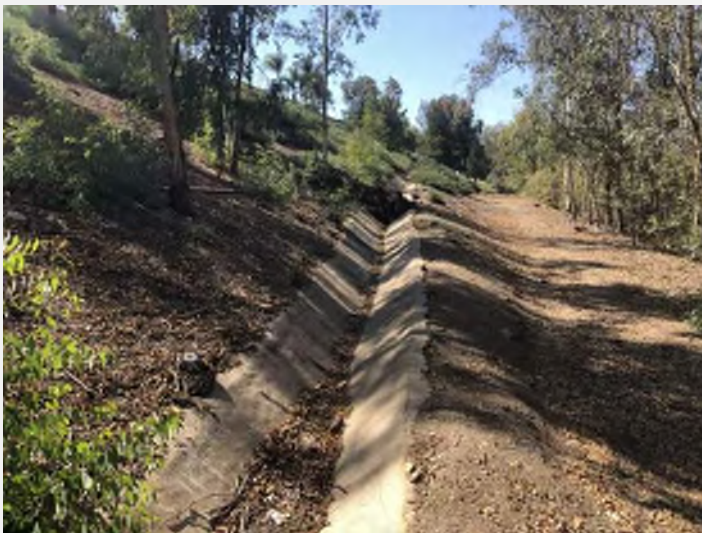
Photograph #: 34.2-2_1

Notes: View of concrete v-ditch and riparian vegetation for Feature 34.1-1.

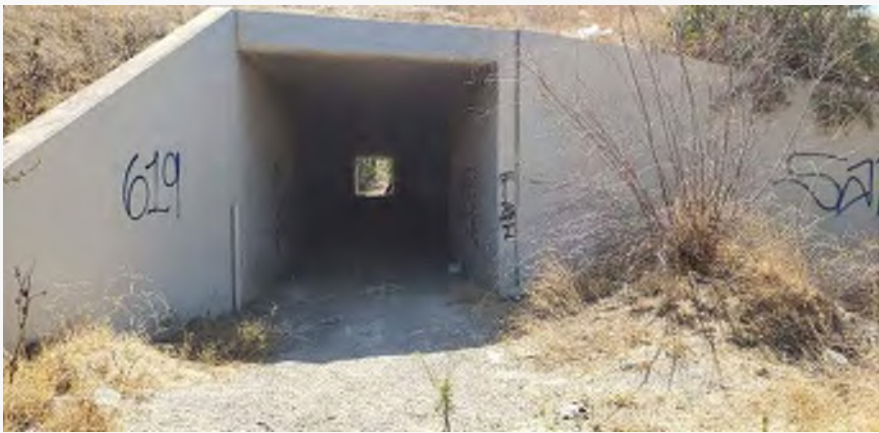
<p>Photograph #: 34.2-3_1</p> <p>Photo Date: 8/12/20</p> <p>Feature Number: 34.2-3</p> <p>Direction: Southwest</p> <p>Notes: View of concrete channel for Feature 34.2-3.</p>

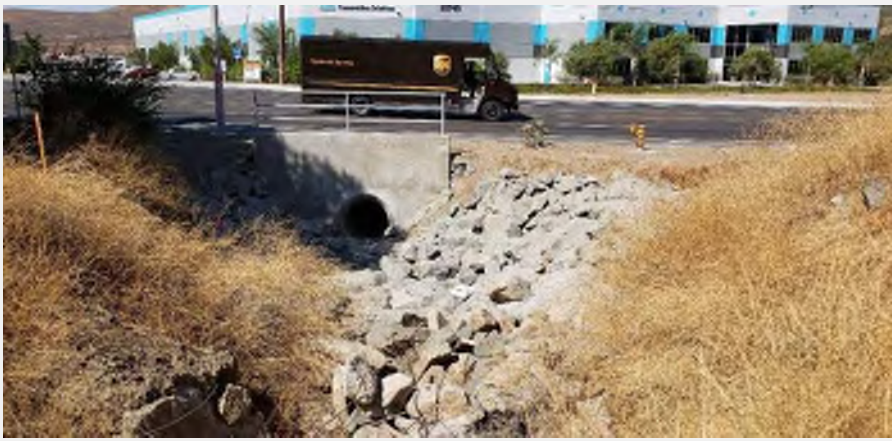
<p>Photograph #: 34.2-3_2</p> <p>Photo Date: 8/12/20</p> <p>Feature Number: 34.2-3</p> <p>Direction: Northeast</p> <p>Notes: View of rip-rap and concrete culvert for Feature 34.2-3.</p>

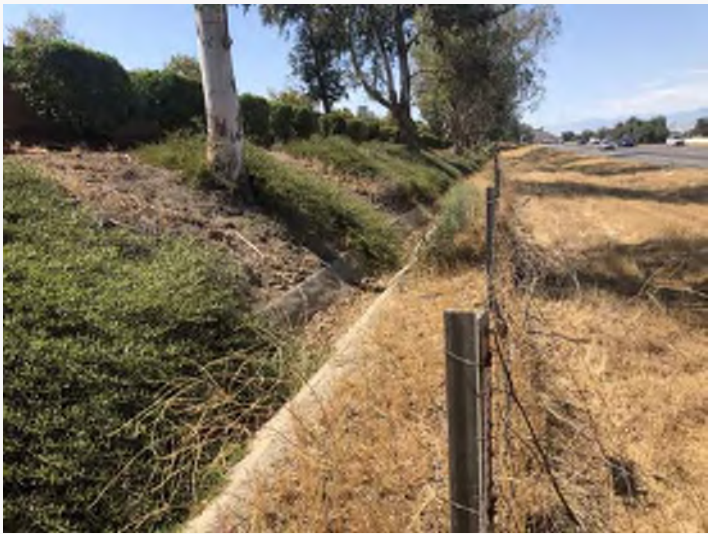
<p>Photograph #: 34.3-1_3</p> <p>Photo Date: 8/12/20</p> <p>Feature Number: 34.3-1</p> <p>Direction: Northwest</p> <p>Notes: View of concrete v-ditch for Feature 34.3-1.</p>

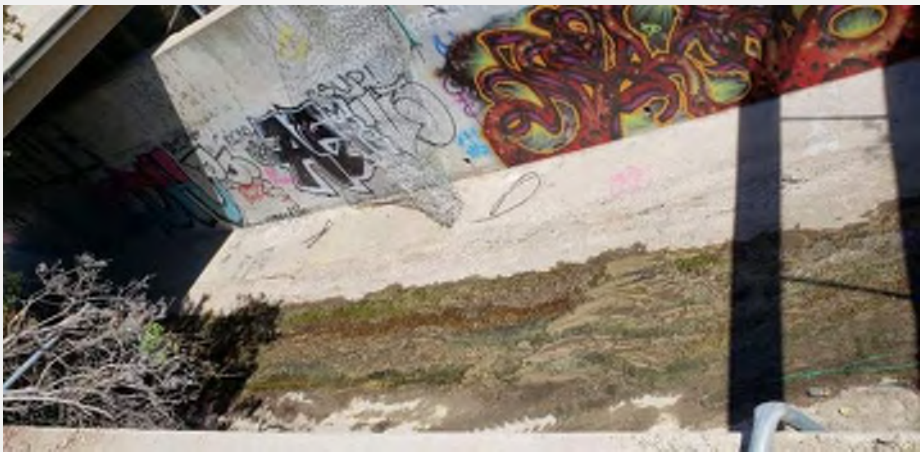
<p>Photograph #: 34.7-1_1</p> <p>Photo Date: 8/27/20</p> <p>Feature Number: 34.7-1 (McBride Canyon)</p> <p>Direction: Southeast</p> <p>Notes: View of concrete channel with staining for Feature 34.7-1.</p>

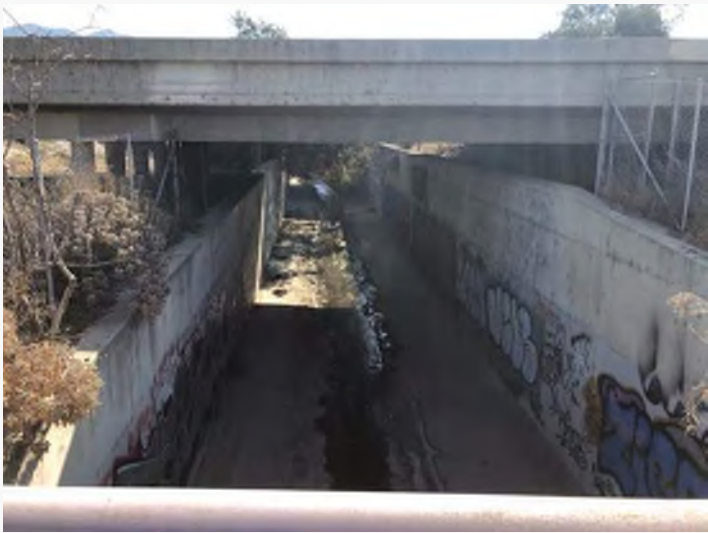
<p>Photograph #: 34.7-1_2</p> <p>Photo Date: 8/27/20</p> <p>Feature Number: 34.7-1 (McBride Canyon)</p> <p>Direction: Southwest</p> <p>Notes: View of concrete channel with staining for Feature 34.7-1.</p>

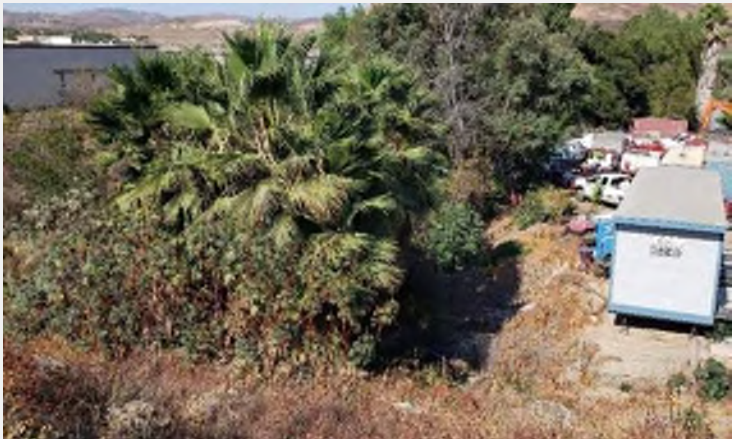
<p>Photograph #: 35.5-1_1</p> <p>Photo Date: 8/27/20</p> <p>Feature Number: 35.5-1</p> <p>Direction: Northeast</p> <p>Notes: View of riparian vegetation for Feature 35.5-1.</p>

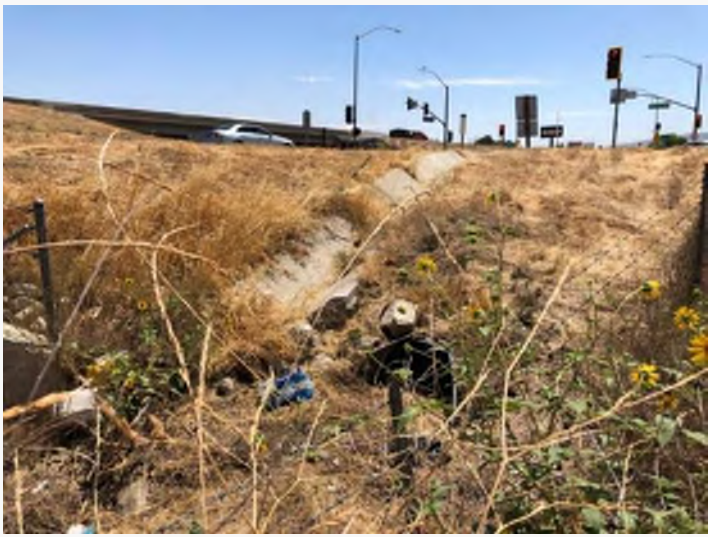
<p>Photograph #: 35.6-1_1</p> <p>Photo Date: 8/12/20</p> <p>Feature Number: 35.6-1</p> <p>Direction: Southeast</p> <p>Notes: View of concrete v-ditch for Feature 35.6-1.</p>

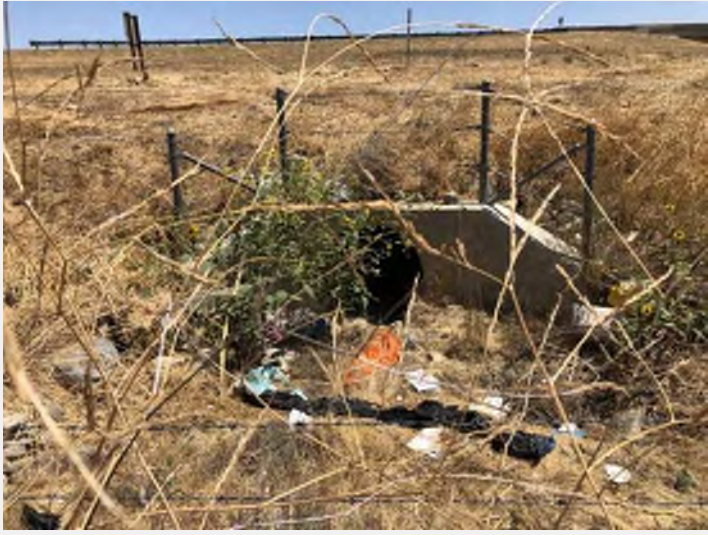
<p>Photograph #: 35.6-1_2</p> <p>Photo Date: 8/12/20</p> <p>Feature Number: 35.6-1</p> <p>Direction: Northeast</p> <p>Notes: View of concrete culvert for Feature 35.6-1.</p>

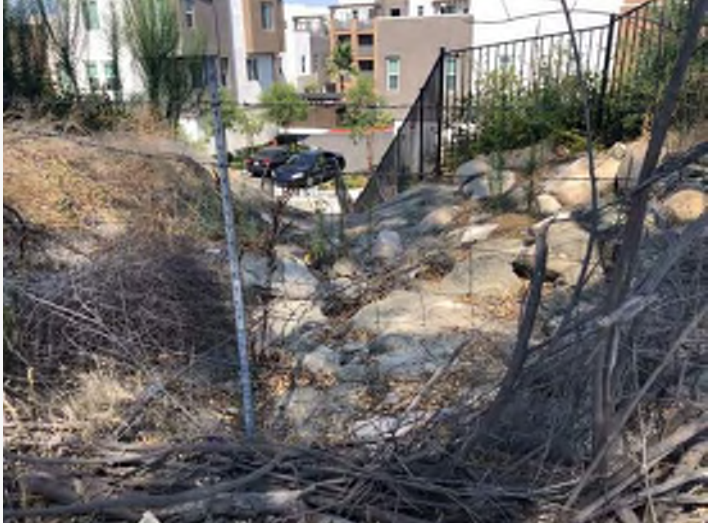
<p>Photograph #: 35.6-2_1</p> <p>Photo Date: 8/25/20</p> <p>Feature Number: 35.6-2</p> <p>Direction: Northeast</p> <p>Notes: View of rocky hillside channel for Feature 35.6-2.</p>

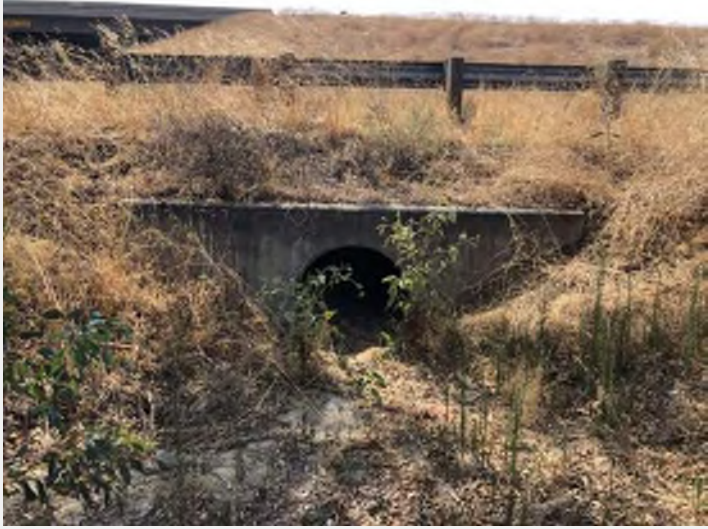
<p>Photograph #: 35.6-2_2</p> <p>Photo Date: 8/25/20</p> <p>Feature Number: 35.6-2</p> <p>Direction: Southwest</p> <p>Notes: View of concrete culvert for Feature 35.6-2.</p>

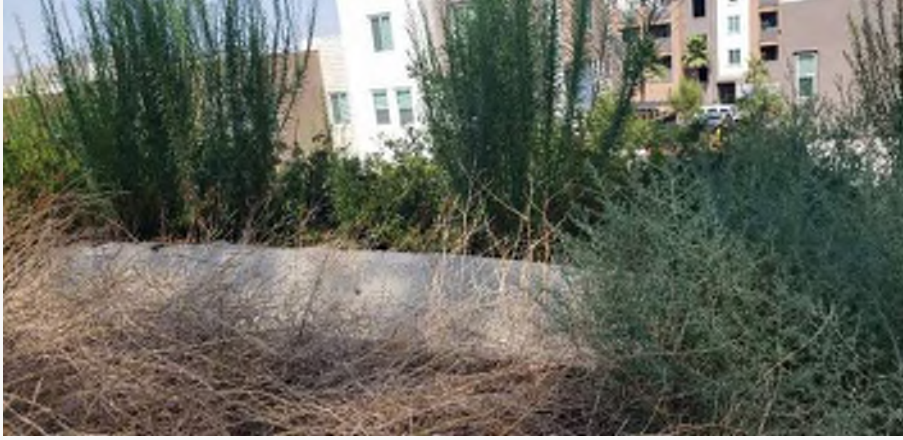
<p>Photograph #: 35.6-3_1</p> <p>Photo Date: 8/25/20</p> <p>Feature Number: 35.6-3</p> <p>Direction: Northeast</p> <p>Notes: View of concrete channel for Feature 35.6-3.</p>

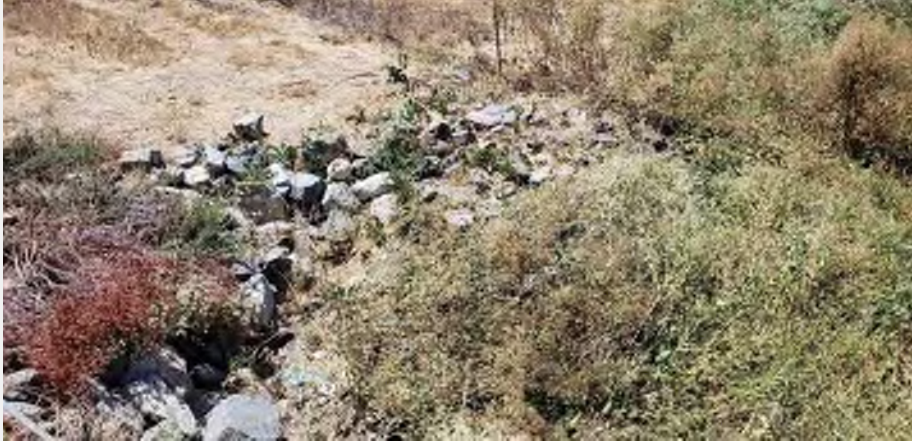
<p>Photograph #: 35.7-1_1</p> <p>Photo Date: 8/25/20</p> <p>Feature Number: 35.7-1</p> <p>Direction: Southwest</p> <p>Notes: View of rip-rap channel and riparian vegetation for Feature 35.7-1.</p>

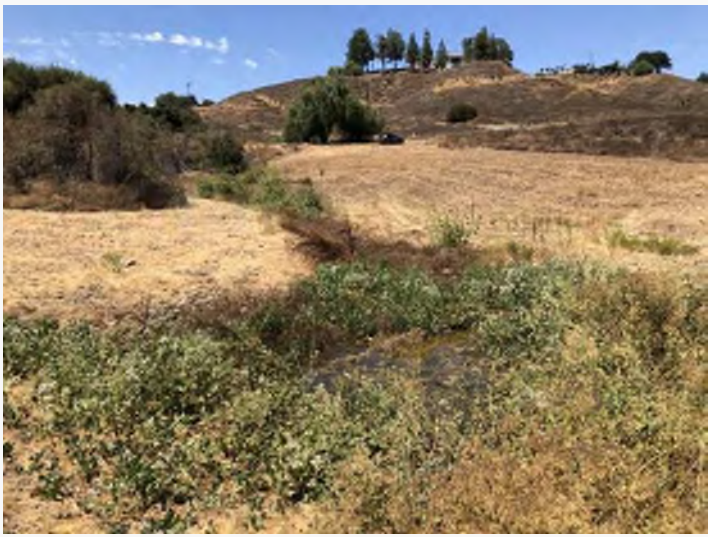
<p>Photograph #: 35.7-1_2</p> <p>Photo Date: 8/25/20</p> <p>Feature Number: 35.7-1</p> <p>Direction: Northwest</p> <p>Notes: View of riparian vegetation and open water for Feature 35.7-1.</p>

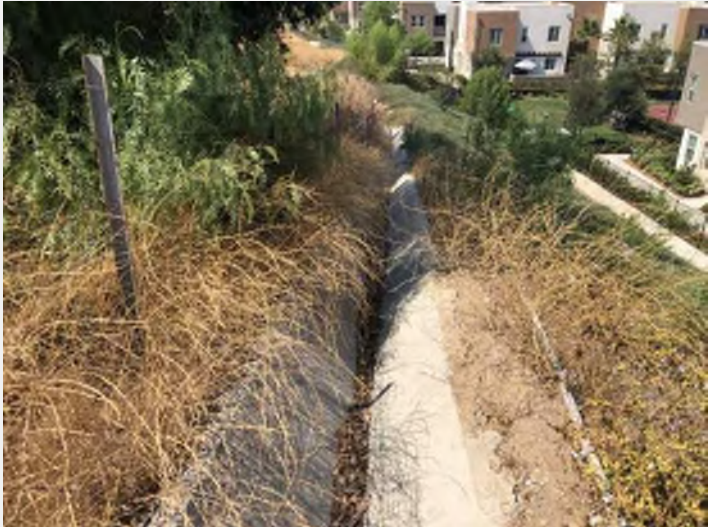
<p>Photograph #: 35.7-2_1</p> <p>Photo Date: 8/25/20</p> <p>Feature Number: 35.7-2</p> <p>Direction: Northwest</p> <p>Notes: View of concrete v-ditch for Feature 35.7-2.</p>

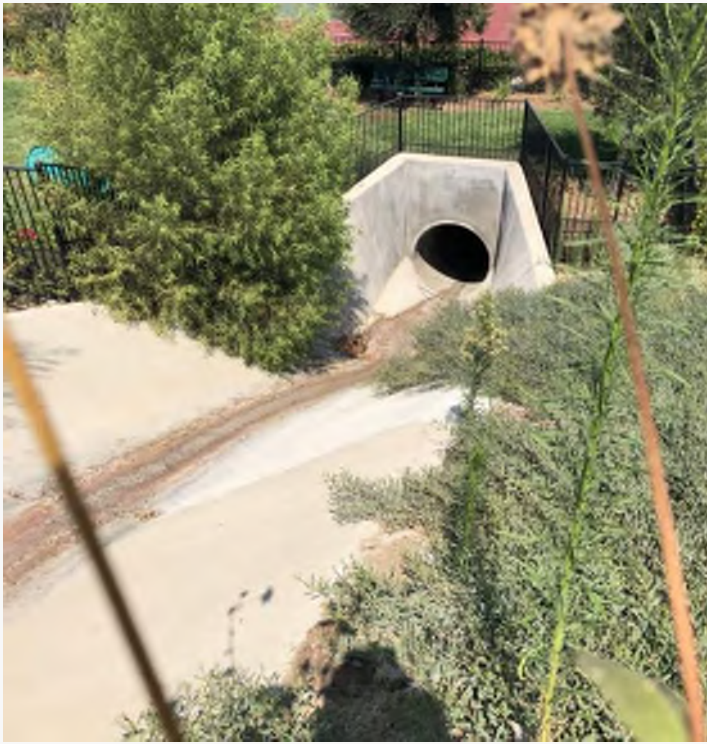
Photograph #: 35.7-3_1

Notes: View of concrete channel with staining and concrete culvert for Feature 35.7-3.

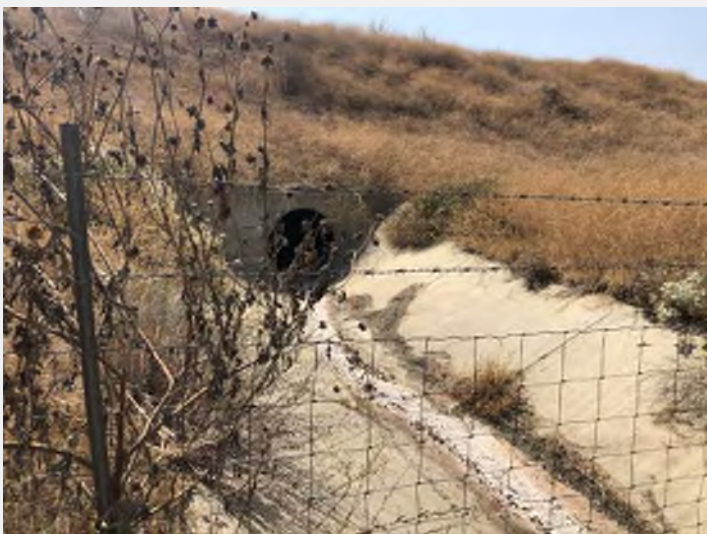
Photograph #: 35.7-3_2

Notes: View of concrete channel with staining and concrete culvert for Feature 35.7-3.

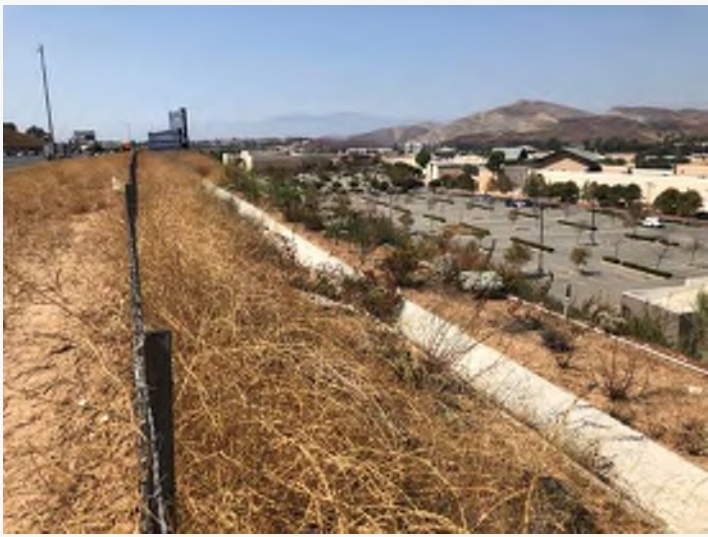
<p>Photograph #: 35.8-1_1</p> <p>Photo Date: 8/25/20</p> <p>Feature Number: 35.8-1</p> <p>Direction: Northwest</p> <p>Notes: View of concrete v-ditch for Feature 35.8-1.</p>
 	<p>Photograph #: 35.9-1_1</p> <p>Photo Date: 8/25/20</p> <p>Feature Number: 35.9-1</p> <p>Direction: Northeast</p> <p>Notes: View of concrete channel for Feature 35.9-1.</p>
 	<p>Photograph #: 36.1-1_1</p> <p>Photo Date: 8/26/20</p> <p>Feature Number: 36.1-1</p> <p>Direction: Northeast</p> <p>Notes: View of concrete culvert for Feature 36.1-1.</p>

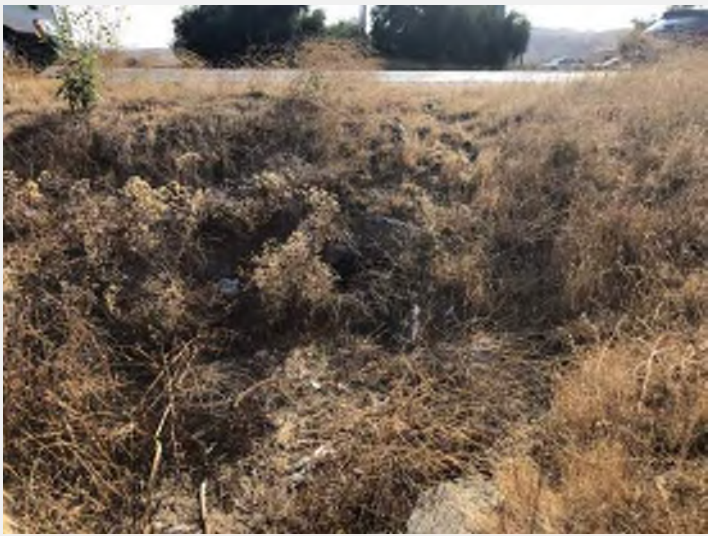
<p>Photograph #: 36.1-1_2</p> <p>Photo Date: 8/26/20</p> <p>Feature Number: 36.1-1</p> <p>Direction: East</p> <p>Notes: View of swale for Feature 36.1-1.</p>

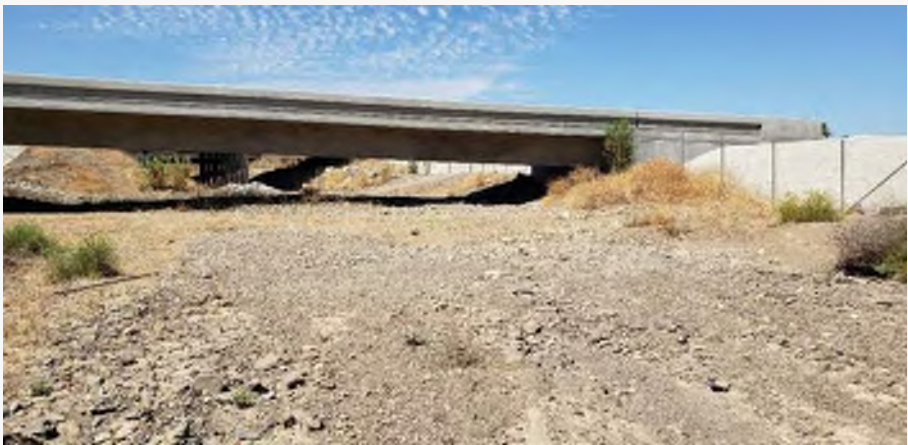
<p>Photograph #: 36.5-1_1</p> <p>Photo Date: 8/12/20</p> <p>Feature Number: 36.5-1 (Bedford Wash)</p> <p>Direction: Southwest</p> <p>Notes: View of earthen channel and riparian vegetation for Feature 36.5-1.</p>

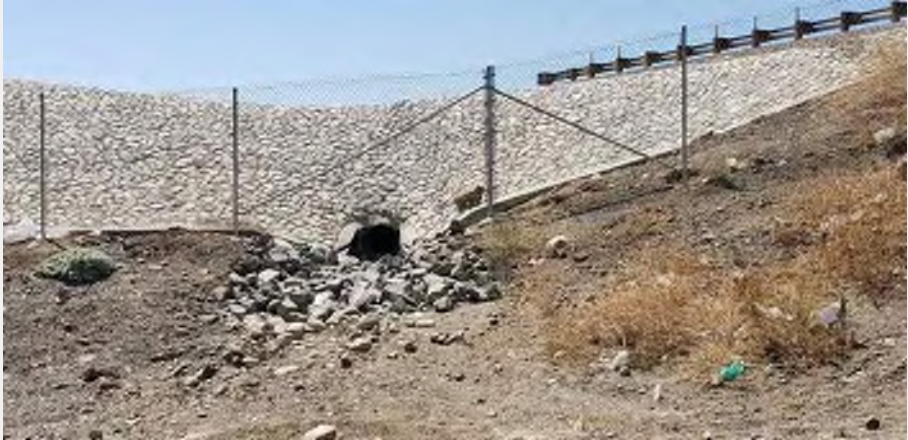
<p>Photograph #: 36.5-1_2</p> <p>Photo Date: 8/12/20</p> <p>Feature Number: 36.5-1 (Bedford Wash)</p> <p>Direction: Southeast</p> <p>Notes: Concrete culvert and rip-rap for Feature 36.5-1.</p>

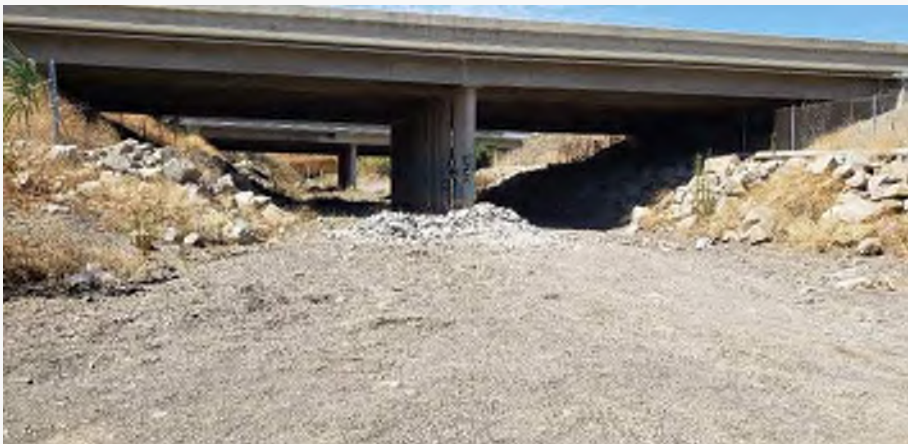
<p>Photograph #: 36.5-1_3</p> <p>Photo Date: 8/12/20</p> <p>Feature Number: 36.5-1 (Bedford Wash)</p> <p>Direction: Northeast</p> <p>Notes: View of earthen channel and riparian vegetation for Feature 36.5-1.</p>

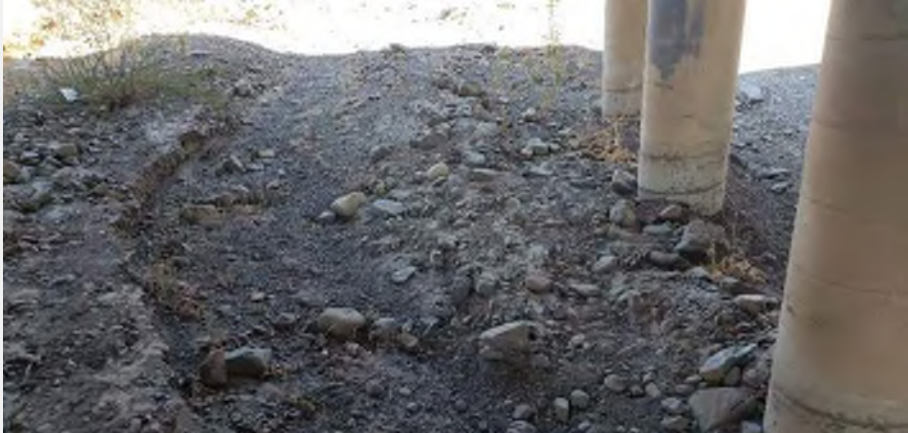
<p>Photograph #: 36.5-1_4</p> <p>Photo Date: 8/12/20</p> <p>Feature Number: 36.5-1 (Bedford Wash)</p> <p>Direction: Southwest</p> <p>Notes: View of earthen channel for Feature 36.5-1.</p>

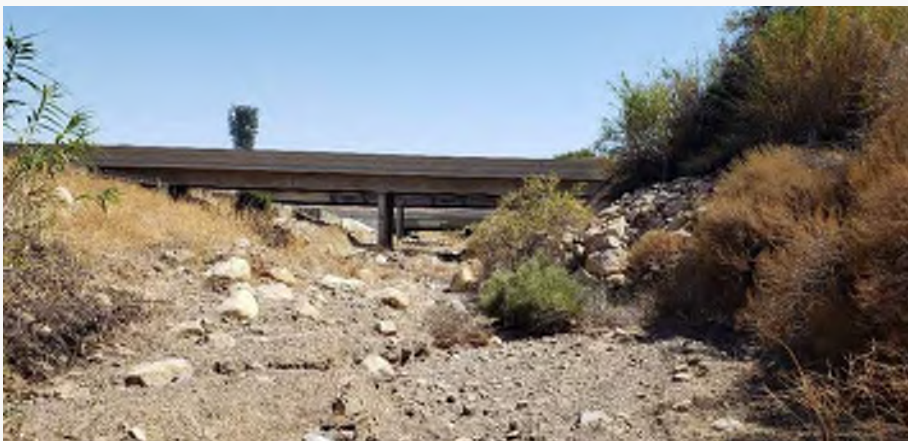
<p>Photograph #: 36.5-1_7</p> <p>Photo Date: 8/12/20</p> <p>Feature Number: 36.5-1 (Bedford Wash)</p> <p>Direction: Southwest</p> <p>Notes: View of earthen channel and riparian vegetation for Feature 36.5-1.</p>

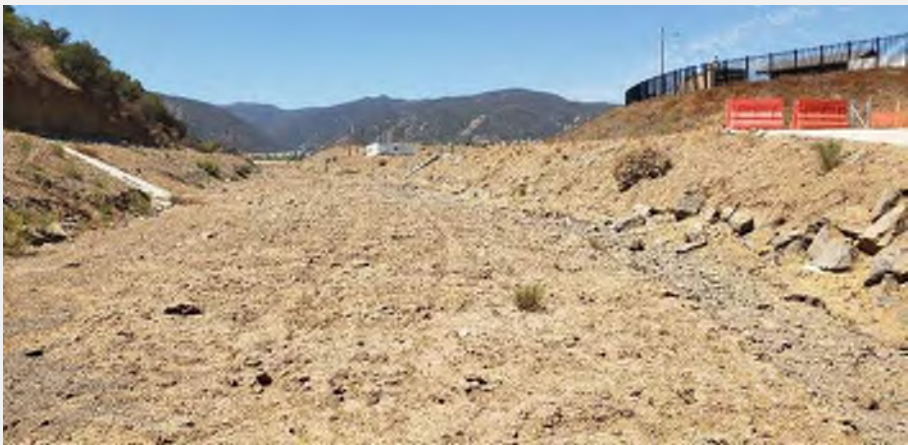
<p>Photograph #: 36.5-1_8</p> <p>Photo Date: 8/12/20</p> <p>Feature Number: 36.5-1 (Bedford Wash)</p> <p>Direction: Southwest</p> <p>Notes: View of earthen channel and riparian vegetation for Feature 36.5-1.</p>

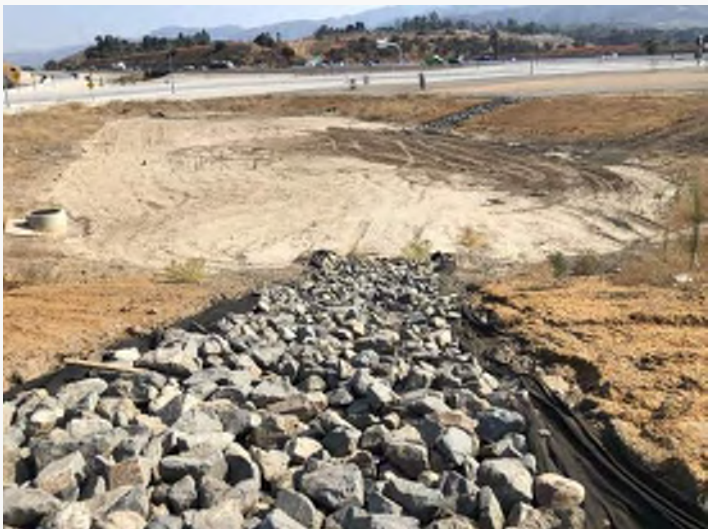
<p>Photograph #: 36.7-1_1</p> <p>Photo Date: 8/25/20</p> <p>Feature Number: 36.7-1</p> <p>Direction: Southwest</p> <p>Notes: View of rip-rap channels and earthen basin for Feature 36.7-1.</p>

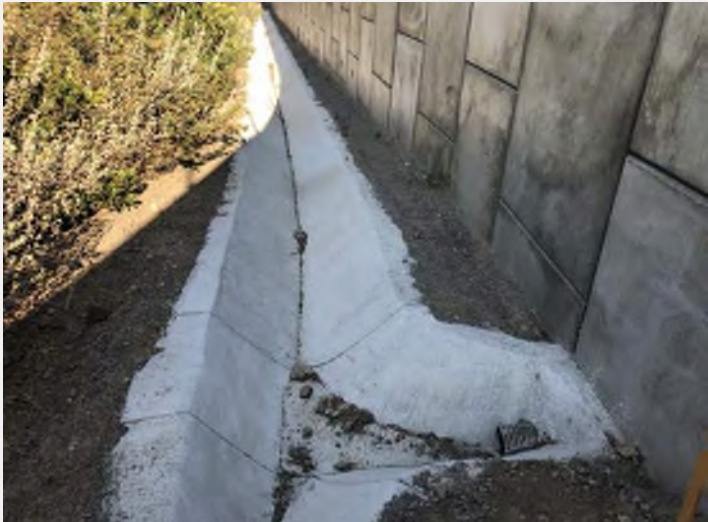
<p>Photograph #: 36.8-1_1</p> <p>Photo Date: 8/25/20</p> <p>Feature Number: 36.8-1</p> <p>Direction: East</p> <p>Notes: View of concrete v-ditch for Feature 36.8-1.</p>

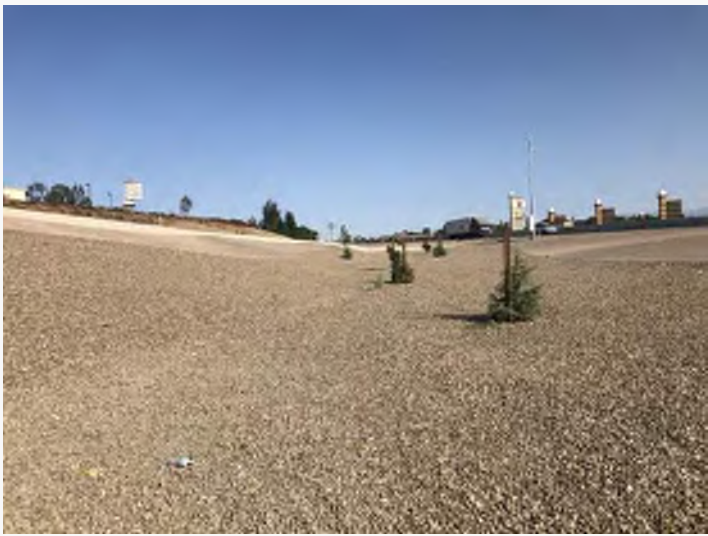
<p>Photograph #: 37.0-1_1</p> <p>Photo Date: 8/26/20</p> <p>Feature Number: 37.0-1</p> <p>Direction: Northwest</p> <p>Notes: View of roadside rocky swale for Feature 37.0-1.</p>

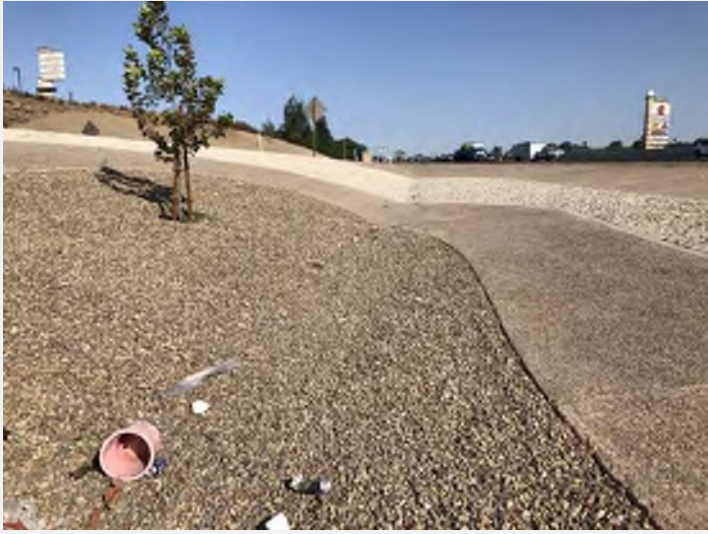
<p>Photograph #: 37.0-1_2</p> <p>Photo Date: 8/26/20</p> <p>Feature Number: 37.0-1</p> <p>Direction: Northwest</p> <p>Notes: View of roadside rocky swale for Feature 37.0-1.</p>

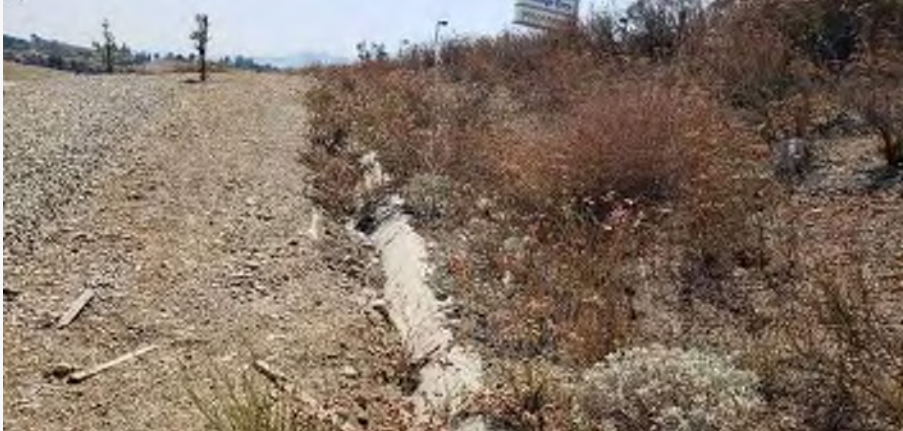
<p>Photograph #: 37.0-2_1</p> <p>Photo Date: 8/25/20</p> <p>Feature Number: 37.0-2</p> <p>Direction: Southeast</p> <p>Notes: View of concrete v-ditch for Feature 37.0-2.</p>

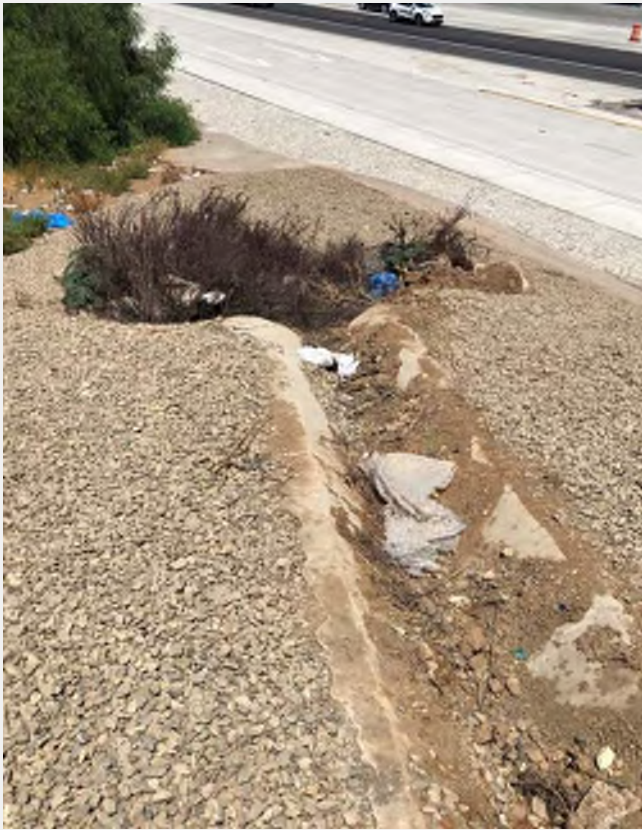
Photograph #: 37.0-2_2

Notes: View of concrete v-ditch for Feature 37.0-2.

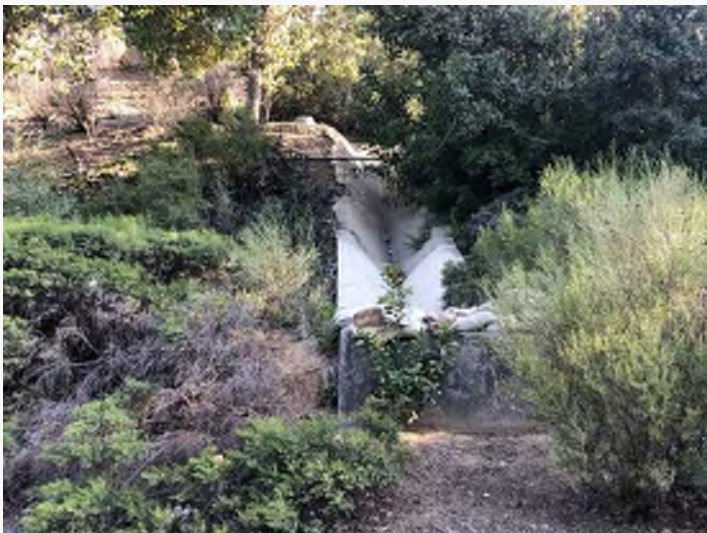
Photograph #: 37.0-3_1

Notes: View of concrete v-ditch for Feature 37.0-3.

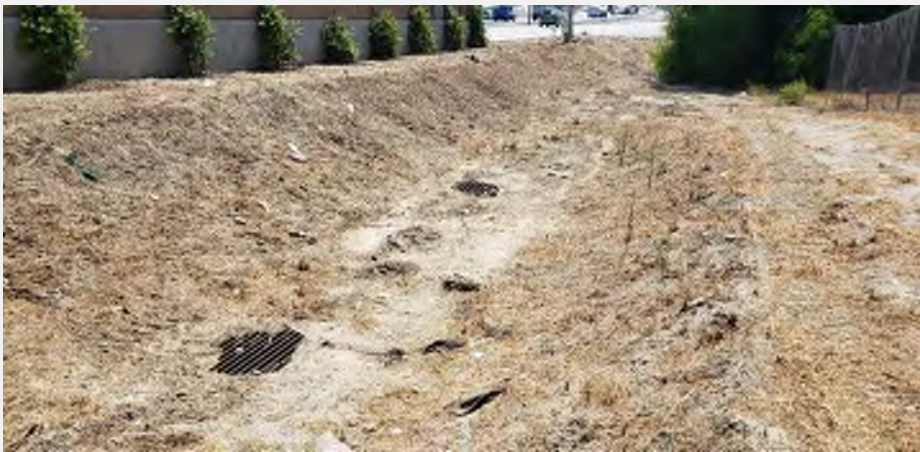
<p>Photograph #: 37.1-1_1</p> <p>Photo Date: 8/25/20</p> <p>Feature Number: 37.1-1</p> <p>Direction: Southeast</p> <p>Notes: View of drop drains and basin for Feature 37.1-1.</p>

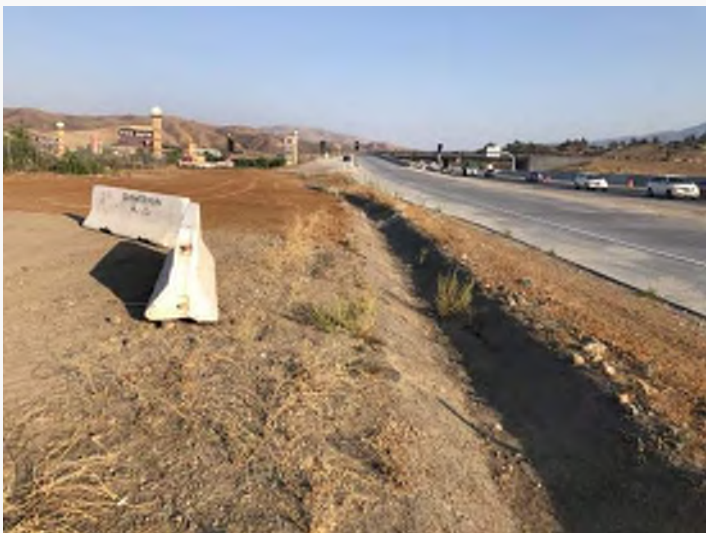
<p>Photograph #: 37.1-2_1</p> <p>Photo Date: 8/25/20</p> <p>Feature Number: 37.1-2</p> <p>Direction: Southeast</p> <p>Notes: View of roadside swale for Feature 37.1-2.</p>

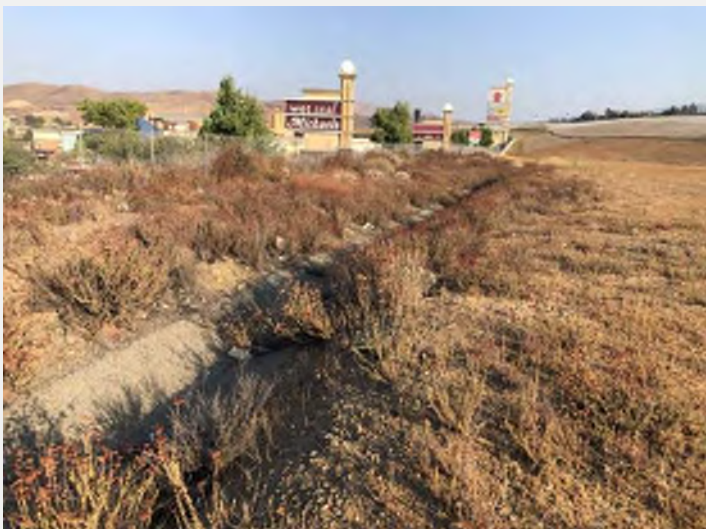
<p>Photograph #: 37.1-2_2</p> <p>Photo Date: 8/25/20</p> <p>Feature Number: 37.1-2</p> <p>Direction: Southeast</p> <p>Notes: View of concrete brow ditch for Feature 37.1-2.</p>

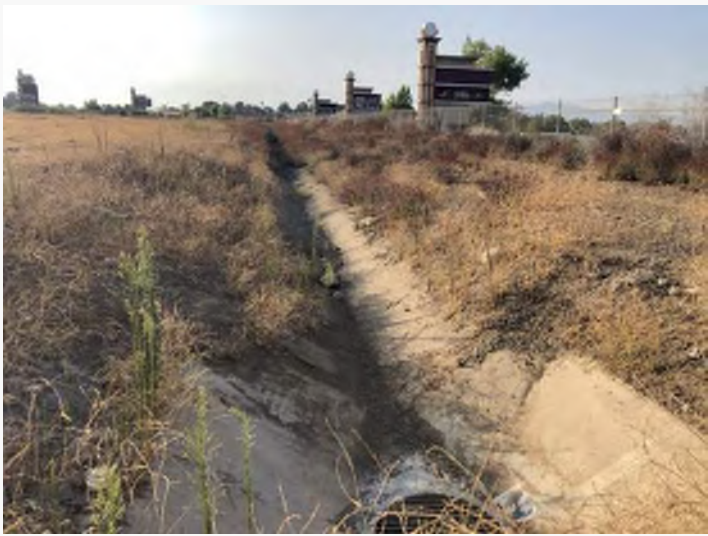
<p>Photograph #: 37.1-2_3</p> <p>Photo Date: 8/25/20</p> <p>Feature Number: 37.1-2</p> <p>Direction: Northwest</p> <p>Notes: View of concrete brow ditch for Feature 37.1-2.</p>

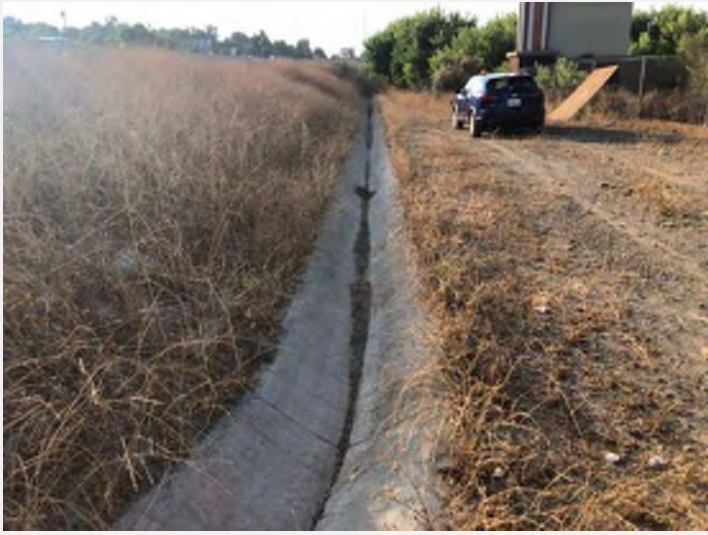
<p>Photograph #: 37.1-3_1</p> <p>Photo Date: 8/25/20</p> <p>Feature Number: 37.1-3</p> <p>Direction: Northwest</p> <p>Notes: View of concrete v-ditch for Feature 37.1-3.</p>

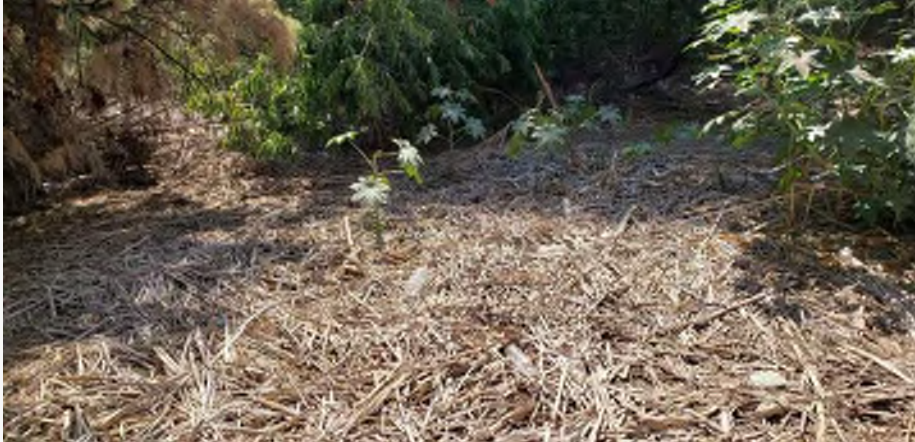
<p>Photograph #: 37.2-1_1</p> <p>Photo Date: 8/25/20</p> <p>Feature Number: 37.2-1</p> <p>Direction: Southeast</p> <p>Notes: View of riparian vegetation for Feature 37.2-1.</p>

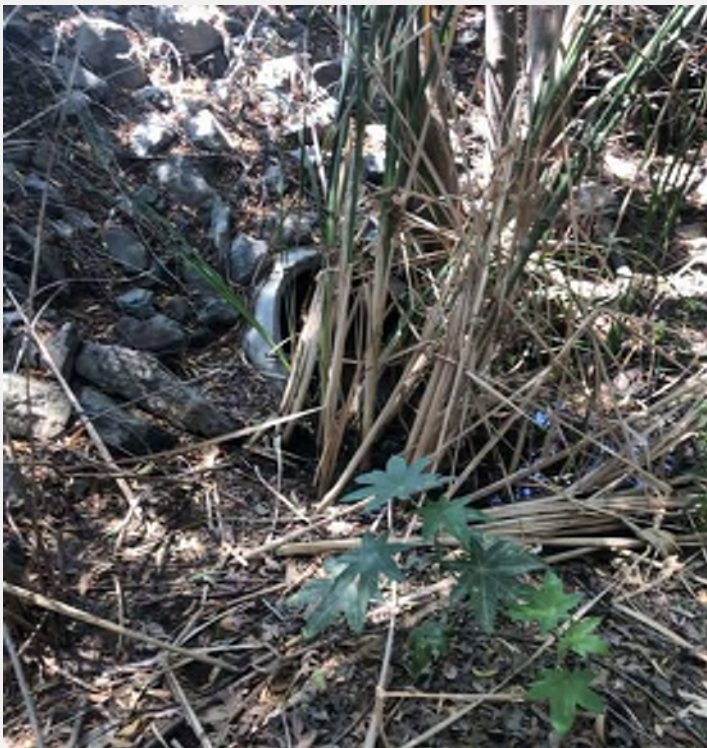
<p>Photograph #: 37.2-1_2</p> <p>Photo Date: 8/25/20</p> <p>Feature Number: 37.2-1</p> <p>Direction: Southwest</p> <p>Notes: View of culvert and riparian vegetation for Feature 37.2-1.</p>
 	<p>Photograph #: 37.2-2_1</p> <p>Photo Date: 8/27/20</p> <p>Feature Number: 37.2-2</p> <p>Direction: Northeast</p> <p>Notes: View of concrete channel with staining for Feature 37.2-2.</p>
