Interstate 15 Express Lanes Project Southern Extension (ELPSE)

RIVERSIDE COUNTY, CALIFORNIA
DISTRICT 8 – RIV-15 PM 20.3 TO PM 40.1
EA: RIV 08-0J0820 / ID: 08-18000063

Jurisdictional Delineation Report

September 2021

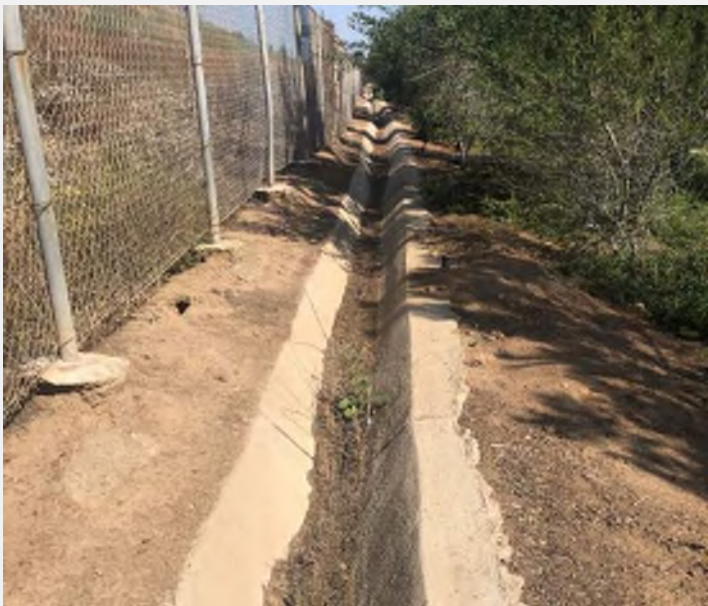
A photograph showing a long, narrow concrete v-ditch running parallel to a chain-link fence. The ditch is filled with dark water. The ground on either side is dirt and sparse vegetation. The fence is supported by metal posts.	<p>Photograph #: 37.9-2_1</p> <p>Photo Date: 8/25/20</p> <p>Feature Number: 37.9-2</p> <p>Direction: Northwest</p> <p>Notes: View of concrete v-ditch for Feature 37.9-2.</p>

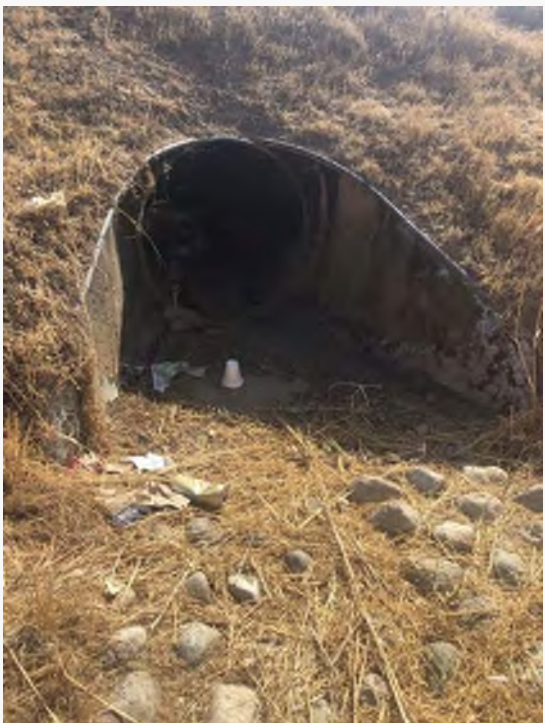
A photograph of a culvert opening. The culvert is a dark, arched structure set into a hillside. The area around the opening is rocky and covered with dry brush and grass. A white cone is visible inside the culvert.	<p>Photograph #:38.0-1_1</p> <p>Photo Date: 8/25/20</p> <p>Feature Number: 38.0-1</p> <p>Direction: Southeast</p> <p>Notes: View of culvert for Feature 38.0-1.</p>

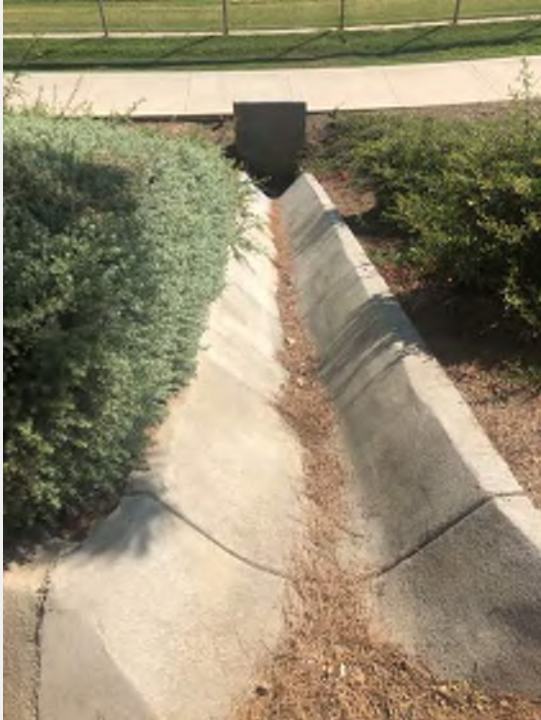
A photograph showing a long, narrow concrete ditch. At the top of the ditch, there is a dark, rectangular manhole cover. The ditch is flanked by green bushes and a concrete curb. The ground around the ditch is covered with dry leaves and some small plants.	<p>Photograph #: 38.0-2_1</p> <p>Photo Date: 8/25/20</p> <p>Feature Number: 38.0-2</p> <p>Direction: Northeast</p> <p>Notes: View of concrete ditch for Feature 38.0-2.</p>

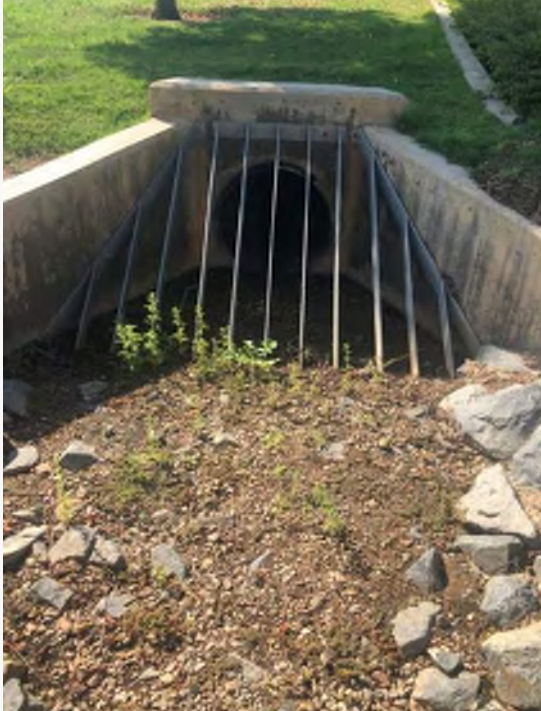
A photograph of a concrete culvert. The culvert is a large, rectangular structure with a metal grate on top. The grate is made of several vertical metal bars. The culvert is surrounded by a concrete curb and a gravel area. There are some small plants growing in the gravel.	<p>Photograph #: 38.0-3_1</p> <p>Photo Date: 8/24/20</p> <p>Feature Number: 38.0-3</p> <p>Direction: Northeast</p> <p>Notes: View of concrete culvert for Feature 38.0-3.</p>
